## Profile/Photo Observation Report

Street:	<b>Brandt Pl.</b>	Flow Control:	<b>Not Controlled</b>
City:	<b>Hobart, IN</b>	Year Renewed:	
Location:	<b>Other</b>	Tape/Media #:	
Purpose:	<b>Not Known</b>	Dia/Height:	<b>10"</b>
Use:	<b>Sanitary</b>	Material:	<b>VCP</b>
Drain Area:	<b>NA</b>	Lining:	
Category:	<b>NA</b>		
Comment:

Location Details:		Direction of Survey:	<b>Downstream</b>
US MH:	<b>M-904-039</b>	DS MH:	<b>M-904-038</b>
		Total Length Surveyed (ft):	<b>83.2</b>

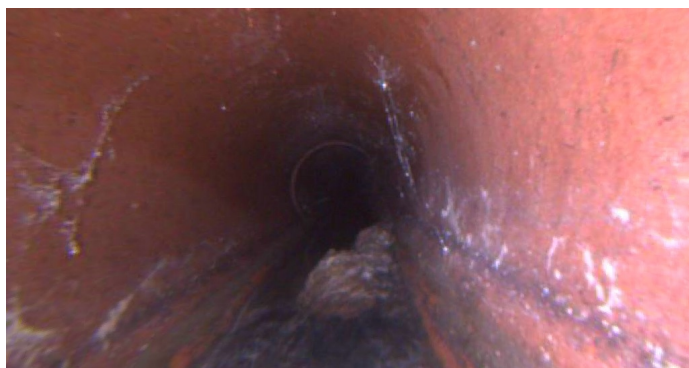
Code: **AMH**  
 Description: **Manhole**

Distance (ft): **.0**  
 Structural Grade: **0**  
 O&M Grade: **0**  
 Clock Start/From:  
 Clock To:  
 1st Value:  
 2nd Value:  
 Value Percent:  
 Continuous Index:  
 Within 8" of Joint: **NO**  
 Remarks: **M-904-039**

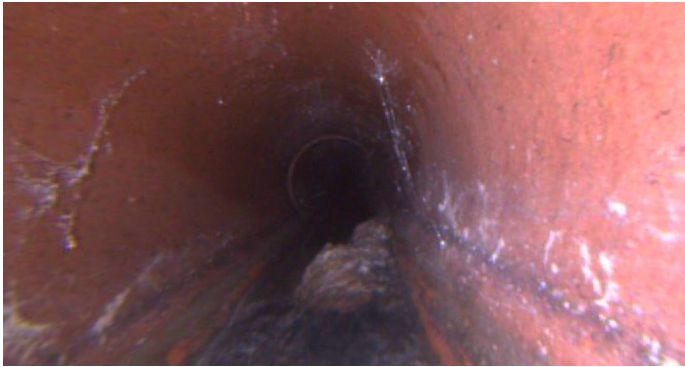
Code:	<b>MWL</b>
Description:	<b>Water Level</b>

Distance (ft):	<b>.0</b>
Structural Grade:	<b>0</b>
O&M Grade:	<b>0</b>
Clock Start/From:	
Clock To:	
1st Value:	
2nd Value:	
Value Percent:	<b>10.000</b>
Continuous Index:	
Within 8" of Joint:	<b>NO</b>
Remarks:

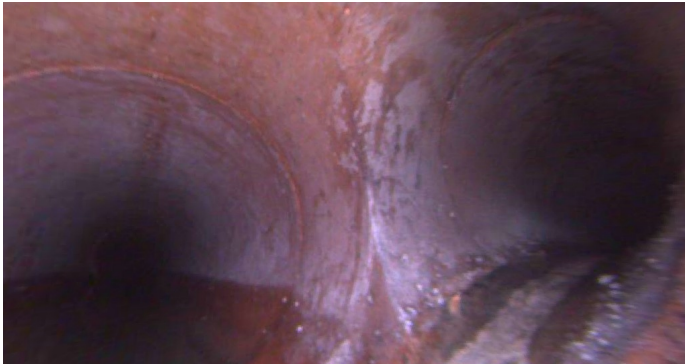
Code:	<b>TF</b>
Description:	<b>Tap Factory</b>

Distance (ft):	<b>39.7</b>
Structural Grade:	<b>0</b>
O&M Grade:	<b>0</b>
Clock Start/From:	<b>4</b>
Clock To:	
1st Value:	<b>4.000</b>
2nd Value:	
Value Percent:	
Continuous Index:	
Within 8" of Joint:	
Remarks:

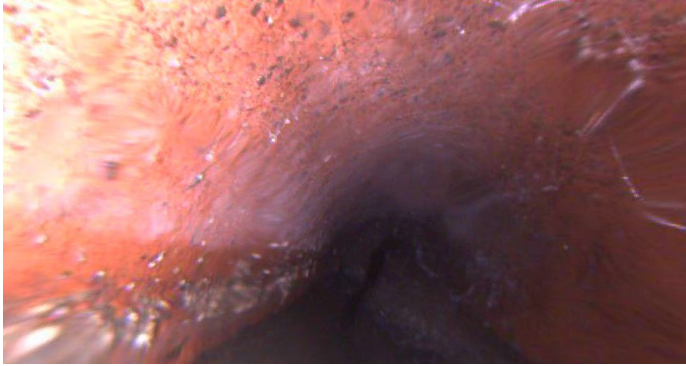
Code:	<b>MSA</b>
Description:	<b>Abandoned Survey</b>
Distance (ft):	<b>83.2</b>
Structural Grade:	<b>0</b>
O&M Grade:	<b>0</b>
Clock Start/From:	
Clock To:	
1st Value:	
2nd Value:	
Value Percent:	
Continuous Index:	
Within 8" of Joint:	<b>NO</b>
Remarks:	<b>Debris</b>
