## Profile/Photo Observation Report

| Street: | <b>BRANDT PL</b> | Flow Control: | <b>Not Controlled</b> |

| US MH: | <b>M-904-039</b> | DS MH: | <b>M-904-038</b> |

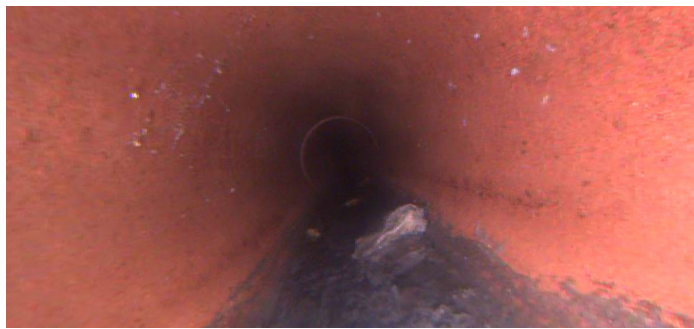
Code: **AMH**  
Description: **Manhole**

Distance (ft): **.0**  
Structural Grade: **0**  
O&M Grade: **0**  
Clock Start/From:  
Clock To:  
1st Value:  
2nd Value:  
Value Percent:  
Continuous Index:  
Within 8" of Joint: **NO**  
Remarks: **M-904-039**

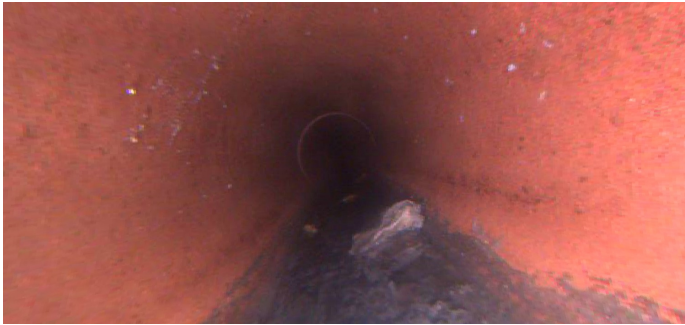
| Code: | <b>MWL</b> |
| Description: | <b>Water Level</b> |

| Distance (ft): | <b>.0</b> |
| Value Percent: | <b>5.000</b> |

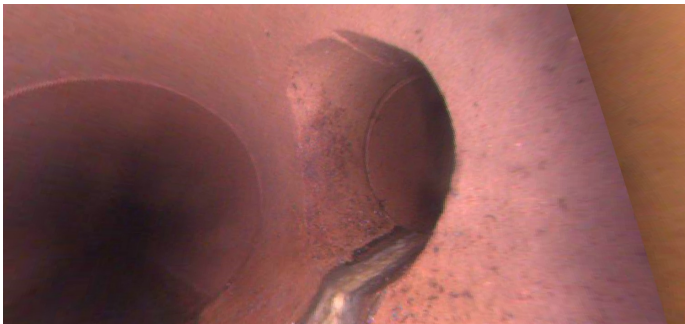
| Code: | <b>TF</b> |
| Description: | <b>Tap Factory</b> |

| Distance (ft): | <b>40.2</b> |
| Clock Start/From: | <b>3</b> |
| 1st Value: | <b>4.000</b> |
