Profile/Photo Observation Report

Date:	10/04/2018	Weather:		Coding:	PACP 6.0
Pipe Length (ft):	230.3	Owner:	NA	Pre Clean:	Not Known
P.O.#:		Surveyor:	Justin Gonzales	PSR:	P-904-038-039
Customer:		Clean Date:	01/01/1900	Shape:	C

Street:	Brandt Pl.	Flow Control:	Not Controlled
City:	Hobart, IN	Year Renewed:	
Location:	Light Highway	Tape/Media #:	
Purpose:	Routine Assessment	Dia/Height:	10"
Use:	Sanitary	Material:	VCP
Drain Area:	NA	Lining:	
Category:	NA		
Comment:

Location Details:		Direction of Survey:	Downstream
US MH:	M-904-039	DS MH:	M-904-038
		Total Length Surveyed (ft):	85.9

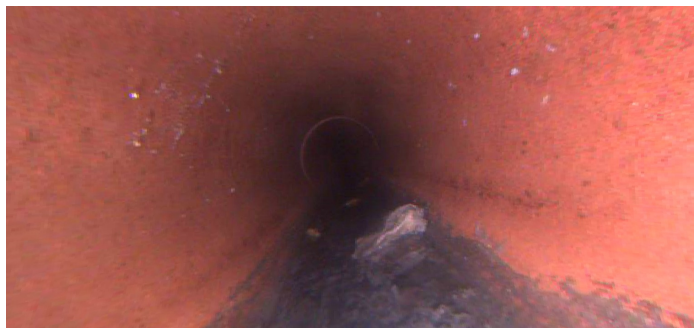
Code: **AMH**
Description: **Manhole**

Distance (ft): **.0**
Structural Grade: **0**
O&M Grade: **0**
Clock Start/From:
Clock To:
1st Value:
2nd Value:
Value Percent:
Continuous Index:
Within 8" of Joint: **NO**
Remarks: **M-904-039**

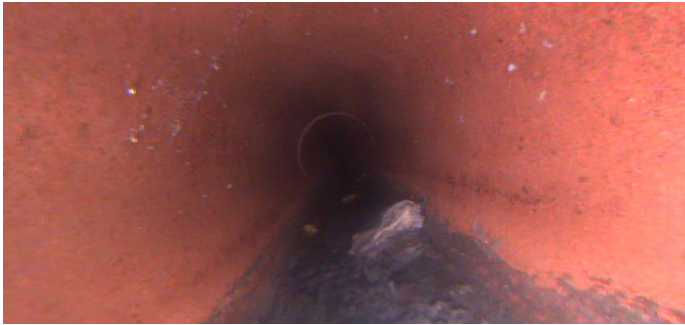
Code:	MWL
Description:	Water Level

Distance (ft):	.0
Structural Grade:	0
O&M Grade:	0
Clock Start/From:	
Clock To:	
1st Value:	
2nd Value:	
Value Percent:	5.000
Continuous Index:	
Within 8" of Joint:	NO
Remarks:

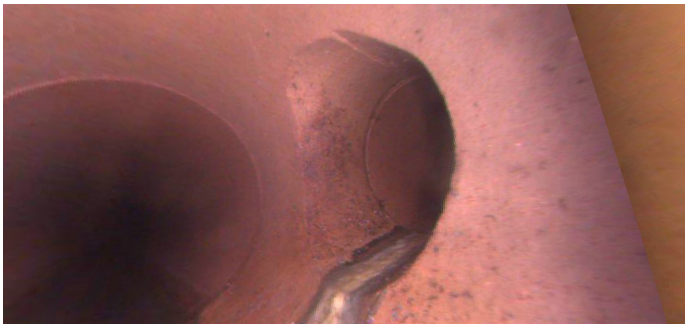
Code:	TF
Description:	Tap Factory

Distance (ft):	40.2
Structural Grade:	0
O&M Grade:	0
Clock Start/From:	3
Clock To:	
1st Value:	4.000
2nd Value:	
Value Percent:	
Continuous Index:	
Within 8" of Joint:	
Remarks:

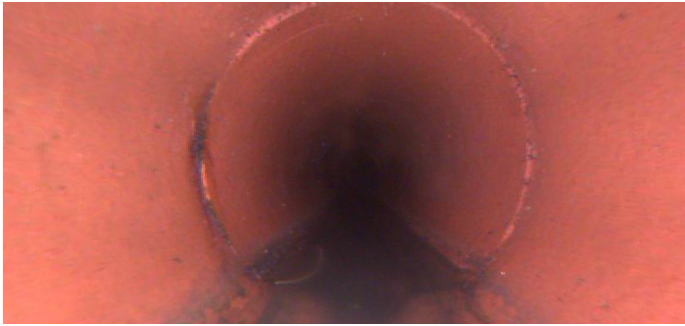
Code: **RFJ**
Description: **Roots Fine Joint**

Distance (ft): **55.9**
Structural Grade: **0**
O&M Grade: **1**
Clock Start/From: **7**
Clock To: **9**
1st Value:
2nd Value:
Value Percent:
Continuous Index:
Within 8" of Joint: **YES**
Remarks:

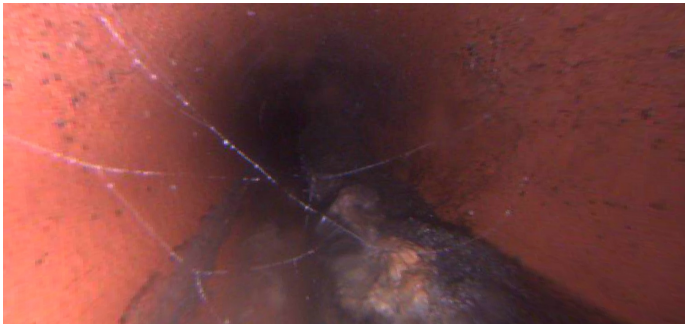
Code: **RMB**
Description: **Roots Medium Barrel**

Distance (ft): **83.9**
Structural Grade: **0**
O&M Grade: **4**
Clock Start/From: **2**
Clock To: **6**
1st Value:
2nd Value:
Value Percent: **20.000**
Continuous Index:
Within 8" of Joint: **NO**
Remarks:

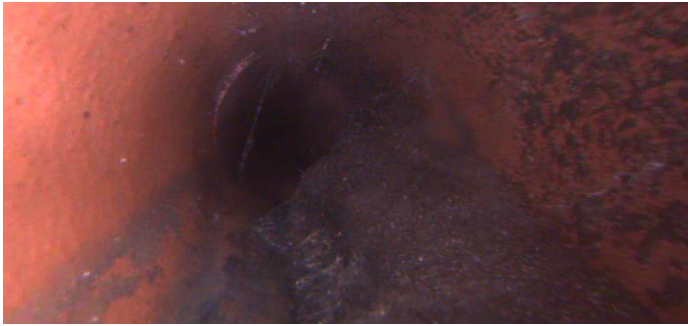
Code:	MSA
Description:	Abandoned Survey
Distance (ft):	85.9
Structural Grade:	0
O&M Grade:	0
Clock Start/From:	
Clock To:	
1st Value:	
2nd Value:	
Value Percent:	
Continuous Index:	
Within 8" of Joint:	NO
Remarks:	CANNOT PASS RMB
