## Profile/Photo Observation Report

Street:	<b>BRANDT PL</b>	Flow Control:	<b>Not Controlled</b>
City:	<b>Hobart, IN</b>	Year Renewed:	
Location:	<b>Other</b>	Tape/Media #:	
Purpose:	<b>Not Known</b>	Dia/Height:	<b>10"</b>
Use:	<b>Sanitary</b>	Material:	<b>VCP</b>
Drain Area:	<b>NA</b>	Lining:	
Category:	<b>NA</b>		
Comment:	<b>NULL - CNL - REV - NULL - CNL</b>

Location Details:		Direction of Survey:	<b>Downstream</b>
US MH:	<b>M-904-039</b>	DS MH:	<b>M-904-041</b>
		Total Length Surveyed (ft):	<b>99.5</b>

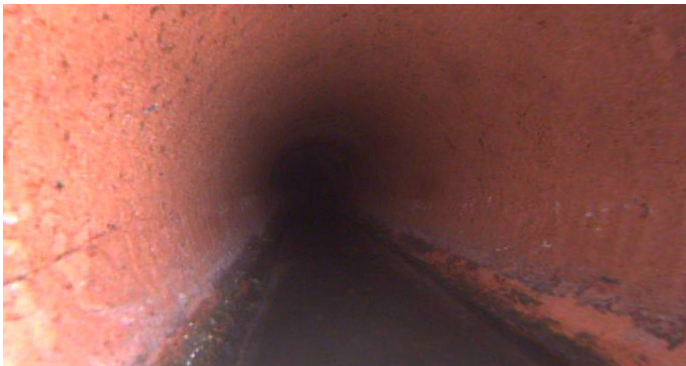
The diagram shows a vertical pipe section. At the top, a circle is labeled **M-904-039**. At the bottom, a circle is labeled **M-904-041**. A red arrow points downwards along the left side of the pipe, labeled **Camera Direction**. A table is positioned to the right of the pipe, with lines connecting its rows to specific points on the pipe. The table has five columns: **Position**, **Code**, **Observation**, **Video (sec)**, and **Grade**.

Position	Code	Observation	Video (sec)	Grade
.0	AMH	Manhole	11	NA
.0	MWL	Water Level	22	NA
23.0	TB	Tap Break-in	80	NA
74.6	TB	Tap Break-in	195	NA
76.7	TF	Tap Factory	212	NA
99.5	AMH	Manhole	269	NA

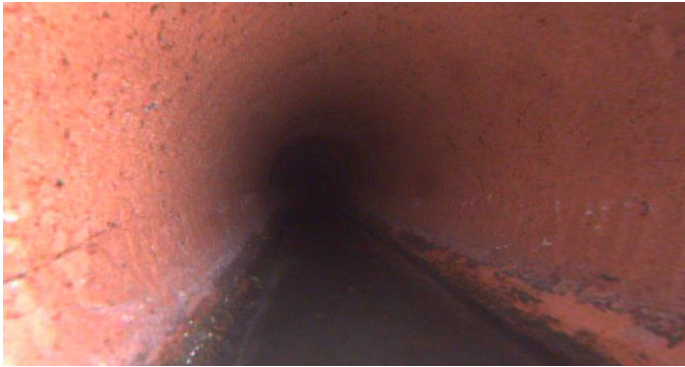
Code:	<b>MWL</b>
Description:	<b>Water Level</b>

Distance (ft):	<b>.0</b>
Structural Grade:	<b>0</b>
O&M Grade:	<b>0</b>
Clock Start/From:	
Clock To:	
1st Value:	
2nd Value:	
Value Percent:	<b>10.000</b>
Continuous Index:	
Within 8" of Joint:	<b>NO</b>
Remarks:

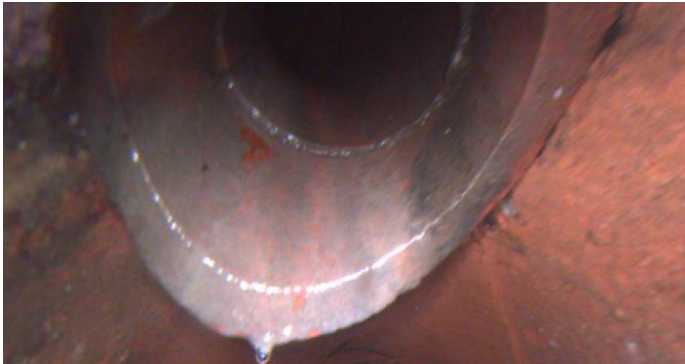
Code:	<b>TB</b>
Description:	<b>Tap Break-in</b>

Distance (ft):	<b>23.0</b>
Structural Grade:	<b>0</b>
O&M Grade:	<b>0</b>
Clock Start/From:	<b>12</b>
Clock To:	
1st Value:	<b>4.000</b>
2nd Value:	
Value Percent:	
Continuous Index:	
Within 8" of Joint:	
Remarks:

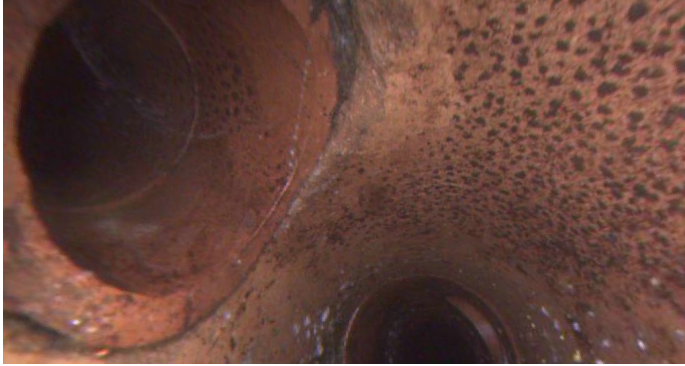
Code: **TB**  
Description: **Tap Break-in**

Distance (ft): **74.6**  
Structural Grade: **0**  
O&M Grade: **0**  
Clock Start/From: **10**  
Clock To:  
1st Value: **4.000**  
2nd Value:  
Value Percent:  
Continuous Index:  
Within 8" of Joint:  
Remarks:

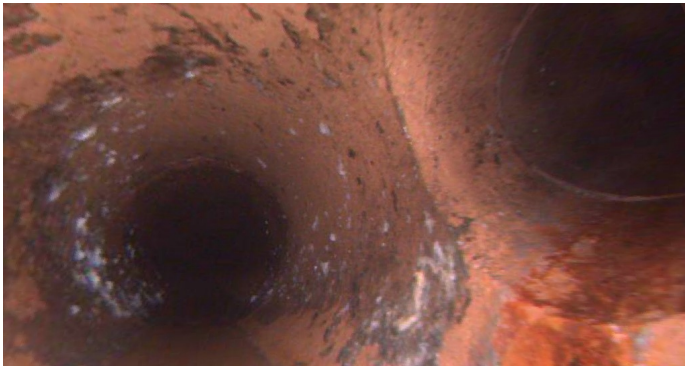
Code: **TF**  
Description: **Tap Factory**

Distance (ft): **76.7**  
Structural Grade: **0**  
O&M Grade: **0**  
Clock Start/From: **3**  
Clock To:  
1st Value: **4.000**  
2nd Value:  
Value Percent:  
Continuous Index:  
Within 8" of Joint:  
Remarks:

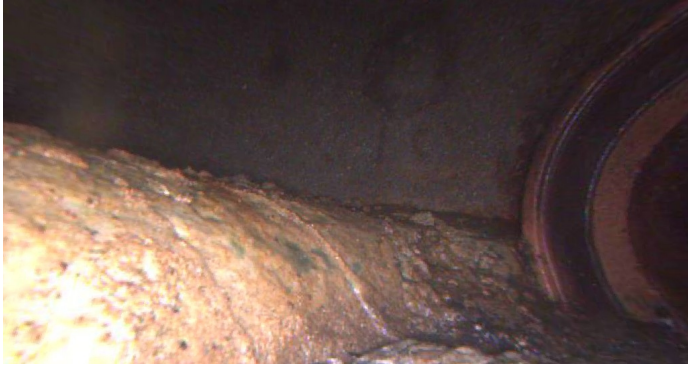
Code:	AMH
Description:	Manhole
Distance (ft):	99.5
Structural Grade:	0
O&M Grade:	0
Clock Start/From:	
Clock To:	
1st Value:	
2nd Value:	
Value Percent:	
Continuous Index:	
Within 8" of Joint:	NO
Remarks:	M-904-041
