Profile/Photo Observation Report

Street:	RUSH CT	Flow Control:	Not Controlled
City:	Hobart, IN	Year Renewed:	
Location:	Other	Tape/Media #:	
Purpose:	Not Known	Dia/Height:	12"
Use:	Sanitary	Material:	VCP
Drain Area:	NA	Lining:	
Category:	NA		
Comment:			
Location Details:		Direction of Survey:	Downstream
US MH:	M-904-045	DS MH:	M-904-046
		Total Length Surveyed (ft):	280.5

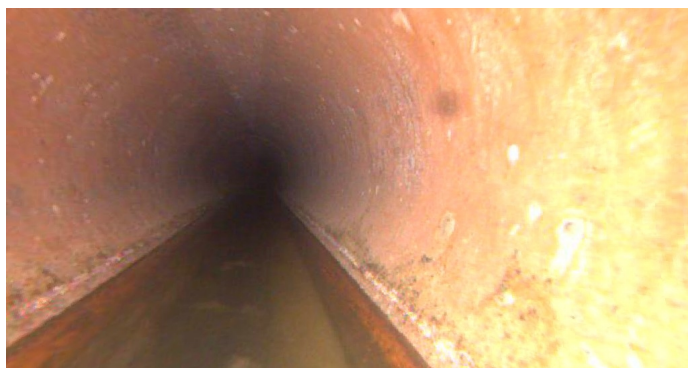
Code: **AMH**
 Description: **Manhole**

Distance (ft): **.0**
 Structural Grade: **0**
 O&M Grade: **0**
 Clock Start/From:
 Clock To:
 1st Value:
 2nd Value:
 Value Percent:
 Continuous Index:
 Within 8" of Joint: **NO**
 Remarks: **M-904-045**

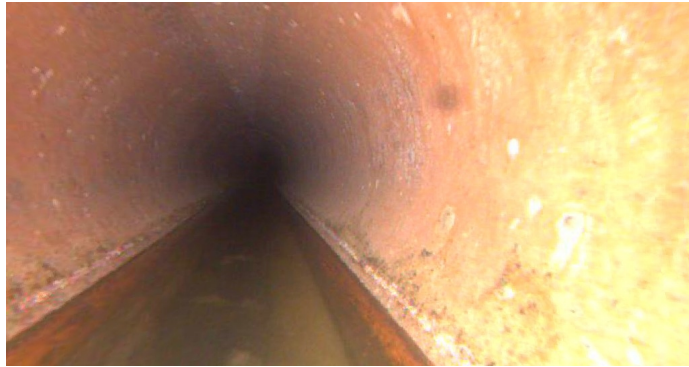
Code: **MWL**
Description: **Water Level**

Distance (ft): **.0**
Structural Grade: **0**
O&M Grade: **0**
Clock Start/From:
Clock To:
1st Value:
2nd Value:
Value Percent: **10.000**
Continuous Index:
Within 8" of Joint: **NO**
Remarks:

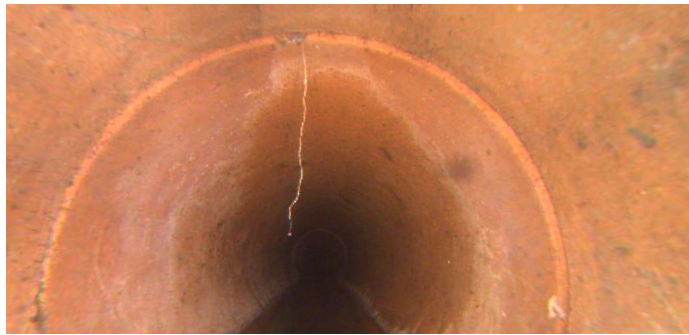
Code: **RFJ**
Description: **Roots Fine Joint**

Distance (ft): **20.1**
Structural Grade: **0**
O&M Grade: **1**
Clock Start/From: **12**
Clock To:
1st Value:
2nd Value:
Value Percent:
Continuous Index:
Within 8" of Joint: **YES**
Remarks:

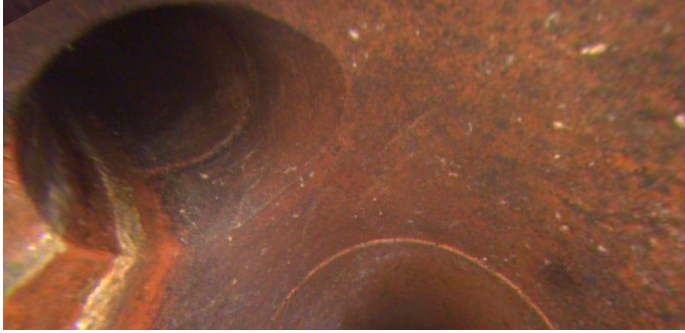
Code: **TF**
Description: **Tap Factory**

Distance (ft): **26.7**
Structural Grade: **0**
O&M Grade: **0**
Clock Start/From: **10**
Clock To:
1st Value: **4.000**
2nd Value:
Value Percent:
Continuous Index:
Within 8" of Joint:
Remarks:

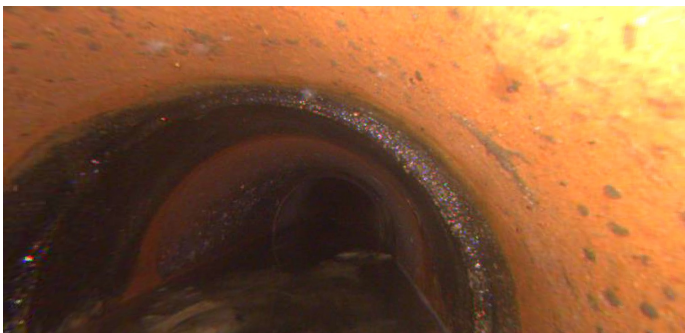
Code: **IW**
Description: **Infil Weeper**

Distance (ft): **37.1**
Structural Grade: **0**
O&M Grade: **2**
Clock Start/From: **8**
Clock To: **4**
1st Value:
2nd Value:
Value Percent:
Continuous Index:
Within 8" of Joint: **YES**
Remarks:

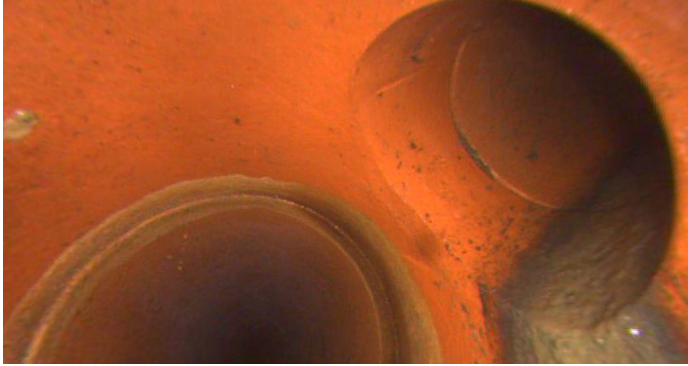
Code: **TF**
Description: **Tap Factory**

Distance (ft): **97.6**
Structural Grade: **0**
O&M Grade: **0**
Clock Start/From: **2**
Clock To:
1st Value: **4.000**
2nd Value:
Value Percent:
Continuous Index:
Within 8" of Joint:
Remarks:

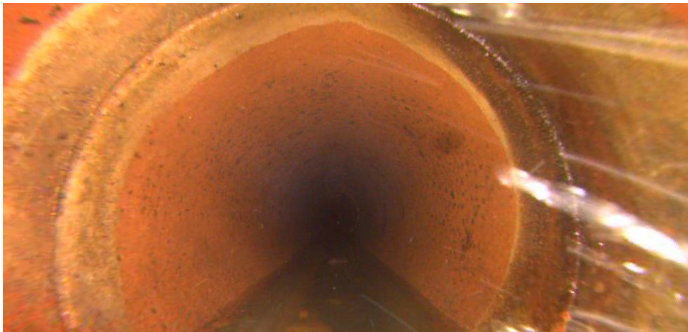
Code: **IW**
Description: **Infil Weeper**

Distance (ft): **98.2**
Structural Grade: **0**
O&M Grade: **2**
Clock Start/From: **8**
Clock To: **4**
1st Value:
2nd Value:
Value Percent:
Continuous Index:
Within 8" of Joint: **YES**
Remarks:

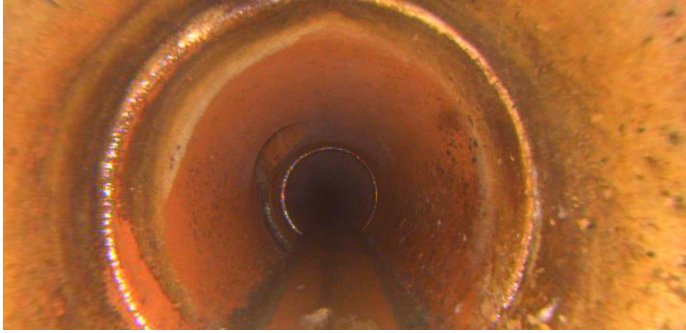
Code: **IW**
Description: **Infil Weeper**

Distance (ft): **143.0**
Structural Grade: **0**
O&M Grade: **2**
Clock Start/From: **8**
Clock To: **4**
1st Value:
2nd Value:
Value Percent:
Continuous Index:
Within 8" of Joint: **YES**
Remarks:

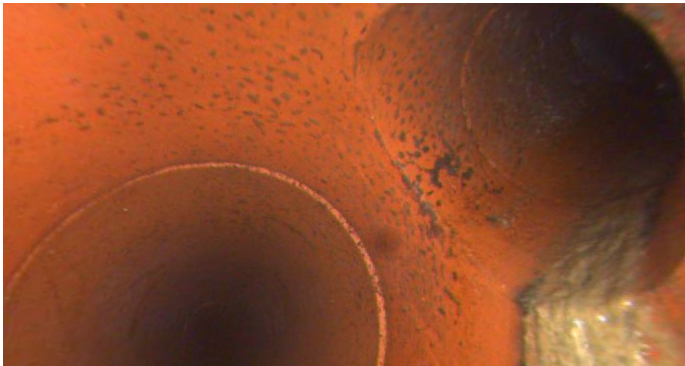
Code: **TF**
Description: **Tap Factory**

Distance (ft): **161.8**
Structural Grade: **0**
O&M Grade: **0**
Clock Start/From: **2**
Clock To:
1st Value: **4.000**
2nd Value:
Value Percent:
Continuous Index:
Within 8" of Joint:
Remarks:

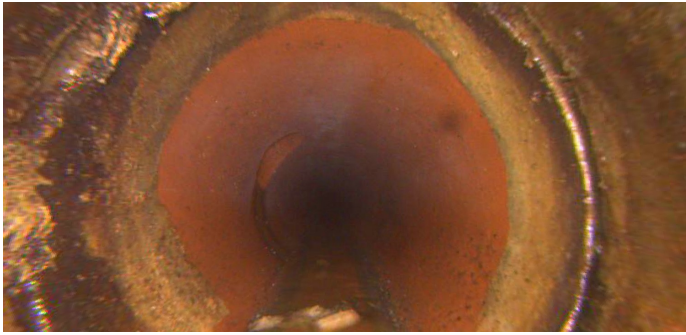
Code: **IW**
Description: **Infil Weeper**

Distance (ft): **202.5**
Structural Grade: **0**
O&M Grade: **2**
Clock Start/From: **8**
Clock To: **4**
1st Value:
2nd Value:
Value Percent:
Continuous Index:
Within 8" of Joint: **YES**
Remarks:

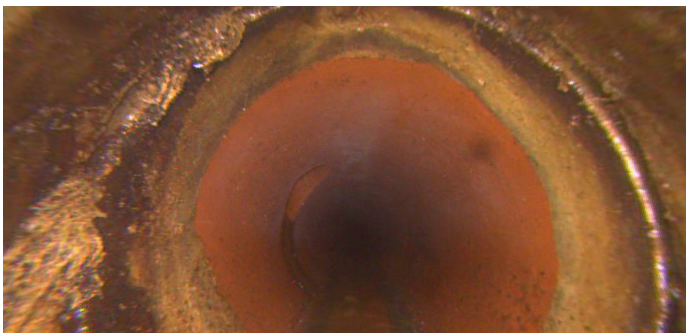
Code: **DAE**
Description: **Deposits Attached Encrustation**

Distance (ft): **202.5**
Structural Grade: **0**
O&M Grade: **2**
Clock Start/From: **8**
Clock To: **12**
1st Value:
2nd Value:
Value Percent: **5.000**
Continuous Index:
Within 8" of Joint: **YES**
Remarks:

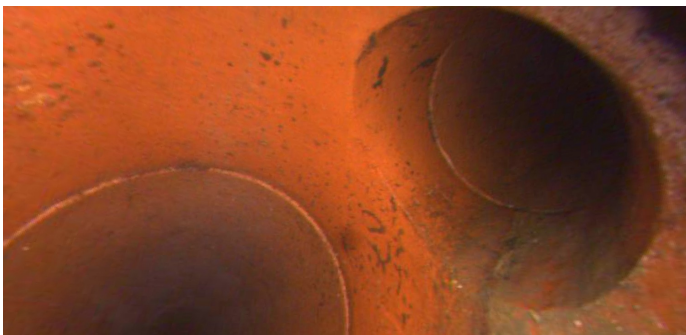
Code: **TF**
Description: **Tap Factory**

Distance (ft): **221.0**
Structural Grade: **0**
O&M Grade: **0**
Clock Start/From: **2**
Clock To:
1st Value: **4.000**
2nd Value:
Value Percent:
Continuous Index:
Within 8" of Joint:
Remarks:

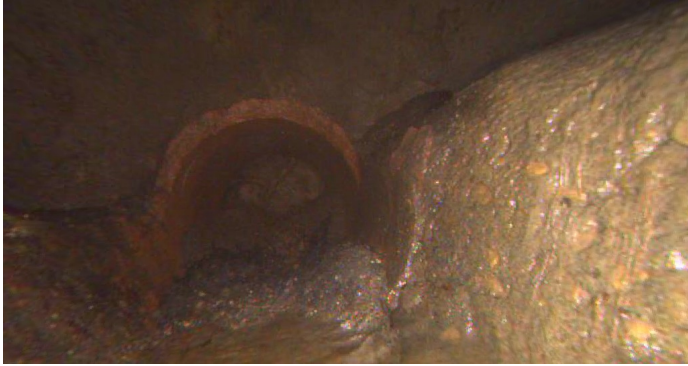
Code:	AMH
Description:	Manhole
Distance (ft):	280.5
Structural Grade:	0
O&M Grade:	0
Clock Start/From:	
Clock To:	
1st Value:	
2nd Value:	
Value Percent:	
Continuous Index:	
Within 8" of Joint:	NO
Remarks:	M-904-046
