Profile/Photo Observation Report

Street:	RUSH ST & HICKEY PL	Flow Control:	Not Controlled
City:	Hobart, IN	Year Renewed:	
Location:	Light Highway	Tape/Media #:	
Purpose:	Routine Assessment	Dia/Height:	10"
Use:	Sanitary	Material:	VCP
Drain Area:	NA	Lining:	
Category:	NA		
Comment:

Location Details:		Direction of Survey:	Upstream
US MH:	M-904-047	DS MH:	M-904-048
		Total Length Surveyed (ft):	35.0

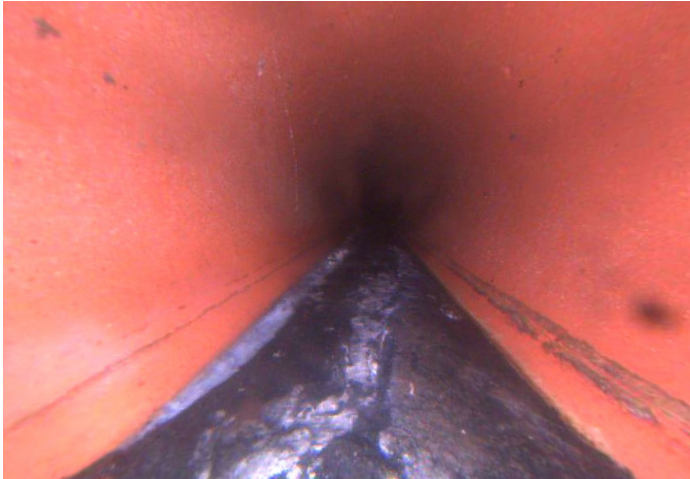
Code:

AMH

Description:

Manhole

Distance (ft):

.0

Remarks:

M-904-048

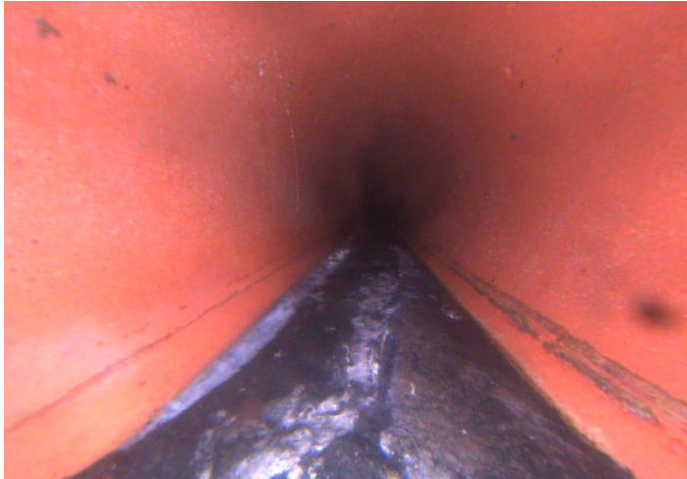
Code: **MWL**
Description: **Water Level**

Distance (ft): **.0**
Structural Grade: **0**
O&M Grade: **0**
Clock Start/From:
Clock To:
1st Value:
2nd Value:
Value Percent: **10.000**
Continuous Index:
Within 8" of Joint: **NO**
Remarks:

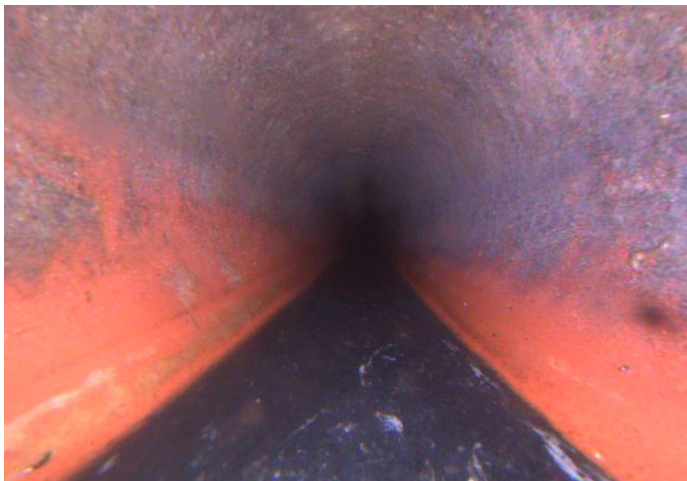
Code: **MSA**
Description: **Abandoned Survey**

Distance (ft): **35.0**
Structural Grade: **0**
O&M Grade: **0**
Clock Start/From:
Clock To:
1st Value:
2nd Value:
Value Percent:
Continuous Index:
Within 8" of Joint: **NO**
Remarks: **Unknown**
