Profile/Photo Observation Report

Date:	04/21/2018	Weather:		Coding:	PACP 4.2
Pipe Length (ft):	170.3	Owner:	City of Hobart	Pre Clean:	No Pre-Cleaning
P.O.#:	2004	Surveyor:	SAN	PSR:	P-904-047-051
Customer:	Red Zone	Clean Date:		Shape:	C

Street:	1705 Hickey St	Flow Control:	Not Controlled
City:	Hobart In	Year Renewed:	
Location:	Woods	Tape/Media #:	Deliverable 1
Purpose:	Routine Assessment	Dia/Height:	18"
Use:	Sanitary	Material:	VCP
Drain Area:	Northeast	Lining:	
Category:	NA		
Comment:	425-2/Incomplete due to debris/ Line needs to be cleaned 62 feet from MH 047.		
Location Details:	Flows from yard to woods	Direction of Survey:	Downstream
US MH:	M-904-047	DS MH:	M-904-051
		Total Length Surveyed (ft):	62.0

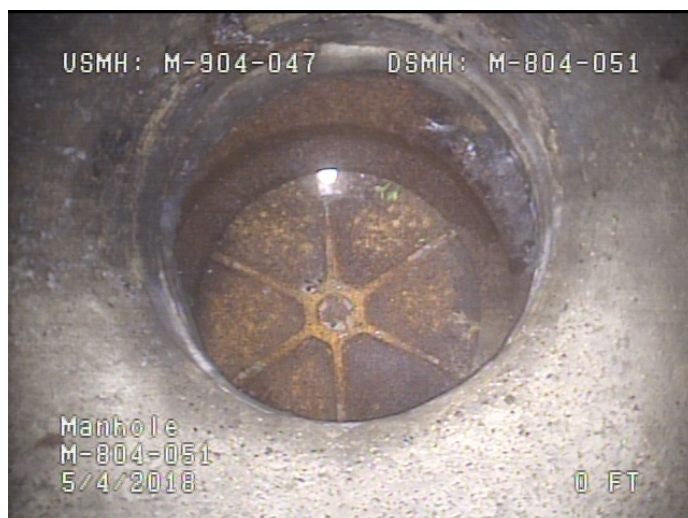
Code:	AMH
Description:	Manhole
Distance (ft):	.0
Structural Grade:	0
O&M Grade:	0
Clock Start/From:	
Clock To:	
1st Value:	
2nd Value:	
Value Percent:	
Continuous Index:	
Within 8" of Joint:	NO
Remarks:	M-904-047

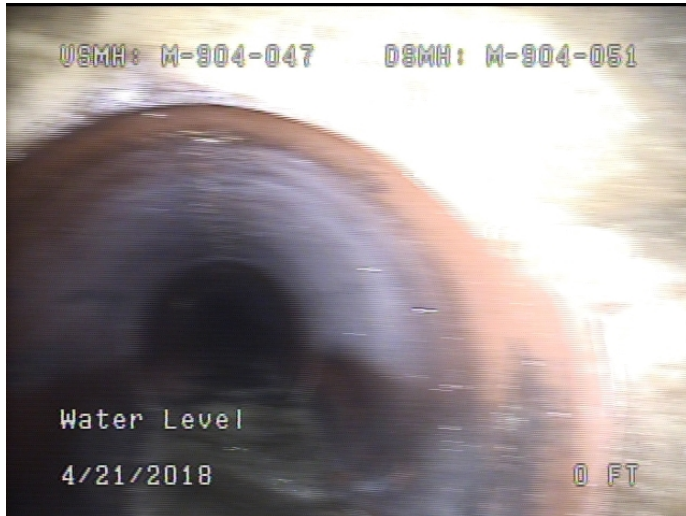
Code: **MWL**
 Description: **Water Level**

Distance (ft): **.0**
 Structural Grade: **0**
 O&M Grade: **0**
 Clock Start/From:
 Clock To:
 1st Value:
 2nd Value:
 Value Percent: **15.000**
 Continuous Index:
 Within 8" of Joint: **NO**
 Remarks:

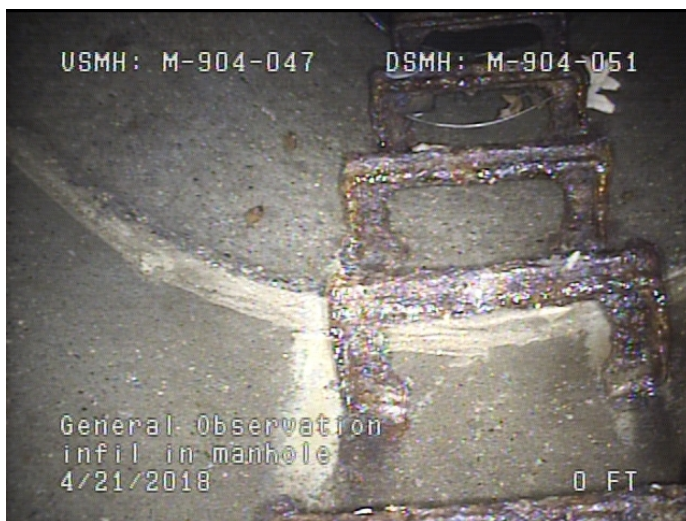
Code: **MGO**
 Description: **General Observation**

Distance (ft): **.0**
 Structural Grade: **0**
 O&M Grade: **0**
 Clock Start/From:
 Clock To:
 1st Value:
 2nd Value:
 Value Percent:
 Continuous Index:
 Within 8" of Joint: **NO**
 Remarks: **infil in manhole**

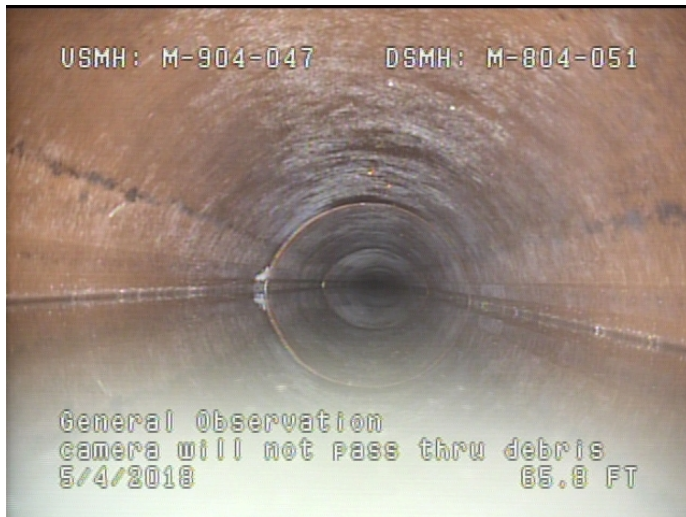
Code:	MGO
Description:	General Observation
Distance (ft):	30.3
Structural Grade:	0
O&M Grade:	0
Clock Start/From:	
Clock To:	
1st Value:	
2nd Value:	
Value Percent:	
Continuous Index:	
Within 8" of Joint:	NO
Remarks:	resume after down sizing

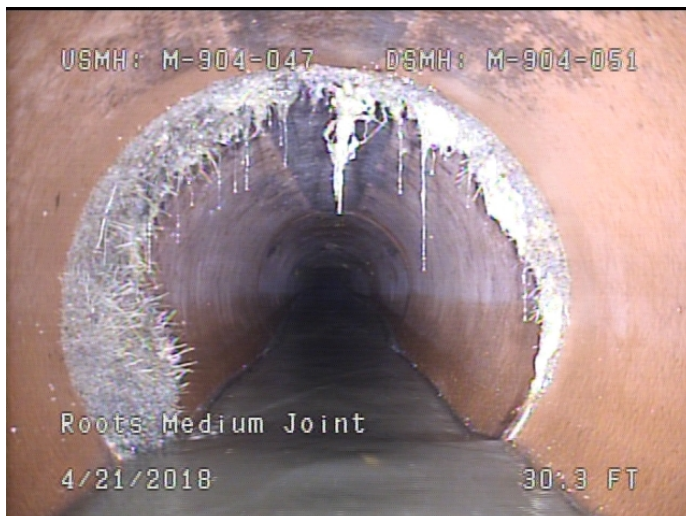
Code:	RMJ
Description:	Roots Medium Joint
Distance (ft):	30.3
Structural Grade:	0
O&M Grade:	3
Clock Start/From:	7
Clock To:	5
1st Value:	
2nd Value:	
Value Percent:	15.000
Continuous Index:	
Within 8" of Joint:	YES
Remarks:

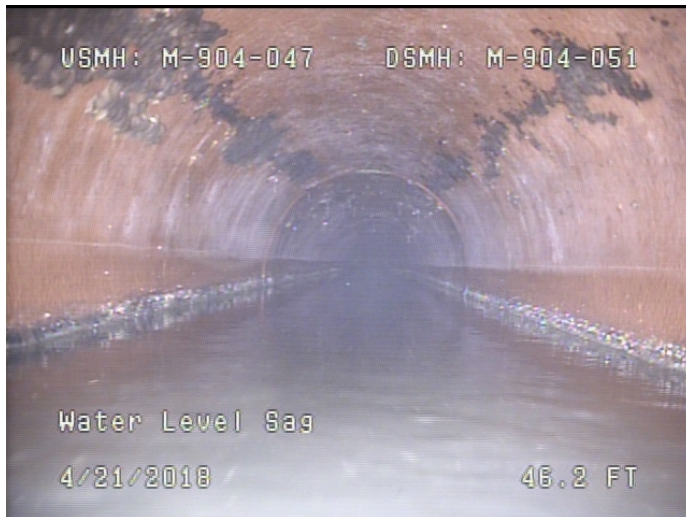
Code:	MWLS
Description:	Water Level Sag
Distance (ft):	46.2
Structural Grade:	3
O&M Grade:	3
Clock Start/From:	
Clock To:	
1st Value:	
2nd Value:	
Value Percent:	35.000
Continuous Index:	
Within 8" of Joint:	NO
Remarks:

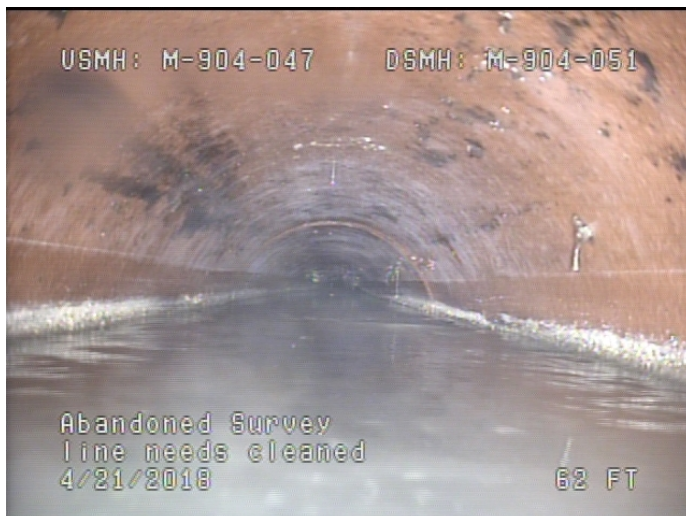
Code:	MSA
Description:	Abandoned Survey
Distance (ft):	62.0
Structural Grade:	0
O&M Grade:	0
Clock Start/From:	
Clock To:	
1st Value:	
2nd Value:	
Value Percent:	
Continuous Index:	
Within 8" of Joint:	NO
Remarks:	line needs cleaned
