## Profile/Photo Observation Report

Date:	01/17/2025	Weather:		Coding:	PACP 7.0
Pipe Length (ft):	170.0	Owner:	City of Hobart	Pre Clean:	Heavy Cleaning
P.O.#:	YES502259	Surveyor:	S. Bucklin	PSR:	P-904-047-051
Customer:	City of Hobart	Clean Date:	12/18/2024	Shape:	C

Street:	Hickey Place	Flow Control:	Not Controlled
City:	Hobart, IN	Year Renewed:	
Location:	Yard	Tape/Media #:	
Purpose:	Sewer System Evaluation Survey (SS	Dia/Height:	18"
Use:	Sanitary Sewage Pipe	Material:	VCP
Drain Area:		Lining:	None
Category:	NA		
Comment:			
Location Details:		Direction of Survey:	Downstream
US MH:	M-904-047	DS MH:	M-904-051
		Total Length Surveyed (ft):	169.8

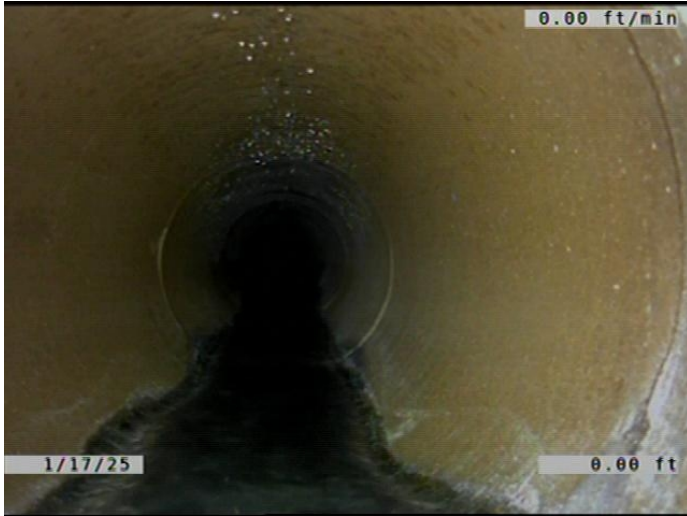
Code:	<b>MWL</b>
Description:	<b>Miscellaneous Water Level</b>
Distance (ft):	<b>.0</b>
Structural Grade:	<b>0</b>
O&M Grade:	<b>0</b>
Clock Start/From:	
Clock To:	
1st Value:	
2nd Value:	
Value Percent:	<b>10.000</b>
Continuous Index:	
Within 8" of Joint:	<b>NO</b>
Remarks:

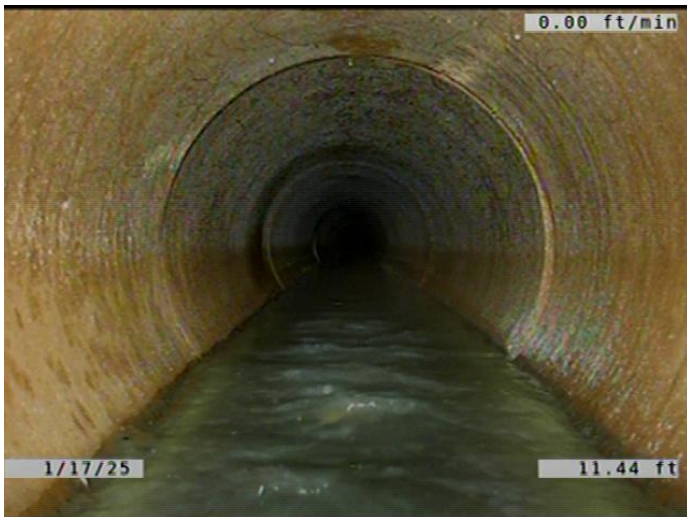
Code:	<b>MWLS</b>
Description:	<b>Miscellaneous Water Level Sag</b>
Distance (ft):	<b>11.4</b>
Structural Grade:	<b>2</b>
O&M Grade:	<b>0</b>
Clock Start/From:	
Clock To:	
1st Value:	
2nd Value:	
Value Percent:	<b>15.000</b>
Continuous Index:	<b>S01</b>
Within 8" of Joint:	<b>NO</b>
Remarks:

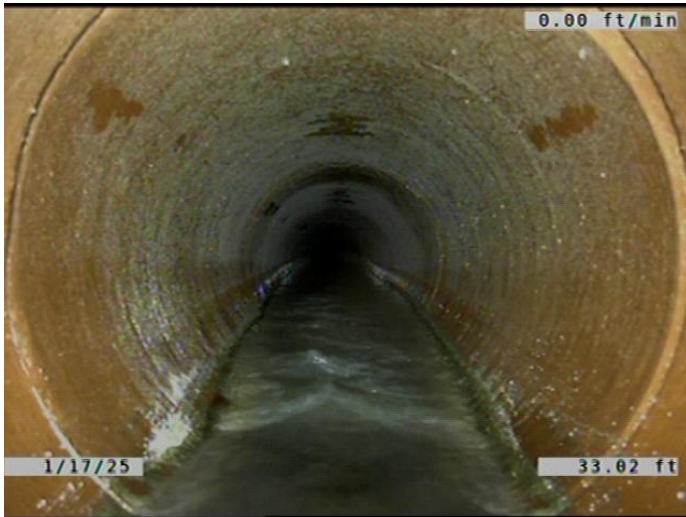
Code: **MWLS**  
Description: **Miscellaneous Water Level Sag**

Distance (ft): **33.0**  
Structural Grade: **2**  
O&M Grade: **0**  
Clock Start/From:  
Clock To:  
1st Value:  
2nd Value:  
Value Percent: **15.000**  
Continuous Index: **F01**  
Within 8" of Joint: **NO**  
Remarks:

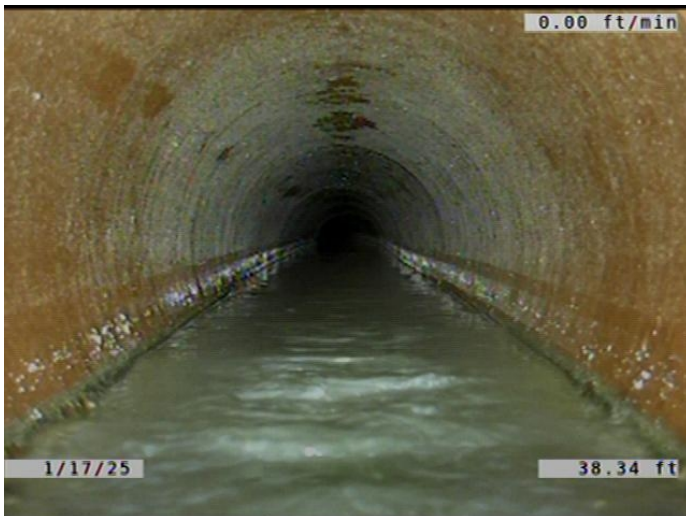
Code: **MWL**  
Description: **Miscellaneous Water Level**

Distance (ft): **38.3**  
Structural Grade: **0**  
O&M Grade: **0**  
Clock Start/From:  
Clock To:  
1st Value:  
2nd Value:  
Value Percent: **25.000**  
Continuous Index:  
Within 8" of Joint: **NO**  
Remarks:

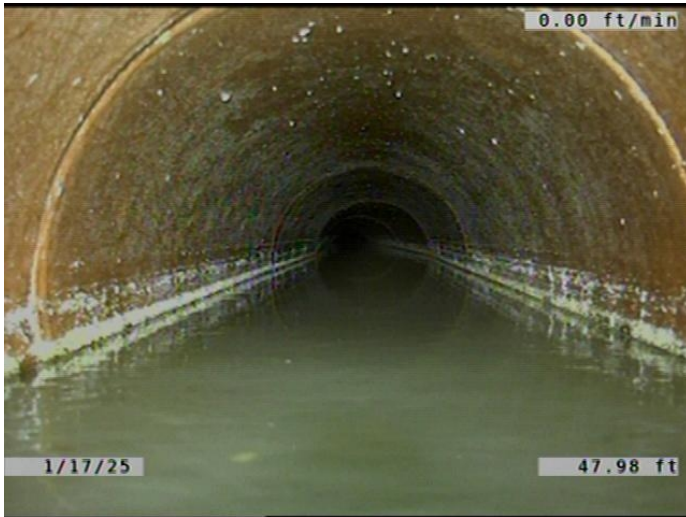
Code: **MWL**  
Description: **Miscellaneous Water Level**

Distance (ft): **48.0**  
Structural Grade: **0**  
O&M Grade: **0**  
Clock Start/From:  
Clock To:  
1st Value:  
2nd Value:  
Value Percent: **40.000**  
Continuous Index:  
Within 8" of Joint: **NO**  
Remarks:

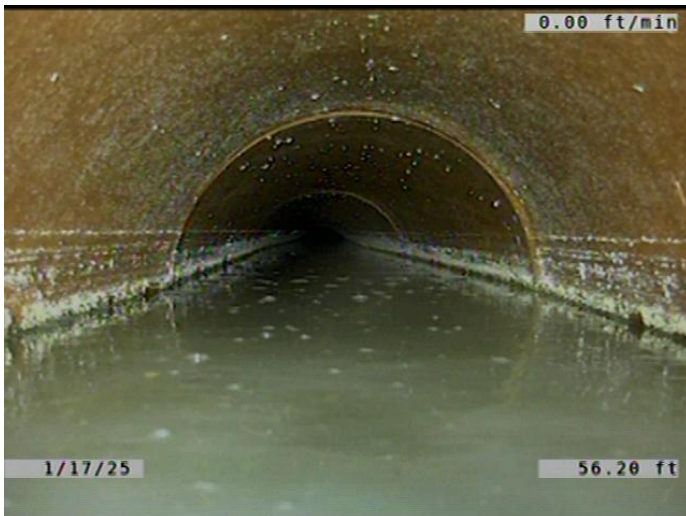
Code: **MWL**  
Description: **Miscellaneous Water Level**

Distance (ft): **56.2**  
Structural Grade: **0**  
O&M Grade: **0**  
Clock Start/From:  
Clock To:  
1st Value:  
2nd Value:  
Value Percent: **60.000**  
Continuous Index:  
Within 8" of Joint: **NO**  
Remarks:

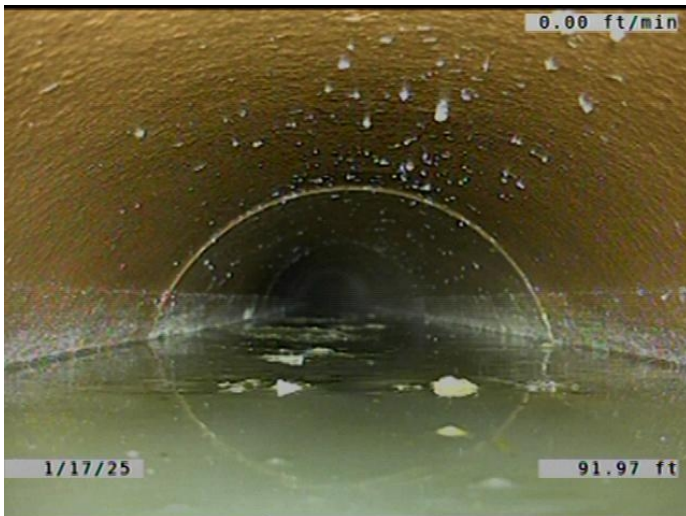
Code: **MWL**  
Description: **Miscellaneous Water Level**

Distance (ft): **92.0**  
Structural Grade: **0**  
O&M Grade: **0**  
Clock Start/From:  
Clock To:  
1st Value:  
2nd Value:  
Value Percent: **60.000**  
Continuous Index:  
Within 8" of Joint: **NO**  
Remarks:

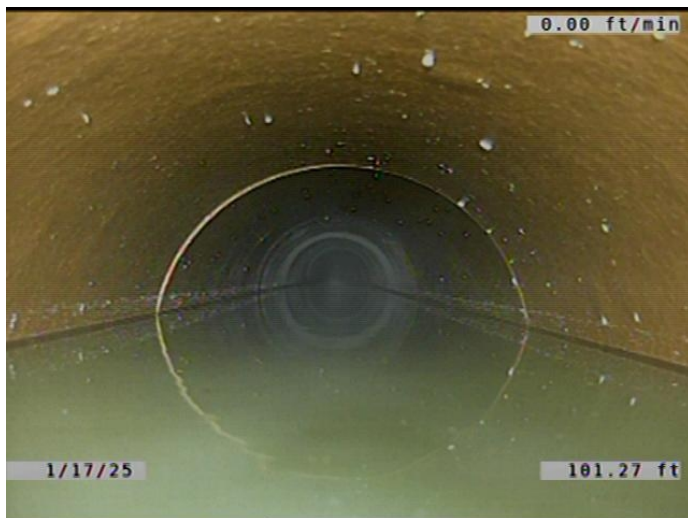
Code: **MWL**  
Description: **Miscellaneous Water Level**

Distance (ft): **101.3**  
Structural Grade: **0**  
O&M Grade: **0**  
Clock Start/From:  
Clock To:  
1st Value:  
2nd Value:  
Value Percent: **60.000**  
Continuous Index:  
Within 8" of Joint: **NO**  
Remarks:

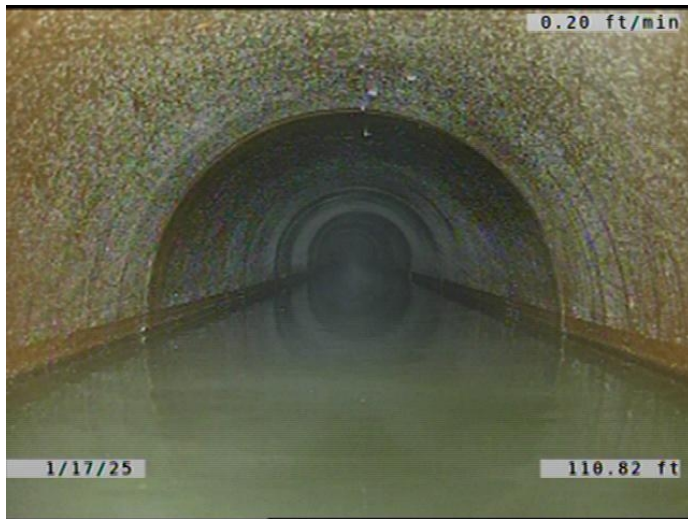
Code: **MWL**  
Description: **Miscellaneous Water Level**

Distance (ft): **110.8**  
Structural Grade: **0**  
O&M Grade: **0**  
Clock Start/From:  
Clock To:  
1st Value:  
2nd Value:  
Value Percent: **40.000**  
Continuous Index:  
Within 8" of Joint: **NO**  
Remarks:

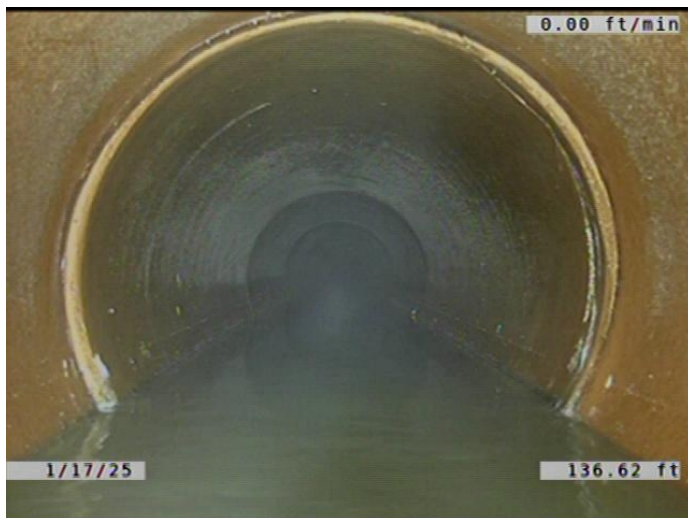
Code: **MWL**  
Description: **Miscellaneous Water Level**

Distance (ft): **136.6**  
Structural Grade: **0**  
O&M Grade: **0**  
Clock Start/From:  
Clock To:  
1st Value:  
2nd Value:  
Value Percent: **20.000**  
Continuous Index:  
Within 8" of Joint: **NO**  
Remarks:
