Profile/Photo Observation Report

Street:	RUSH ST	Flow Control:	Not Controlled
City:	Hobart, IN	Year Renewed:	
Location:	Light Highway	Tape/Media #:	
Purpose:	Routine Assessment	Dia/Height:	10"
Use:	Sanitary	Material:	VCP
Drain Area:	NA	Lining:	
Category:	NA		
Comment:

Location Details:		Direction of Survey:	Downstream
US MH:	M-904-048	DS MH:	M-904-049
		Total Length Surveyed (ft):	66.4

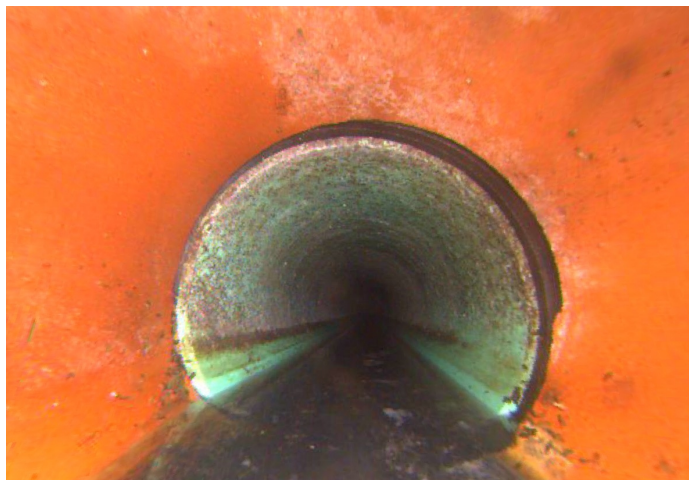
Code: **AMH**
Description: **Manhole**

Distance (ft): **.0**
Structural Grade: **0**
O&M Grade: **0**
Clock Start/From:
Clock To:
1st Value:
2nd Value:
Value Percent:
Continuous Index:
Within 8" of Joint: **NO**
Remarks: **M-904-048**

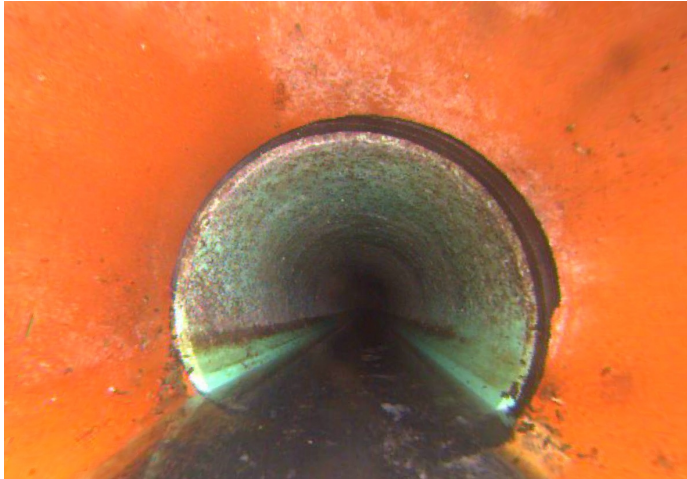
Code: **MWL**
Description: **Water Level**

Distance (ft): **.0**
Structural Grade: **0**
O&M Grade: **0**
Clock Start/From:
Clock To:
1st Value:
2nd Value:
Value Percent: **15.000**
Continuous Index:
Within 8" of Joint: **NO**
Remarks:

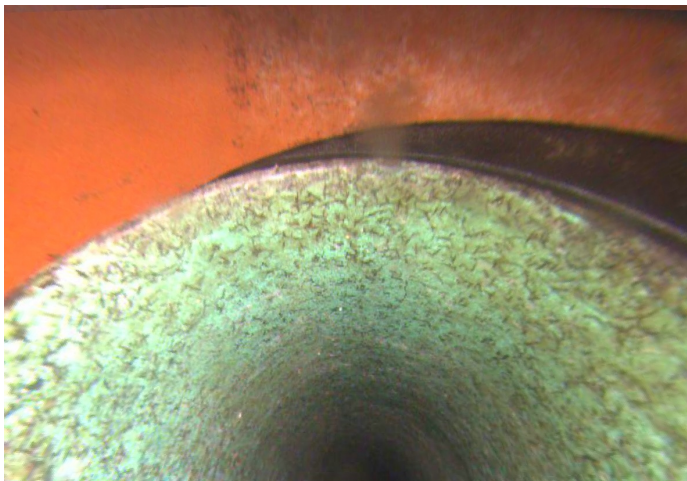
Code: **MMC**
Description: **Material Change**

Distance (ft): **1.1**
Structural Grade: **0**
O&M Grade: **0**
Clock Start/From:
Clock To:
1st Value:
2nd Value:
Value Percent:
Continuous Index:
Within 8" of Joint: **NO**
Remarks: **PVC**

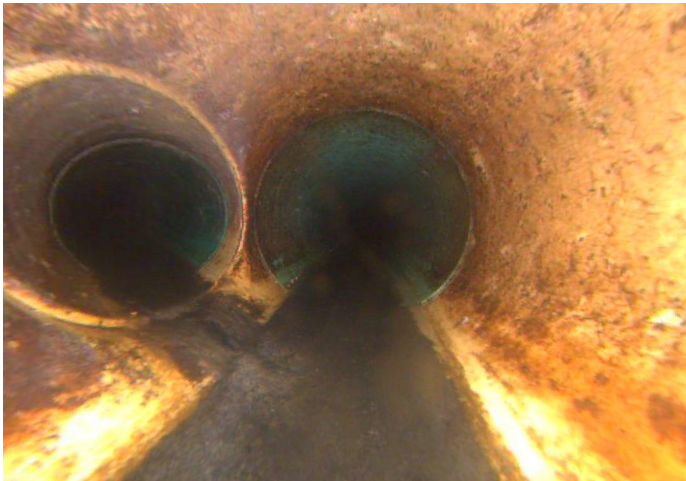
Code: **TF**
Description: **Tap Factory**

Distance (ft): **36.6**
Structural Grade: **0**
O&M Grade: **0**
Clock Start/From: **9**
Clock To:
1st Value: **6.000**
2nd Value:
Value Percent:
Continuous Index:
Within 8" of Joint:
Remarks:

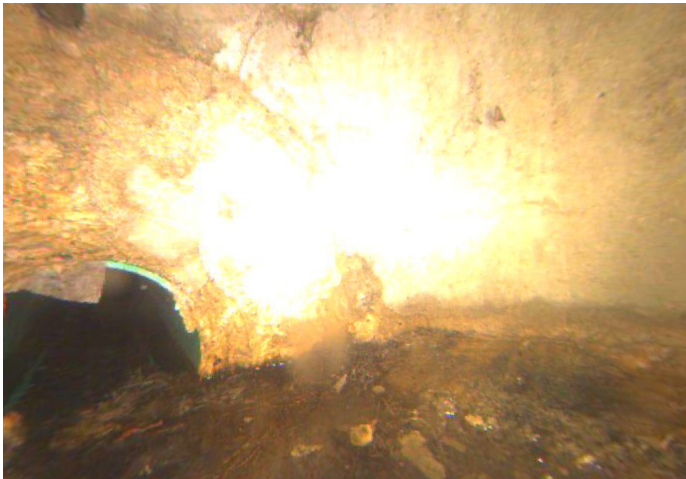
Code: **AMH**
Description: **Manhole**

Distance (ft): **66.4**
Structural Grade: **0**
O&M Grade: **0**
Clock Start/From:
Clock To:
1st Value:
2nd Value:
Value Percent:
Continuous Index:
Within 8" of Joint: **NO**
Remarks: **M-904-049**
