Profile/Photo Observation Report

Date:	10/04/2018	Weather:		Coding:	PACP 6.0
Pipe Length (ft):	69.4	Owner:	NA	Pre Clean:	Not Known
P.O.#:		Surveyor:	Michael Carlino	PSR:	P-904-049-048
Customer:		Clean Date:	01/01/1900	Shape:	C

Street:	Rush St.	Flow Control:	Not Controlled
City:	Hobart, IN	Year Renewed:	
Location:	Light Highway	Tape/Media #:	
Purpose:	Routine Assessment	Dia/Height:	10"
Use:	Sanitary	Material:	VCP
Drain Area:	NA	Lining:	
Category:	NA		
Comment:

Location Details:		Direction of Survey:	Downstream
US MH:	M-904-048	DS MH:	M-904-049
		Total Length Surveyed (ft):	66.4

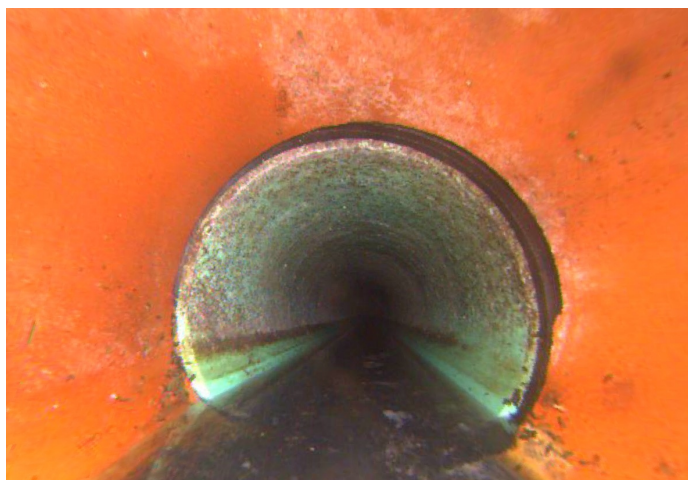
Code: **AMH**
Description: **Manhole**

Distance (ft): **.0**
Structural Grade: **0**
O&M Grade: **0**
Clock Start/From:
Clock To:
1st Value:
2nd Value:
Value Percent:
Continuous Index:
Within 8" of Joint: **NO**
Remarks: **M-904-048**

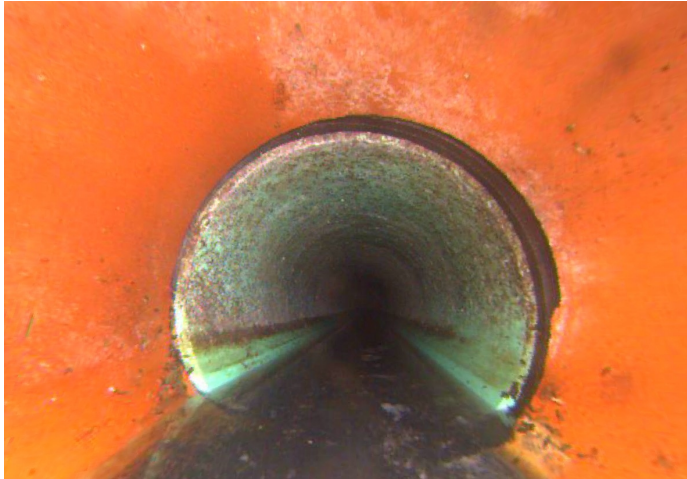
Code: **MWL**
Description: **Water Level**

Distance (ft): **.0**
Structural Grade: **0**
O&M Grade: **0**
Clock Start/From:
Clock To:
1st Value:
2nd Value:
Value Percent: **15.000**
Continuous Index:
Within 8" of Joint: **NO**
Remarks:

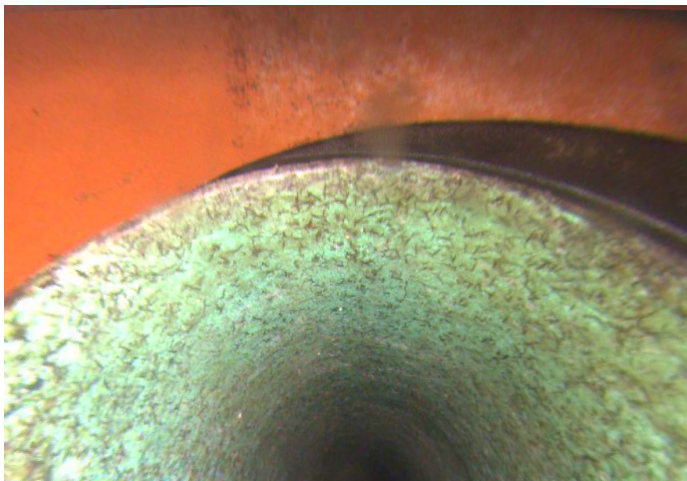
Code: **MMC**
Description: **Material Change**

Distance (ft): **1.1**
Structural Grade: **0**
O&M Grade: **0**
Clock Start/From:
Clock To:
1st Value:
2nd Value:
Value Percent:
Continuous Index:
Within 8" of Joint: **NO**
Remarks: **PVC**

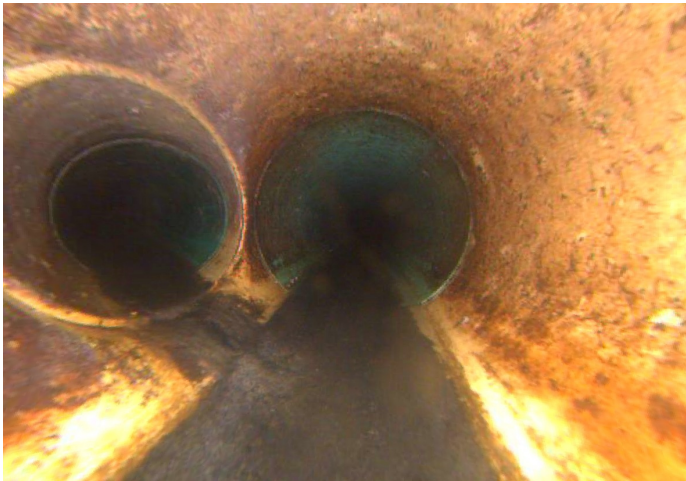
Code: **TF**
Description: **Tap Factory**

Distance (ft): **36.6**
Structural Grade: **0**
O&M Grade: **0**
Clock Start/From: **9**
Clock To:
1st Value: **6.000**
2nd Value:
Value Percent:
Continuous Index:
Within 8" of Joint:
Remarks:

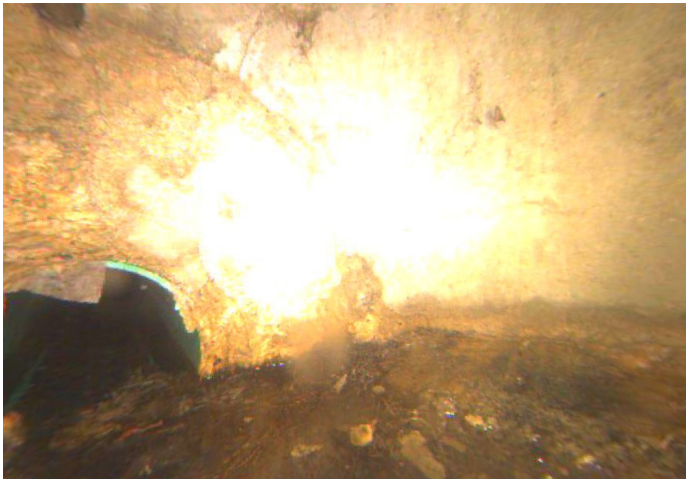
Code: **AMH**
Description: **Manhole**

Distance (ft): **66.4**
Structural Grade: **0**
O&M Grade: **0**
Clock Start/From:
Clock To:
1st Value:
2nd Value:
Value Percent:
Continuous Index:
Within 8" of Joint: **NO**
Remarks: **M-904-049**
