Profile/Photo Observation Report

Street:	RUSH ST	Flow Control:	Not Controlled
City:	Hobart, IN	Year Renewed:	
Location:	Light Highway	Tape/Media #:	
Purpose:	Routine Assessment	Dia/Height:	10"
Use:	Sanitary	Material:	VCP
Drain Area:	NA	Lining:	
Category:	NA		
Comment:

Location Details:		Direction of Survey:	Downstream
US MH:	M-904-048	DS MH:	M-904-050
		Total Length Surveyed (ft):	62.8

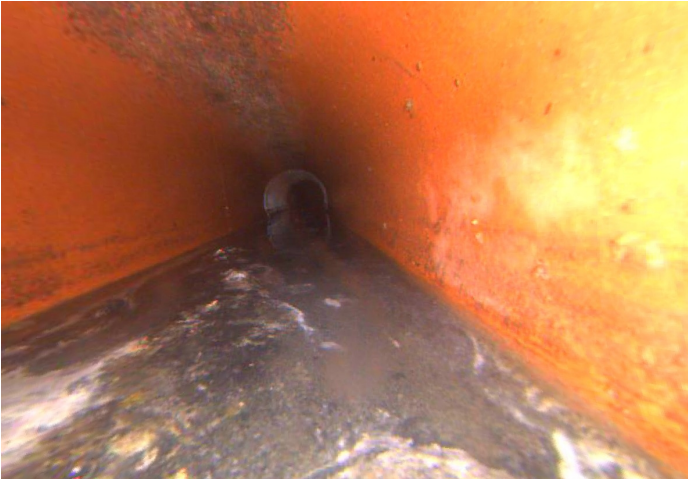
AMH

Manhole

.0

M-904-048

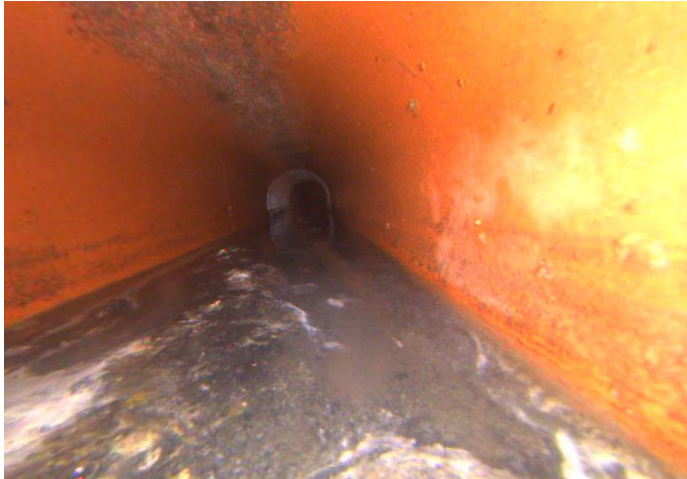
Code: **MWL**
Description: **Water Level**

Distance (ft): **.0**
Structural Grade: **0**
O&M Grade: **0**
Clock Start/From:
Clock To:
1st Value:
2nd Value:
Value Percent: **20.000**
Continuous Index:
Within 8" of Joint: **NO**
Remarks:

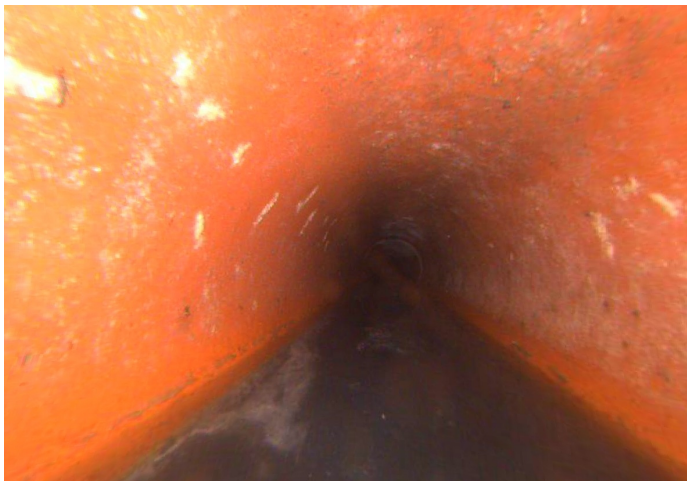
Code: **MSA**
Description: **Abandoned Survey**

Distance (ft): **62.8**
Structural Grade: **0**
O&M Grade: **0**
Clock Start/From:
Clock To:
1st Value:
2nd Value:
Value Percent:
Continuous Index:
Within 8" of Joint: **NO**
Remarks: **Possible Debris**
