Profile/Photo Observation Report

Street:	Rush St.	Flow Control:	Not Controlled
City:	Hobart, IN	Year Renewed:	
Location:	Light Highway	Tape/Media #:	
Purpose:	Routine Assessment	Dia/Height:	10"
Use:	Sanitary	Material:	VCP
Drain Area:	NA	Lining:	
Category:	NA		
Comment:

Location Details:		Direction of Survey:	Downstream
US MH:	M-904-048	DS MH:	M-904-050
		Total Length Surveyed (ft):	62.8

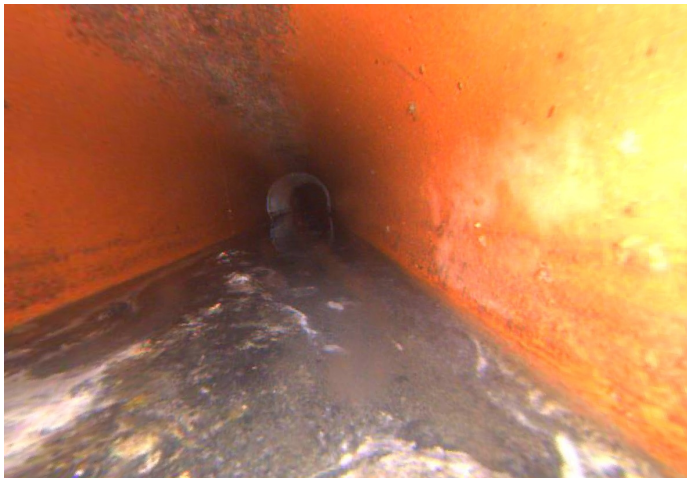
Code: **AMH**
Description: **Manhole**

Distance (ft): **.0**
Structural Grade: **0**
O&M Grade: **0**
Clock Start/From:
Clock To:
1st Value:
2nd Value:
Value Percent:
Continuous Index:
Within 8" of Joint: **NO**
Remarks: **M-904-048**

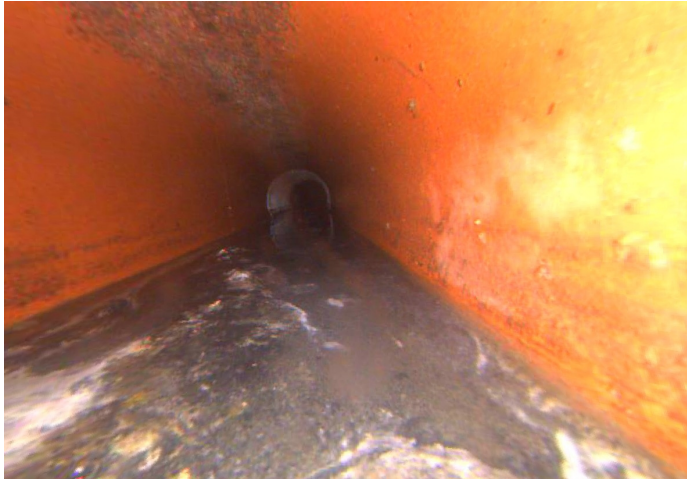
Code: **MWL**
Description: **Water Level**

Distance (ft): **.0**
Structural Grade: **0**
O&M Grade: **0**
Clock Start/From:
Clock To:
1st Value:
2nd Value:
Value Percent: **20.000**
Continuous Index:
Within 8" of Joint: **NO**
Remarks:

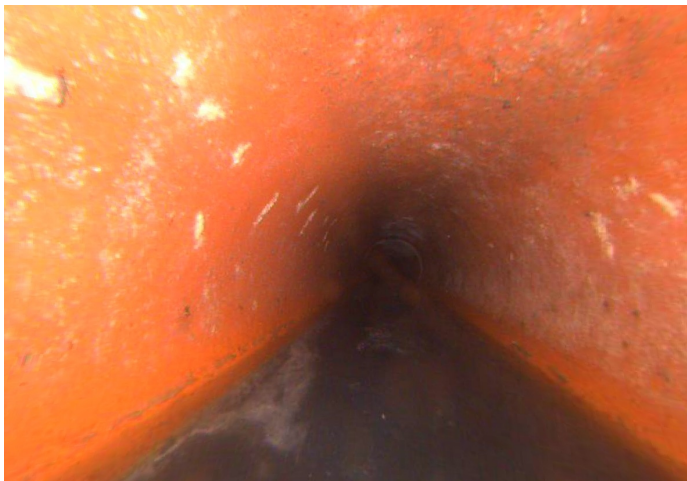
Code: **MSA**
Description: **Abandoned Survey**

Distance (ft): **62.8**
Structural Grade: **0**
O&M Grade: **0**
Clock Start/From:
Clock To:
1st Value:
2nd Value:
Value Percent:
Continuous Index:
Within 8" of Joint: **NO**
Remarks: **Possible Debris**
