Profile/Photo Observation Report

Street:	Division St.	Flow Control:	Not Controlled
City:	Hobart, IN	Year Renewed:	
Location:	Other	Tape/Media #:	
Purpose:	Not Known	Dia/Height:	10"
Use:	Sanitary	Material:	VCP
Drain Area:	NA	Lining:	
Category:	NA		
Comment:

Location Details:		Direction of Survey:	Downstream
US MH:	M-904-060	DS MH:	M-904-059
		Total Length Surveyed (ft):	337.8

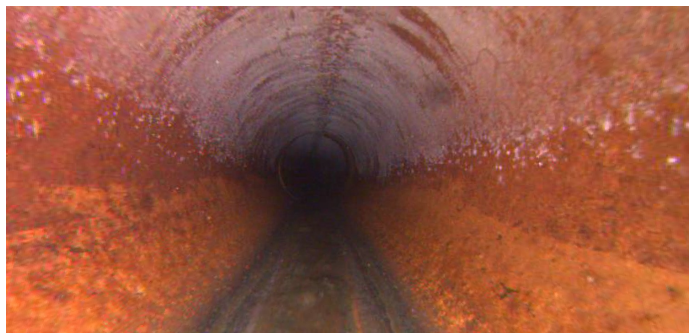
Code: **AMH**
Description: **Manhole**

Distance (ft): **.0**
Structural Grade: **0**
O&M Grade: **0**
Clock Start/From:
Clock To:
1st Value:
2nd Value:
Value Percent:
Continuous Index:
Within 8" of Joint: **NO**
Remarks: **M-904-060**

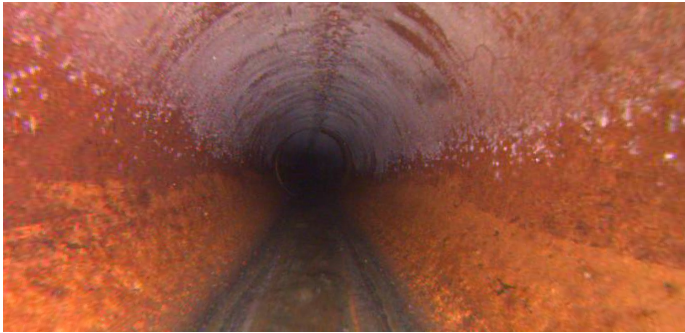
Code: **MWL**
Description: **Water Level**

Distance (ft): **.0**
Structural Grade: **0**
O&M Grade: **0**
Clock Start/From:
Clock To:
1st Value:
2nd Value:
Value Percent: **5.000**
Continuous Index:
Within 8" of Joint: **NO**
Remarks:

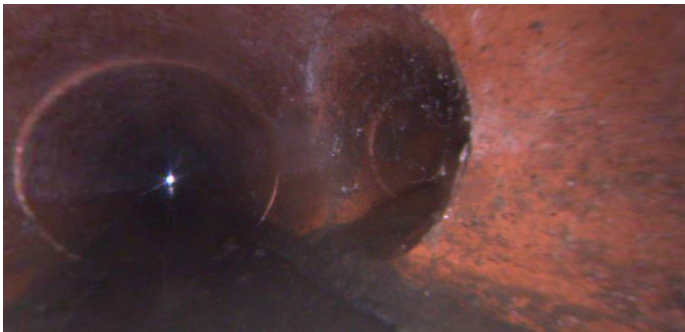
Code: **TFA**
Description: **Tap Factory Active**

Distance (ft): **39.6**
Structural Grade: **0**
O&M Grade: **0**
Clock Start/From: **9**
Clock To:
1st Value: **4.000**
2nd Value:
Value Percent:
Continuous Index:
Within 8" of Joint:
Remarks:

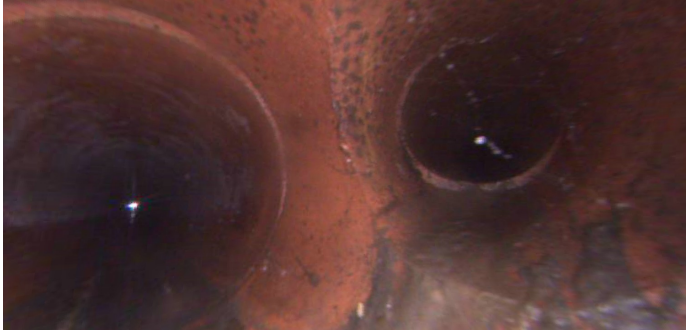
Code: **TF**
Description: **Tap Factory**

Distance (ft): **61.2**
Structural Grade: **0**
O&M Grade: **0**
Clock Start/From: **9**
Clock To:
1st Value: **4.000**
2nd Value:
Value Percent:
Continuous Index:
Within 8" of Joint:
Remarks:

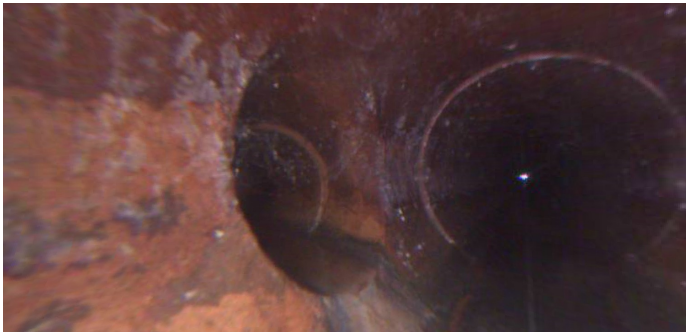
Code: **TFA**
Description: **Tap Factory Active**

Distance (ft): **93.6**
Structural Grade: **0**
O&M Grade: **0**
Clock Start/From: **3**
Clock To:
1st Value: **4.000**
2nd Value:
Value Percent:
Continuous Index:
Within 8" of Joint:
Remarks:

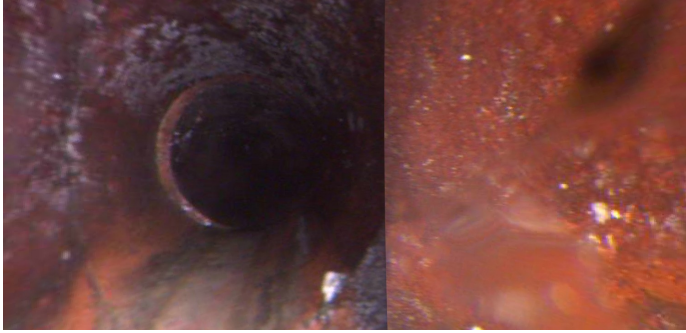
Code: **TFA**
Description: **Tap Factory Active**

Distance (ft): **140.3**
Structural Grade: **0**
O&M Grade: **0**
Clock Start/From: **9**
Clock To:
1st Value: **4.000**
2nd Value:
Value Percent:
Continuous Index:
Within 8" of Joint:
Remarks:

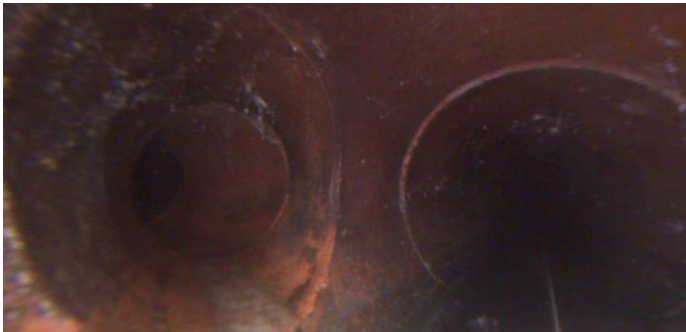
Code: **TFA**
Description: **Tap Factory Active**

Distance (ft): **197.4**
Structural Grade: **0**
O&M Grade: **0**
Clock Start/From: **3**
Clock To:
1st Value: **4.000**
2nd Value:
Value Percent:
Continuous Index:
Within 8" of Joint:
Remarks:

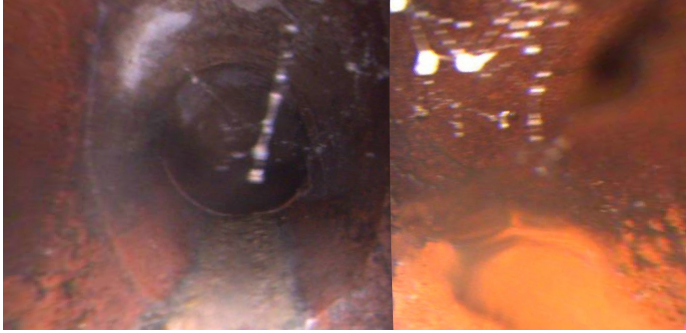
Code: **TF**
Description: **Tap Factory**

Distance (ft): **204.4**
Structural Grade: **0**
O&M Grade: **0**
Clock Start/From: **9**
Clock To:
1st Value: **4.000**
2nd Value:
Value Percent:
Continuous Index:
Within 8" of Joint:
Remarks:

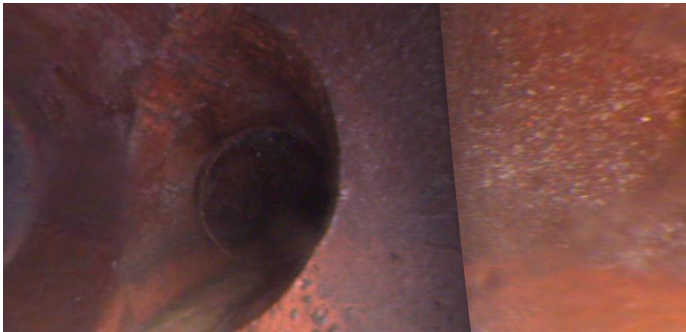
Code: **TFA**
Description: **Tap Factory Active**

Distance (ft): **246.7**
Structural Grade: **0**
O&M Grade: **0**
Clock Start/From: **9**
Clock To:
1st Value: **4.000**
2nd Value:
Value Percent:
Continuous Index:
Within 8" of Joint:
Remarks:

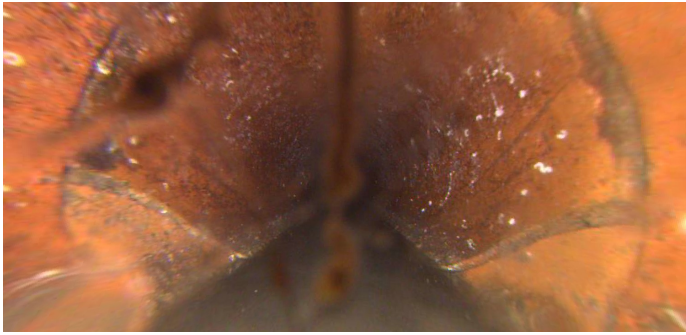
Code: **FM**
Description: **Fracture Multiple**

Distance (ft): **312.0**
Structural Grade: **4**
O&M Grade: **0**
Clock Start/From: **8**
Clock To: **4**
1st Value:
2nd Value:
Value Percent:
Continuous Index:
Within 8" of Joint: **YES**
Remarks:

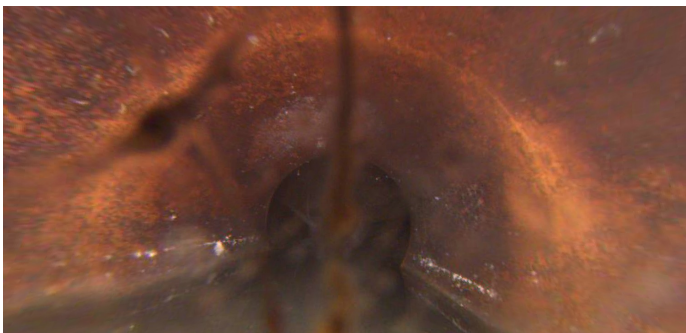
Code: **FC**
Description: **Fracture Circumferential**

Distance (ft): **335.9**
Structural Grade: **2**
O&M Grade: **0**
Clock Start/From: **8**
Clock To: **4**
1st Value:
2nd Value:
Value Percent:
Continuous Index:
Within 8" of Joint:
Remarks:

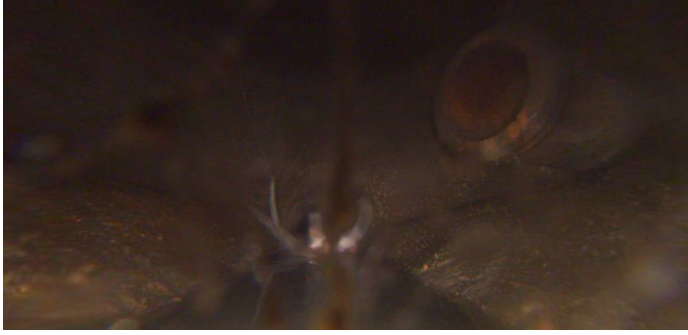
Code:	AMH
Description:	Manhole
Distance (ft):	337.8
Structural Grade:	0
O&M Grade:	0
Clock Start/From:	
Clock To:	
1st Value:	
2nd Value:	
Value Percent:	
Continuous Index:	
Within 8" of Joint:	NO
Remarks:	M-904-059
