Profile/Photo Observation Report

Street:	Division St.	Flow Control:	Not Controlled
City:	Hobart, IN	Year Renewed:	
Location:	Other	Tape/Media #:	
Purpose:	Not Known	Dia/Height:	10"
Use:	Sanitary	Material:	VCP
Drain Area:	NA	Lining:	
Category:	NA		
Comment:

Location Details:		Direction of Survey:	Upstream
US MH:	M-904-061	DS MH:	M-904-060
		Total Length Surveyed (ft):	36.4

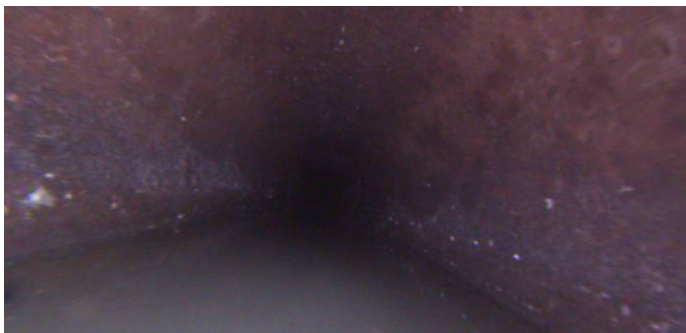
Code: **AMH**
Description: **Manhole**

Distance (ft): **.0**
Structural Grade: **0**
O&M Grade: **0**
Clock Start/From:
Clock To:
1st Value:
2nd Value:
Value Percent:
Continuous Index:
Within 8" of Joint: **NO**
Remarks: **M-904-060**

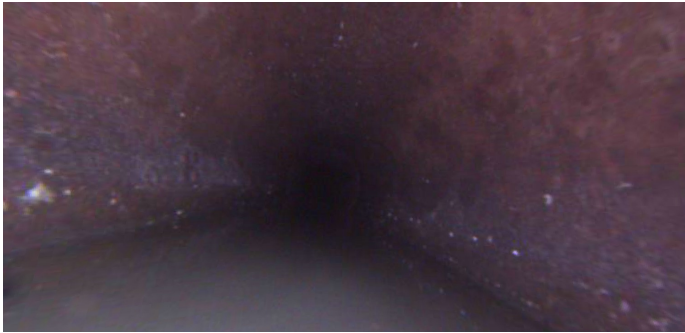
Code:	MWL
Description:	Water Level

Distance (ft):	.0
Structural Grade:	0
O&M Grade:	0
Clock Start/From:	
Clock To:	
1st Value:	
2nd Value:	
Value Percent:	20.000
Continuous Index:	
Within 8" of Joint:	NO
Remarks:

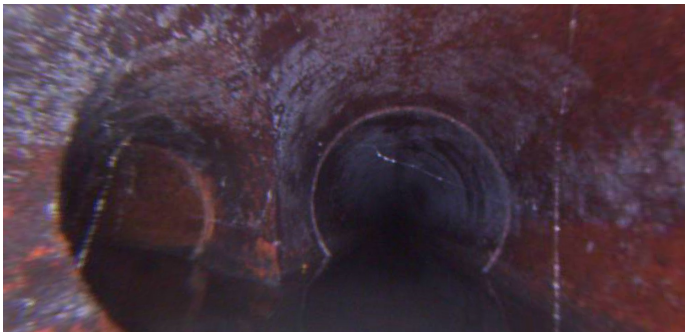
Code:	TFA
Description:	Tap Factory Active

Distance (ft):	25.3
Structural Grade:	0
O&M Grade:	0
Clock Start/From:	9
Clock To:	
1st Value:	4.000
2nd Value:	
Value Percent:	
Continuous Index:	
Within 8" of Joint:	
Remarks:

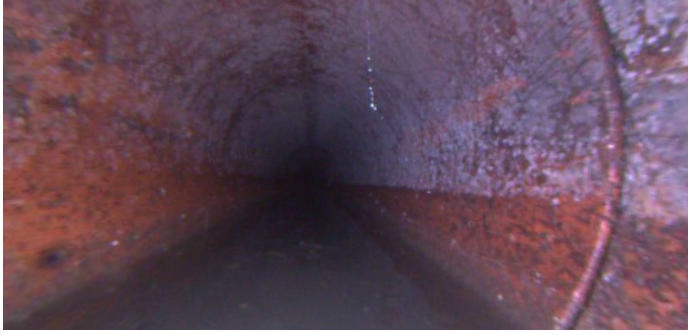
Code:	MSA
Description:	Abandoned Survey
Distance (ft):	36.4
Structural Grade:	0
O&M Grade:	0
Clock Start/From:	
Clock To:	
1st Value:	
2nd Value:	
Value Percent:	
Continuous Index:	
Within 8" of Joint:	NO
Remarks:	UNKNOWN
