Profile/Photo Observation Report

Street:	DIVISION ST & RUSH CT	Flow Control:	Not Controlled
City:	Hobart, IN	Year Renewed:	
Location:	Light Highway	Tape/Media #:	
Purpose:	Routine Assessment	Dia/Height:	10"
Use:	Sanitary	Material:	VCP
Drain Area:	NA	Lining:	
Category:	NA		
Comment:

Location Details:		Direction of Survey:	Upstream
US MH:	M-904-061	DS MH:	M-904-060
		Total Length Surveyed (ft):	326.8

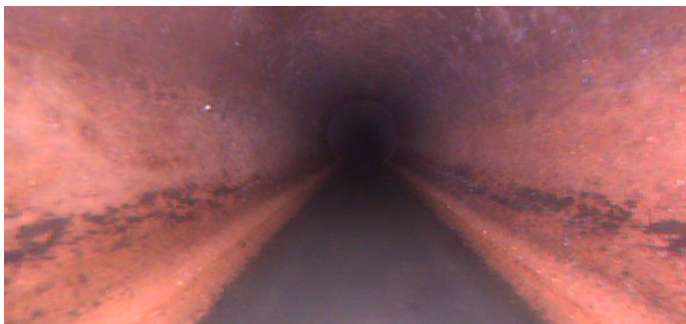
Code: **AMH**
Description: **Manhole**

Distance (ft): **.0**
Structural Grade: **0**
O&M Grade: **0**
Clock Start/From:
Clock To:
1st Value:
2nd Value:
Value Percent:
Continuous Index:
Within 8" of Joint: **NO**
Remarks: **M-904-060**

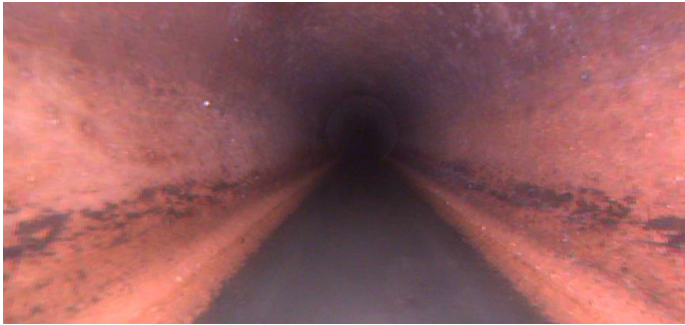
Code:	MWL
Description:	Water Level

Distance (ft):	.0
Structural Grade:	0
O&M Grade:	0
Clock Start/From:	
Clock To:	
1st Value:	
2nd Value:	
Value Percent:	5.000
Continuous Index:	
Within 8" of Joint:	NO
Remarks:

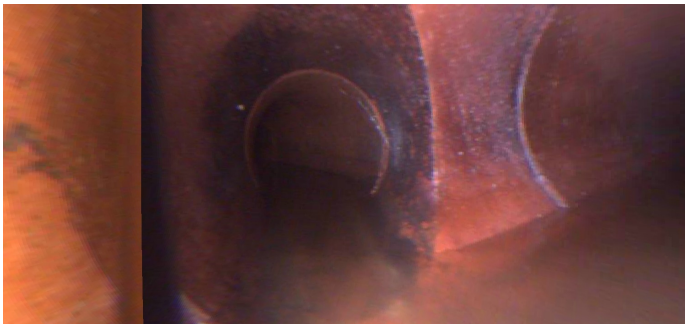
Code:	TFA
Description:	Tap Factory Active

Distance (ft):	25.6
Structural Grade:	0
O&M Grade:	0
Clock Start/From:	9
Clock To:	
1st Value:	6.000
2nd Value:	
Value Percent:	
Continuous Index:	
Within 8" of Joint:	
Remarks:

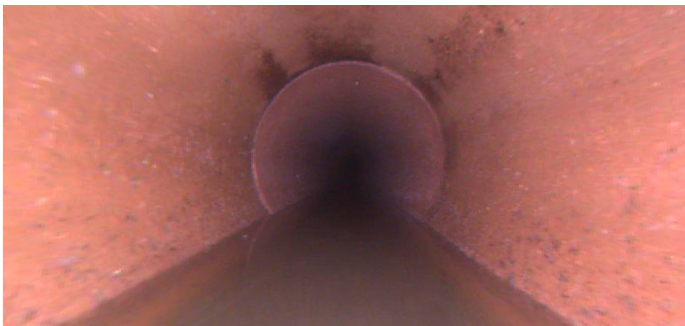
Code: **IS**
Description: **Infil Stain**

Distance (ft): **35.4**
Structural Grade: **0**
O&M Grade: **0**
Clock Start/From: **11**
Clock To: **3**
1st Value:
2nd Value:
Value Percent:
Continuous Index:
Within 8" of Joint: **YES**
Remarks:

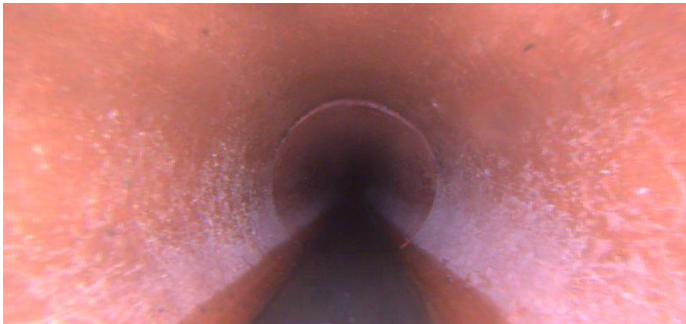
Code: **DAGS**
Description: **Deposits Attached Grease**

Distance (ft): **82.8**
Structural Grade: **0**
O&M Grade: **2**
Clock Start/From: **7**
Clock To: **5**
1st Value:
2nd Value:
Value Percent: **5.000**
Continuous Index: **S01**
Within 8" of Joint: **YES**
Remarks: **WANDER**

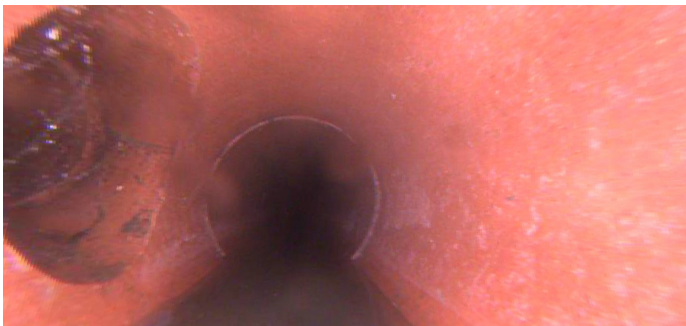
Code: **TF**
Description: **Tap Factory**

Distance (ft): **289.6**
Structural Grade: **0**
O&M Grade: **0**
Clock Start/From: **9**
Clock To:
1st Value: **4.000**
2nd Value:
Value Percent:
Continuous Index:
Within 8" of Joint:
Remarks:

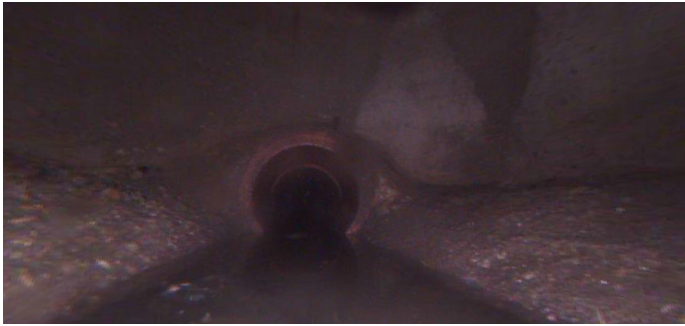
Code: **DAGS**
Description: **Deposits Attached Grease**

Distance (ft): **326.8**
Structural Grade: **0**
O&M Grade: **2**
Clock Start/From: **7**
Clock To: **5**
1st Value:
2nd Value:
Value Percent: **5.000**
Continuous Index: **F01**
Within 8" of Joint: **YES**
Remarks: **WANDER**

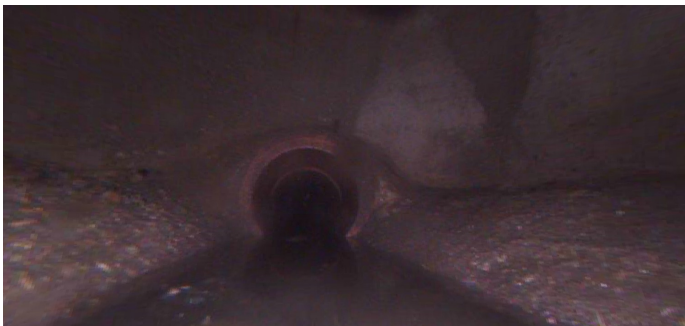
Code: **AMH**
Description: **Manhole**

Distance (ft): **326.8**
Structural Grade: **0**
O&M Grade: **0**
Clock Start/From:
Clock To:
1st Value:
2nd Value:
Value Percent:
Continuous Index:
Within 8" of Joint: **NO**
Remarks: **M-904-061**
