## Profile/Photo Observation Report

Street:	<b>Division St.</b>	Flow Control:	<b>Not Controlled</b>
City:	<b>Hobart, IN</b>	Year Renewed:	
Location:	<b>Light Highway</b>	Tape/Media #:	
Purpose:	<b>Routine Assessment</b>	Dia/Height:	<b>10"</b>
Use:	<b>Sanitary</b>	Material:	<b>VCP</b>
Drain Area:	<b>NA</b>	Lining:	
Category:	<b>NA</b>		
Comment:

Location Details:		Direction of Survey:	<b>Upstream</b>
US MH:	<b>M-904-061</b>	DS MH:	<b>M-904-060</b>
		Total Length Surveyed (ft):	<b>326.8</b>

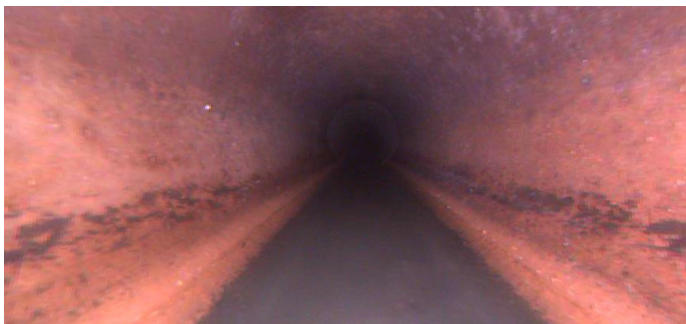
Code: **AMH**  
Description: **Manhole**

Distance (ft): **.0**  
Structural Grade: **0**  
O&M Grade: **0**  
Clock Start/From:  
Clock To:  
1st Value:  
2nd Value:  
Value Percent:  
Continuous Index:  
Within 8" of Joint: **NO**  
Remarks: **M-904-060**

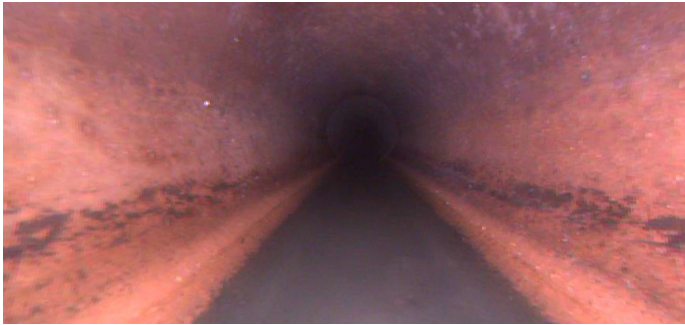
Code:	<b>MWL</b>
Description:	<b>Water Level</b>

Distance (ft):	<b>.0</b>
Structural Grade:	<b>0</b>
O&M Grade:	<b>0</b>
Clock Start/From:	
Clock To:	
1st Value:	
2nd Value:	
Value Percent:	<b>5.000</b>
Continuous Index:	
Within 8" of Joint:	<b>NO</b>
Remarks:

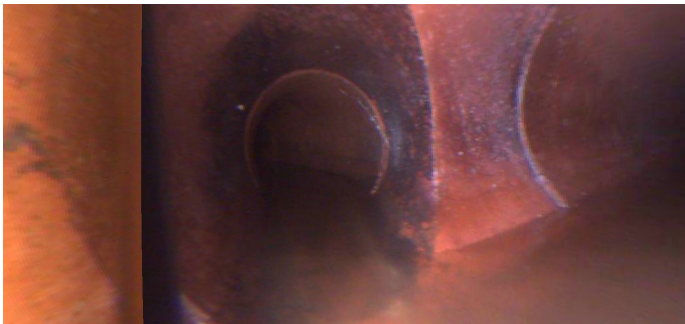
Code:	<b>TFA</b>
Description:	<b>Tap Factory Active</b>

Distance (ft):	<b>25.6</b>
Structural Grade:	<b>0</b>
O&M Grade:	<b>0</b>
Clock Start/From:	<b>9</b>
Clock To:	
1st Value:	<b>6.000</b>
2nd Value:	
Value Percent:	
Continuous Index:	
Within 8" of Joint:	
Remarks:

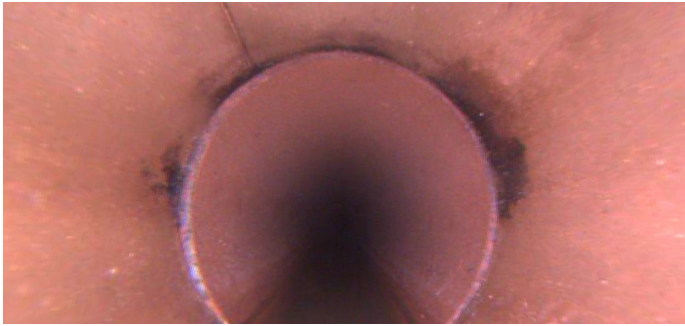
Code: **IS**  
Description: **Infil Stain**

Distance (ft): **30.9**  
Structural Grade: **0**  
O&M Grade: **0**  
Clock Start/From: **9**  
Clock To: **3**  
1st Value:  
2nd Value:  
Value Percent:  
Continuous Index:  
Within 8" of Joint: **YES**  
Remarks:

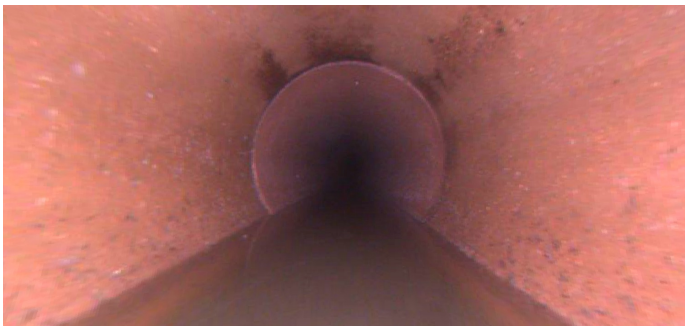
Code: **IS**  
Description: **Infil Stain**

Distance (ft): **35.4**  
Structural Grade: **0**  
O&M Grade: **0**  
Clock Start/From: **11**  
Clock To: **3**  
1st Value:  
2nd Value:  
Value Percent:  
Continuous Index:  
Within 8" of Joint: **YES**  
Remarks:

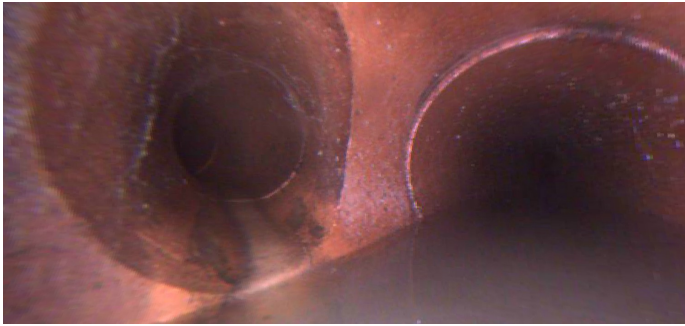
Code: **TF**  
Description: **Tap Factory**

Distance (ft): **67.9**  
Structural Grade: **0**  
O&M Grade: **0**  
Clock Start/From: **9**  
Clock To:  
1st Value: **6.000**  
2nd Value:  
Value Percent:  
Continuous Index:  
Within 8" of Joint:  
Remarks:

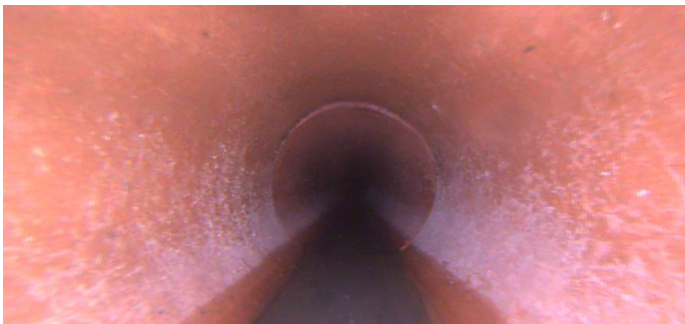
Code: **DAGS**  
Description: **Deposits Attached Grease**

Distance (ft): **82.8**  
Structural Grade: **0**  
O&M Grade: **2**  
Clock Start/From: **7**  
Clock To: **5**  
1st Value:  
2nd Value:  
Value Percent: **5.000**  
Continuous Index: **S01**  
Within 8" of Joint: **YES**  
Remarks: **WANDER**

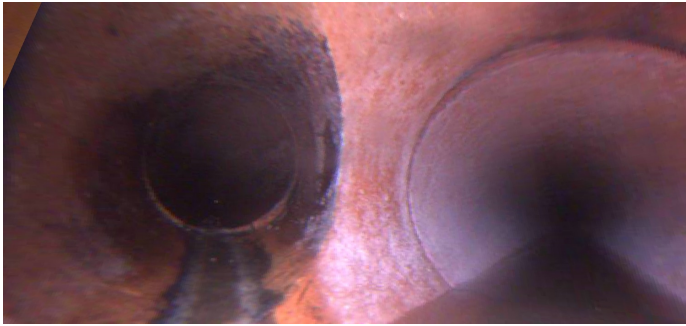
Code: **TF**  
Description: **Tap Factory**

Distance (ft): **181.7**  
Structural Grade: **0**  
O&M Grade: **0**  
Clock Start/From: **9**  
Clock To:  
1st Value: **6.000**  
2nd Value:  
Value Percent:  
Continuous Index:  
Within 8" of Joint:  
Remarks:

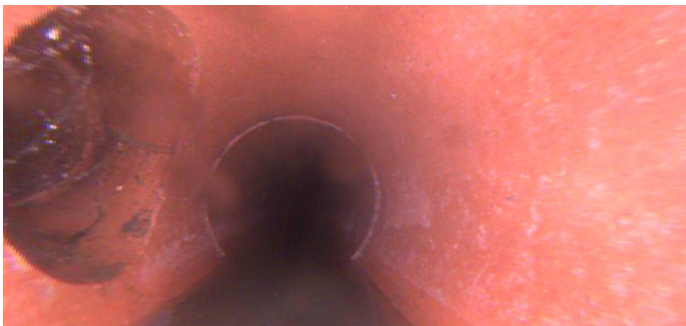
Code: **TF**  
Description: **Tap Factory**

Distance (ft): **289.6**  
Structural Grade: **0**  
O&M Grade: **0**  
Clock Start/From: **9**  
Clock To:  
1st Value: **4.000**  
2nd Value:  
Value Percent:  
Continuous Index:  
Within 8" of Joint:  
Remarks:

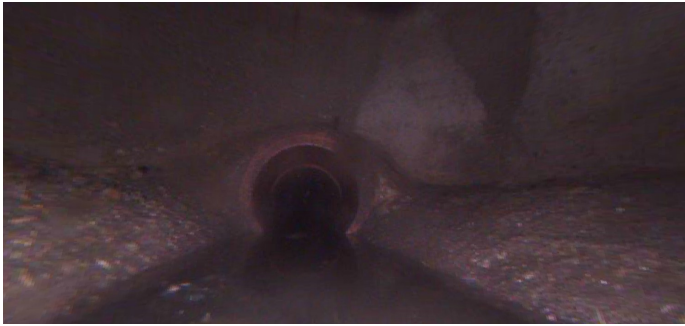
Code: **DAGS**  
Description: **Deposits Attached Grease**

Distance (ft): **326.8**  
Structural Grade: **0**  
O&M Grade: **2**  
Clock Start/From: **7**  
Clock To: **5**  
1st Value:  
2nd Value:  
Value Percent: **5.000**  
Continuous Index: **F01**  
Within 8" of Joint: **YES**  
Remarks: **WANDER**

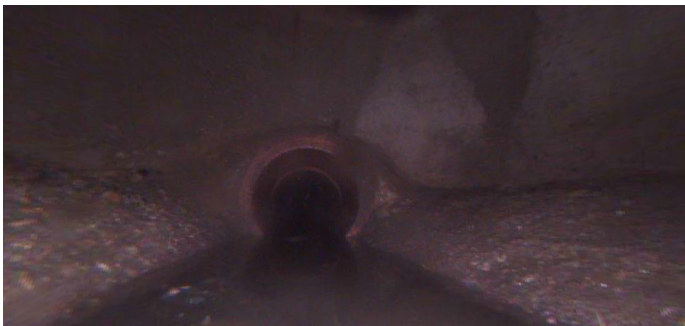
Code: **AMH**  
Description: **Manhole**

Distance (ft): **326.8**  
Structural Grade: **0**  
O&M Grade: **0**  
Clock Start/From:  
Clock To:  
1st Value:  
2nd Value:  
Value Percent:  
Continuous Index:  
Within 8" of Joint: **NO**  
Remarks: **M-904-061**
