Profile/Photo Observation Report

Street:	DIVISION ST & SHELBY ST	Flow Control:	Not Controlled
City:	Hobart, IN	Year Renewed:	
Location:	Other	Tape/Media #:	
Purpose:	Not Known	Dia/Height:	8"
Use:	Sanitary	Material:	VCP
Drain Area:	NA	Lining:	
Category:	NA		
Comment:

Location Details:		Direction of Survey:	Upstream
US MH:	M-904-062	DS MH:	M-904-063
		Total Length Surveyed (ft):	23.8

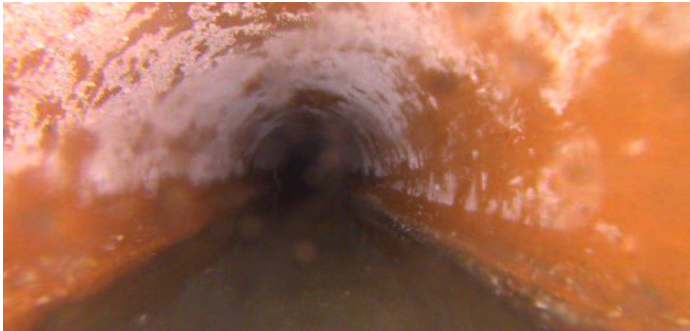
Code: AMH

Description: Manhole

Distance (ft): .0

Remarks: M-904-063

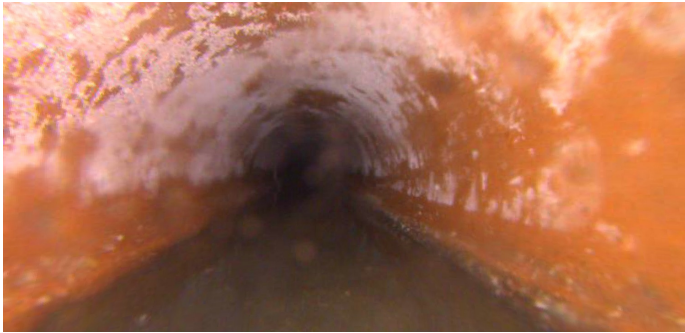
Code:	MWL
Description:	Water Level

Distance (ft):	.0
Structural Grade:	0
O&M Grade:	0
Clock Start/From:	
Clock To:	
1st Value:	
2nd Value:	
Value Percent:	20.000
Continuous Index:	
Within 8" of Joint:	NO
Remarks:

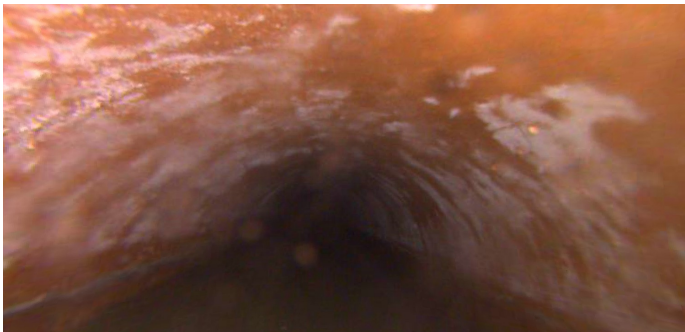
Code:	MSA
Description:	Abandoned Survey

Distance (ft):	23.8
Structural Grade:	0
O&M Grade:	0
Clock Start/From:	
Clock To:	
1st Value:	
2nd Value:	
Value Percent:	
Continuous Index:	
Within 8" of Joint:	NO
Remarks:	DEBRIS UNDER WATER
