Profile/Photo Observation Report

Street:	DIVISION ST & SHELBY ST	Flow Control:	Not Controlled
City:	Hobart, IN	Year Renewed:	
Location:	Light Highway	Tape/Media #:	
Purpose:	Routine Assessment	Dia/Height:	8"
Use:	Sanitary	Material:	VCP
Drain Area:	NA	Lining:	
Category:	NA		
Comment:

Location Details:		Direction of Survey:	Downstream
US MH:	M-904-062	DS MH:	M-904-063
		Total Length Surveyed (ft):	237.8

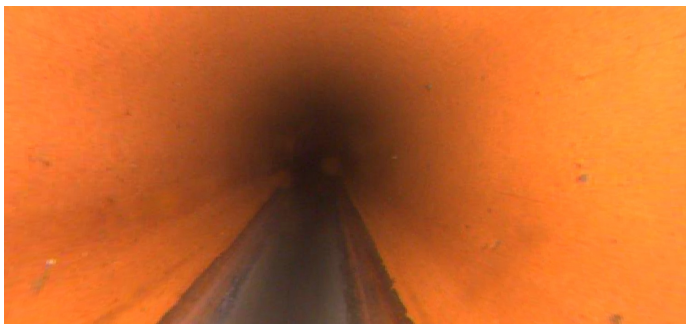
Code: **AMH**
Description: **Manhole**

Distance (ft): **.0**
Structural Grade: **0**
O&M Grade: **0**
Clock Start/From:
Clock To:
1st Value:
2nd Value:
Value Percent:
Continuous Index:
Within 8" of Joint: **NO**
Remarks: **M-904-062**

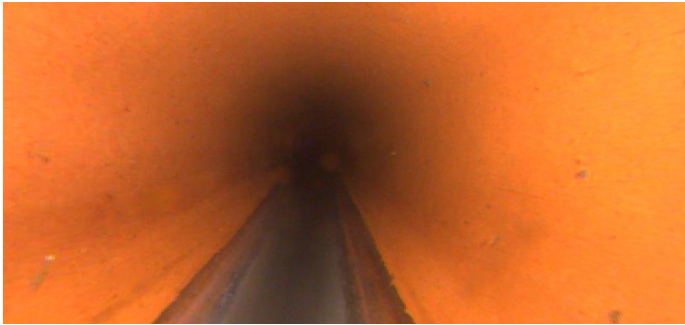
Code:	MWL
Description:	Water Level

Distance (ft):	.0
Structural Grade:	0
O&M Grade:	0
Clock Start/From:	
Clock To:	
1st Value:	
2nd Value:	
Value Percent:	5.000
Continuous Index:	
Within 8" of Joint:	NO
Remarks:

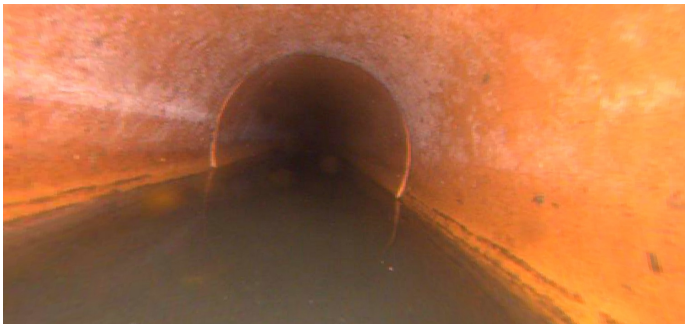
Code:	DAGS
Description:	Deposits Attached Grease

Distance (ft):	8.5
Structural Grade:	0
O&M Grade:	2
Clock Start/From:	7
Clock To:	5
1st Value:	
2nd Value:	
Value Percent:	5.000
Continuous Index:	S01
Within 8" of Joint:	YES
Remarks:	WANDER

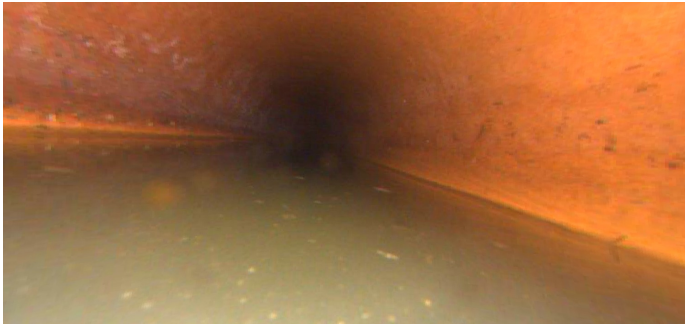
Code: **MWLS**
Description: **Water Level Sag**

Distance (ft): **14.8**
Structural Grade: **2**
O&M Grade: **3**
Clock Start/From:
Clock To:
1st Value:
2nd Value:
Value Percent: **15.000**
Continuous Index:
Within 8" of Joint: **NO**
Remarks:

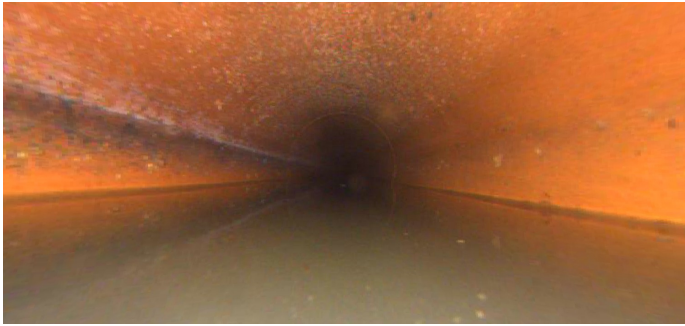
Code: **MCU**
Description: **Camera Underwater**

Distance (ft): **182.2**
Structural Grade: **0**
O&M Grade: **4**
Clock Start/From:
Clock To:
1st Value:
2nd Value:
Value Percent:
Continuous Index: **F02**
Within 8" of Joint: **NO**
Remarks:
