Profile/Photo Observation Report

Street:	SHELBY ST	Flow Control:	Not Controlled
City:	Hobart, IN	Year Renewed:	
Location:	Other	Tape/Media #:	
Purpose:	Not Known	Dia/Height:	8"
Use:	Sanitary	Material:	VCP
Drain Area:	NA	Lining:	
Category:	NA		
Comment:

Location Details:		Direction of Survey:	Downstream
US MH:	M-904-063	DS MH:	M-904-072
		Total Length Surveyed (ft):	7.8

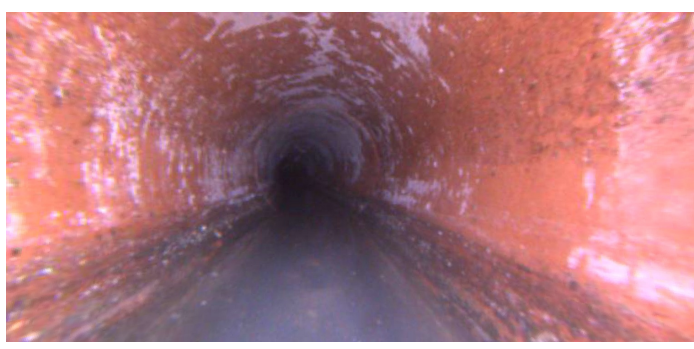
Code: **AMH**
Description: **Manhole**

Distance (ft): **.0**
Structural Grade: **0**
O&M Grade: **0**
Clock Start/From:
Clock To:
1st Value:
2nd Value:
Value Percent:
Continuous Index:
Within 8" of Joint: **NO**
Remarks: **M-904-063**

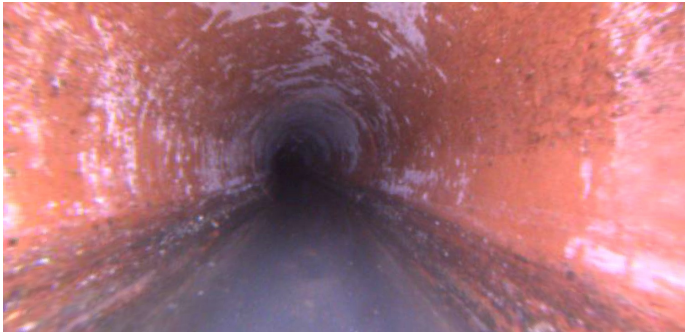
Code:	MWL
Description:	Water Level

Distance (ft):	.0
Structural Grade:	0
O&M Grade:	0
Clock Start/From:	
Clock To:	
1st Value:	
2nd Value:	
Value Percent:	10.000
Continuous Index:	
Within 8" of Joint:	NO
Remarks:

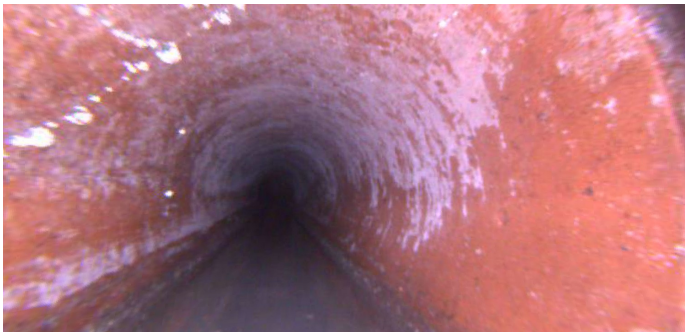
Code:	LL
Description:	Alignment Left

Distance (ft):	2.6
Structural Grade:	0
O&M Grade:	1
Clock Start/From:	
Clock To:	
1st Value:	
2nd Value:	
Value Percent:	5.000
Continuous Index:	
Within 8" of Joint:	NO
Remarks:

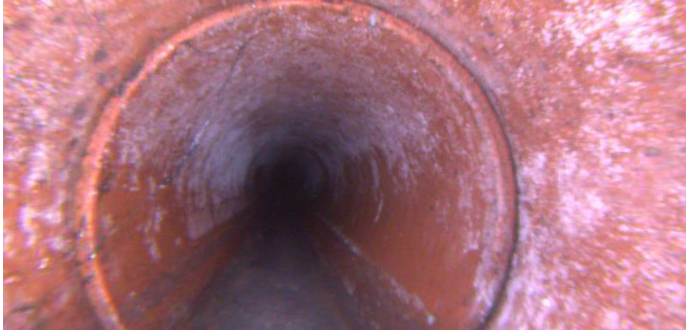
Code: **LL**
Description: **Alignment Left**

Distance (ft): **7.3**
Structural Grade: **0**
O&M Grade: **1**
Clock Start/From:
Clock To:
1st Value:
2nd Value:
Value Percent: **5.000**
Continuous Index:
Within 8" of Joint: **NO**
Remarks:

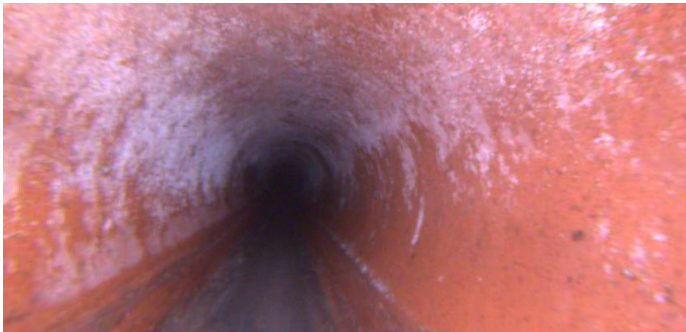
Code: **MSA**
Description: **Abandoned Survey**

Distance (ft): **7.8**
Structural Grade: **0**
O&M Grade: **0**
Clock Start/From:
Clock To:
1st Value:
2nd Value:
Value Percent:
Continuous Index:
Within 8" of Joint: **NO**
Remarks: **UNKNOWN**
