Profile/Photo Observation Report

Street:	E PEMBROKE DR E & PEMBROKE DR	Flow Control:	Not Controlled
City:	Hobart, IN	Year Renewed:	
Location:	Other	Tape/Media #:	
Purpose:	Not Known	Dia/Height:	8"
Use:	Sanitary	Material:	PVC
Drain Area:	NA	Lining:	
Category:	NA		
Comment:

Location Details:		Direction of Survey:	Downstream
US MH:	M-904-065	DS MH:	M-904-064
		Total Length Surveyed (ft):	274.0

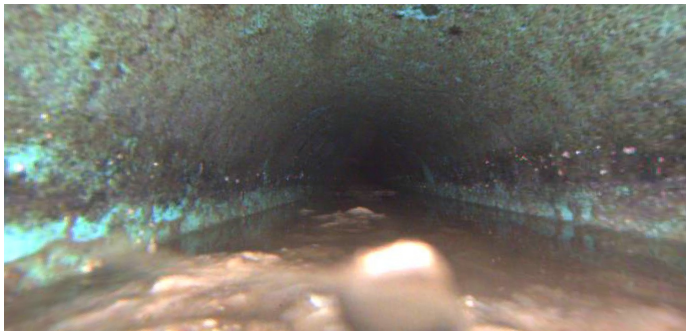
Code: **AMH**
Description: **Manhole**

Distance (ft): **.0**
Structural Grade: **0**
O&M Grade: **0**
Clock Start/From:
Clock To:
1st Value:
2nd Value:
Value Percent:
Continuous Index:
Within 8" of Joint: **NO**
Remarks: **M-904-065**

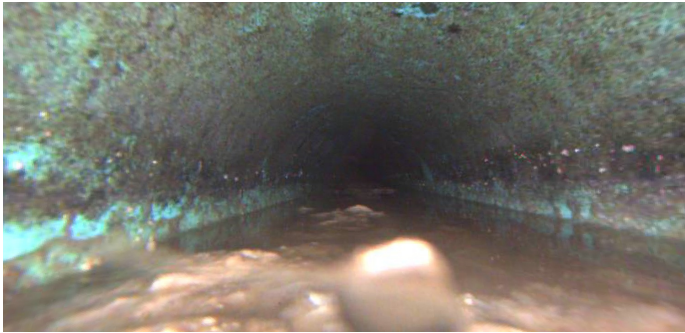
Code:	MWL
Description:	Water Level

Distance (ft):	.0
Structural Grade:	0
O&M Grade:	0
Clock Start/From:	
Clock To:	
1st Value:	
2nd Value:	
Value Percent:	40.000
Continuous Index:	
Within 8" of Joint:	NO
Remarks:

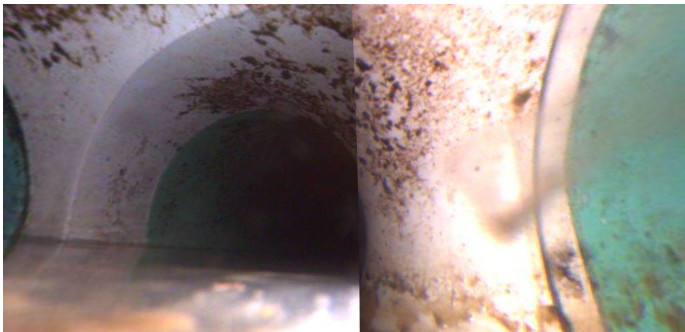
Code:	TFA
Description:	Tap Factory Active

Distance (ft):	22.4
Structural Grade:	0
O&M Grade:	0
Clock Start/From:	3
Clock To:	
1st Value:	4.000
2nd Value:	
Value Percent:	
Continuous Index:	
Within 8" of Joint:	
Remarks:

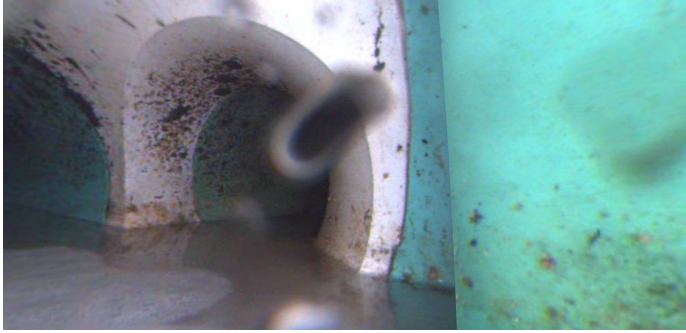
Code: **TFA**
Description: **Tap Factory Active**

Distance (ft): **96.1**
Structural Grade: **0**
O&M Grade: **0**
Clock Start/From: **3**
Clock To:
1st Value: **4.000**
2nd Value:
Value Percent:
Continuous Index:
Within 8" of Joint:
Remarks:

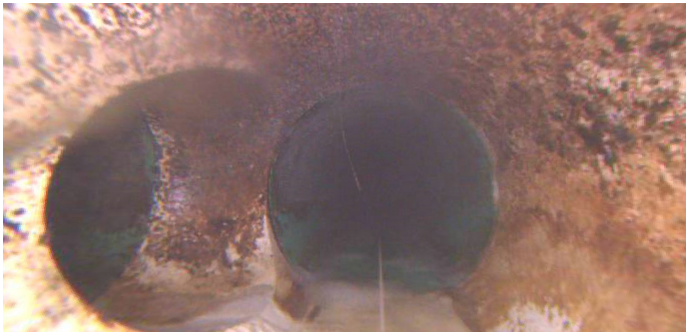
Code: **TFA**
Description: **Tap Factory Active**

Distance (ft): **157.4**
Structural Grade: **0**
O&M Grade: **0**
Clock Start/From: **3**
Clock To:
1st Value: **4.000**
2nd Value:
Value Percent:
Continuous Index:
Within 8" of Joint:
Remarks:

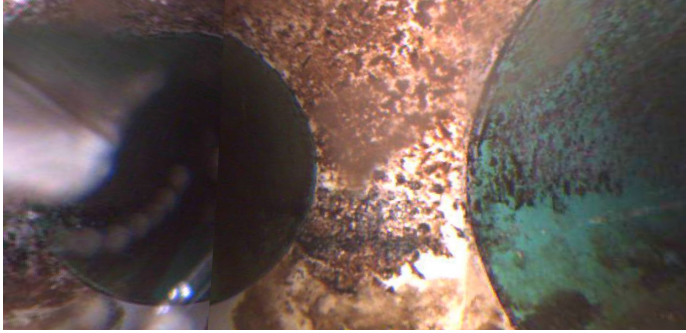
Code: **TF**
Description: **Tap Factory**

Distance (ft): **223.3**
Structural Grade: **0**
O&M Grade: **0**
Clock Start/From: **3**
Clock To:
1st Value: **4.000**
2nd Value:
Value Percent:
Continuous Index:
Within 8" of Joint:
Remarks:

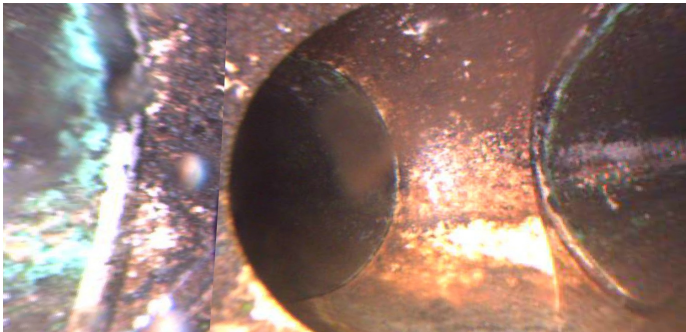
Code: **TFA**
Description: **Tap Factory Active**

Distance (ft): **268.6**
Structural Grade: **0**
O&M Grade: **0**
Clock Start/From: **3**
Clock To:
1st Value: **4.000**
2nd Value:
Value Percent:
Continuous Index:
Within 8" of Joint:
Remarks:

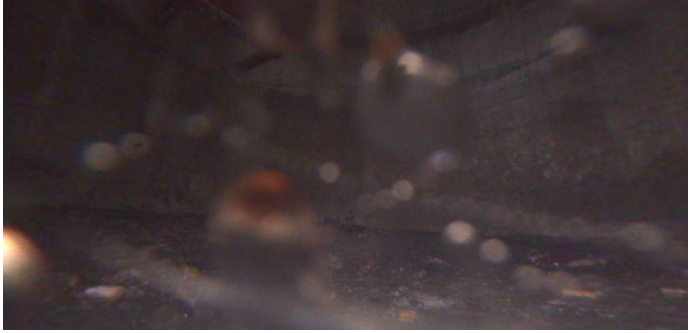
Code:	AMH
Description:	Manhole
Distance (ft):	274.0
Structural Grade:	0
O&M Grade:	0
Clock Start/From:	
Clock To:	
1st Value:	
2nd Value:	
Value Percent:	
Continuous Index:	
Within 8" of Joint:	NO
Remarks:	M-904-064
