Profile/Photo Observation Report

Street:	N Pembroke Dr.	Flow Control:	Not Controlled
City:	Hobart, IN	Year Renewed:	
Location:	Other	Tape/Media #:	
Purpose:	Not Known	Dia/Height:	8"
Use:	Sanitary	Material:	PVC
Drain Area:	NA	Lining:	
Category:	NA		
Comment:

Location Details:		Direction of Survey:	Downstream
US MH:	M-904-065	DS MH:	M-904-064
		Total Length Surveyed (ft):	274.0

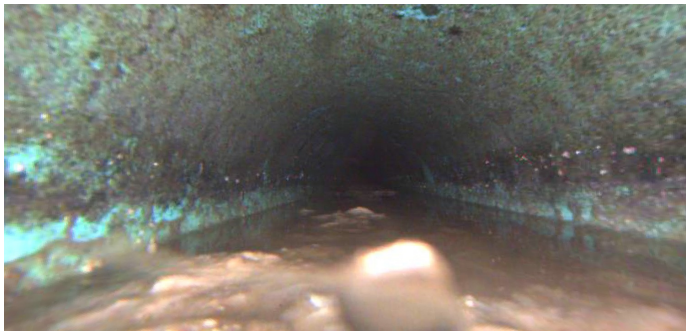
Code: **AMH**
Description: **Manhole**

Distance (ft): **.0**
Structural Grade: **0**
O&M Grade: **0**
Clock Start/From:
Clock To:
1st Value:
2nd Value:
Value Percent:
Continuous Index:
Within 8" of Joint: **NO**
Remarks: **M-904-065**

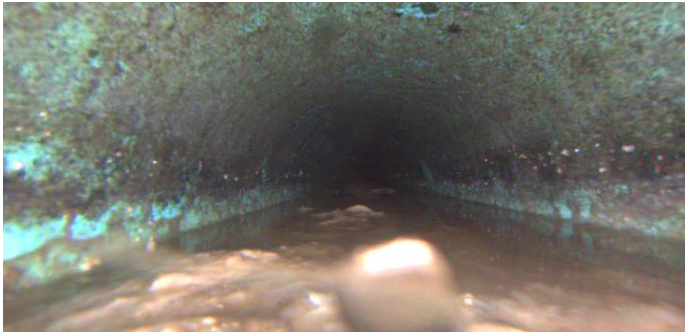
Code:	MWL
Description:	Water Level

Distance (ft):	.0
Structural Grade:	0
O&M Grade:	0
Clock Start/From:	
Clock To:	
1st Value:	
2nd Value:	
Value Percent:	40.000
Continuous Index:	
Within 8" of Joint:	NO
Remarks:

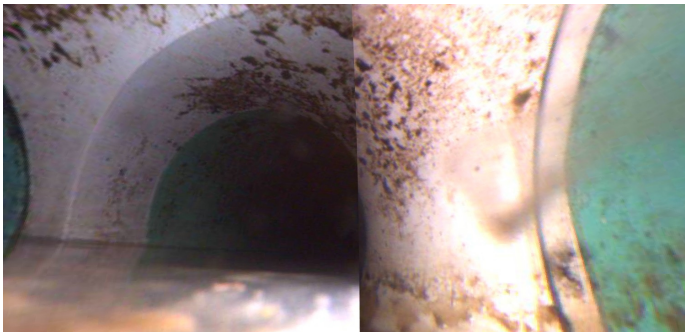
Code:	TFA
Description:	Tap Factory Active

Distance (ft):	22.4
Structural Grade:	0
O&M Grade:	0
Clock Start/From:	3
Clock To:	
1st Value:	4.000
2nd Value:	
Value Percent:	
Continuous Index:	
Within 8" of Joint:	
Remarks:

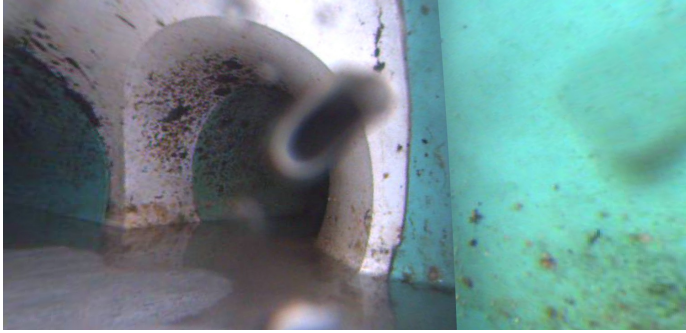
Code: **TFA**
Description: **Tap Factory Active**

Distance (ft): **96.1**
Structural Grade: **0**
O&M Grade: **0**
Clock Start/From: **3**
Clock To:
1st Value: **4.000**
2nd Value:
Value Percent:
Continuous Index:
Within 8" of Joint:
Remarks:

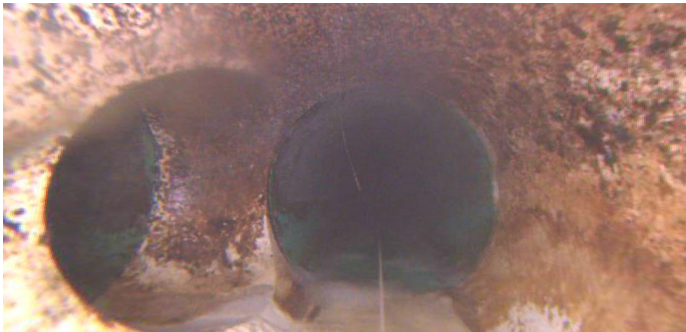
Code: **TFA**
Description: **Tap Factory Active**

Distance (ft): **157.4**
Structural Grade: **0**
O&M Grade: **0**
Clock Start/From: **3**
Clock To:
1st Value: **4.000**
2nd Value:
Value Percent:
Continuous Index:
Within 8" of Joint:
Remarks:

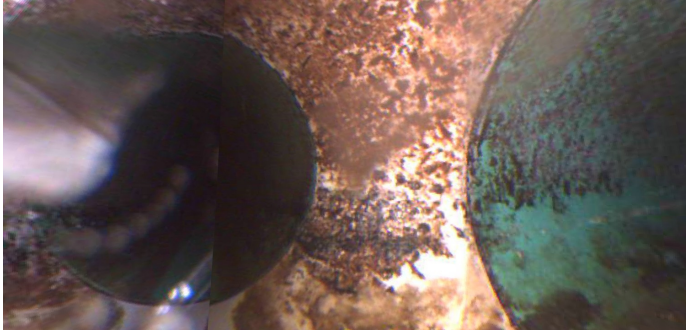
Code: **TF**
Description: **Tap Factory**

Distance (ft): **223.3**
Structural Grade: **0**
O&M Grade: **0**
Clock Start/From: **3**
Clock To:
1st Value: **4.000**
2nd Value:
Value Percent:
Continuous Index:
Within 8" of Joint:
Remarks:

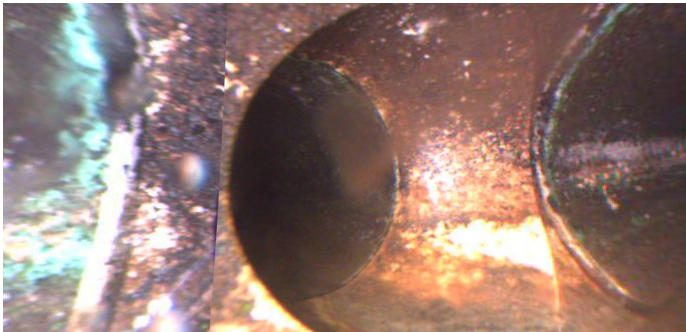
Code: **TFA**
Description: **Tap Factory Active**

Distance (ft): **268.6**
Structural Grade: **0**
O&M Grade: **0**
Clock Start/From: **3**
Clock To:
1st Value: **4.000**
2nd Value:
Value Percent:
Continuous Index:
Within 8" of Joint:
Remarks:

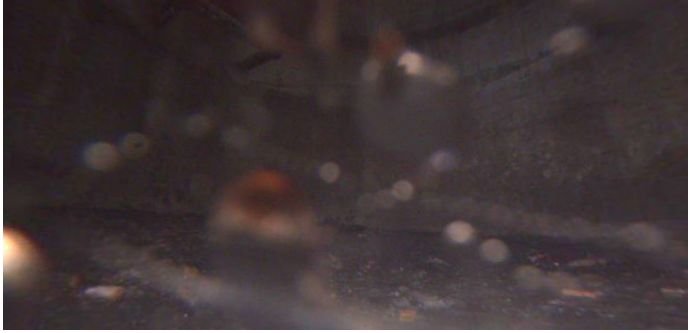
Code:	AMH
Description:	Manhole
Distance (ft):	274.0
Structural Grade:	0
O&M Grade:	0
Clock Start/From:	
Clock To:	
1st Value:	
2nd Value:	
Value Percent:	
Continuous Index:	
Within 8" of Joint:	NO
Remarks:	M-904-064
