Profile/Photo Observation Report

Street:	N Pembroke Dr.	Flow Control:	Not Controlled
City:	Hobart, IN	Year Renewed:	
Location:	Other	Tape/Media #:	
Purpose:	Not Known	Dia/Height:	8"
Use:	Sanitary	Material:	PVC
Drain Area:	NA	Lining:	
Category:	NA		
Comment:

Location Details:		Direction of Survey:	Upstream
US MH:	M-904-066	DS MH:	M-904-065
		Total Length Surveyed (ft):	264.8

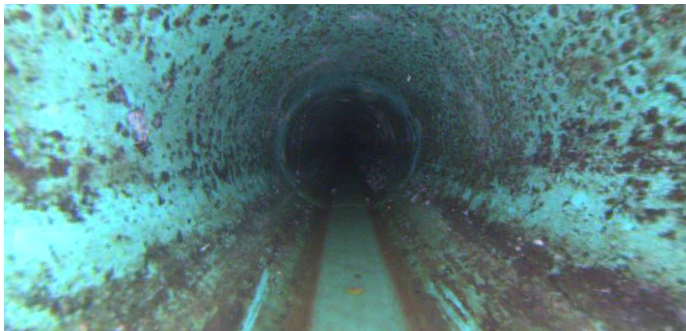
Code: **AMH**
Description: **Manhole**

Distance (ft): **.0**
Structural Grade: **0**
O&M Grade: **0**
Clock Start/From:
Clock To:
1st Value:
2nd Value:
Value Percent:
Continuous Index:
Within 8" of Joint: **NO**
Remarks: **M-904-065**

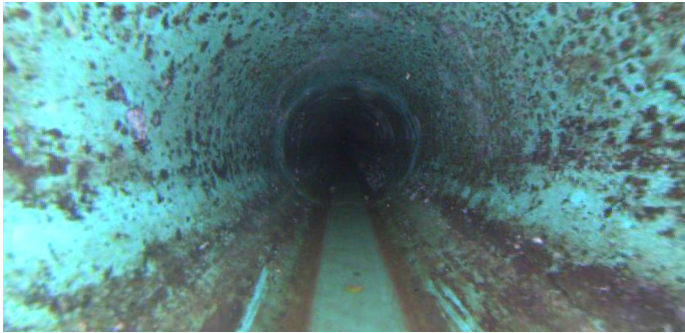
Code:	MWL
Description:	Water Level

Distance (ft):	.0
Structural Grade:	0
O&M Grade:	0
Clock Start/From:	
Clock To:	
1st Value:	
2nd Value:	
Value Percent:	5.000
Continuous Index:	
Within 8" of Joint:	NO
Remarks:

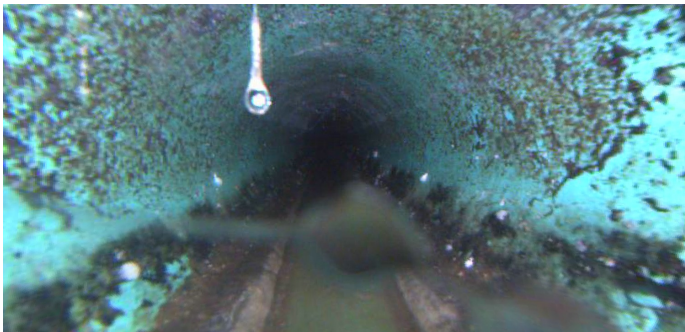
Code:	DAGS
Description:	Deposits Attached Grease

Distance (ft):	14.4
Structural Grade:	0
O&M Grade:	2
Clock Start/From:	8
Clock To:	4
1st Value:	
2nd Value:	
Value Percent:	5.000
Continuous Index:	S01
Within 8" of Joint:	NO
Remarks:

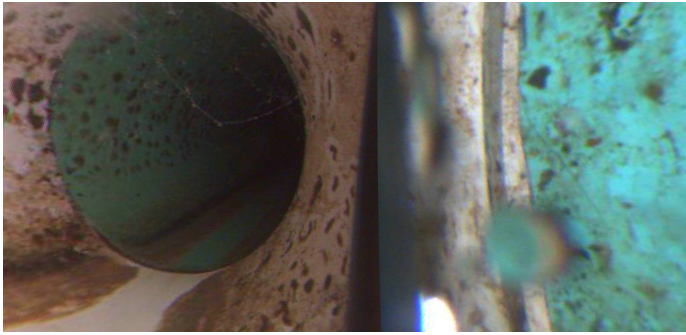
Code: **TF**
Description: **Tap Factory**

Distance (ft): **31.6**
Structural Grade: **0**
O&M Grade: **0**
Clock Start/From: **9**
Clock To:
1st Value: **4.000**
2nd Value:
Value Percent:
Continuous Index:
Within 8" of Joint:
Remarks:

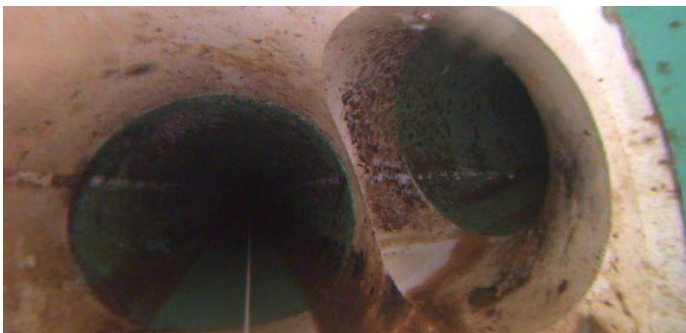
Code: **TFA**
Description: **Tap Factory Active**

Distance (ft): **93.5**
Structural Grade: **0**
O&M Grade: **0**
Clock Start/From: **9**
Clock To:
1st Value: **4.000**
2nd Value:
Value Percent:
Continuous Index:
Within 8" of Joint:
Remarks:

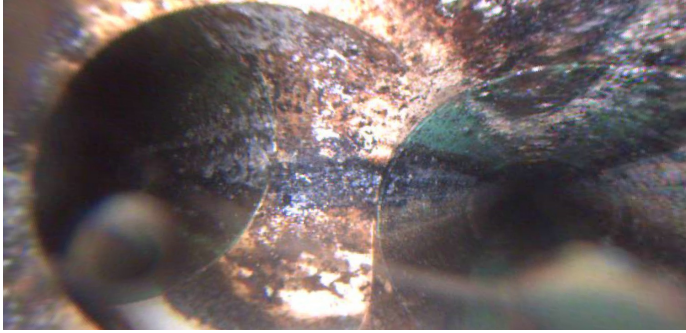
Code: **TF**
Description: **Tap Factory**

Distance (ft): **186.1**
Structural Grade: **0**
O&M Grade: **0**
Clock Start/From: **9**
Clock To:
1st Value: **4.000**
2nd Value:
Value Percent:
Continuous Index:
Within 8" of Joint:
Remarks:

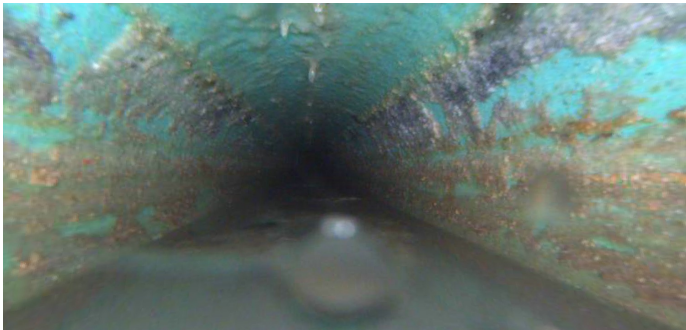
Code: **MWL**
Description: **Water Level**

Distance (ft): **196.9**
Structural Grade: **0**
O&M Grade: **0**
Clock Start/From:
Clock To:
1st Value:
2nd Value:
Value Percent: **30.000**
Continuous Index:
Within 8" of Joint: **NO**
Remarks:

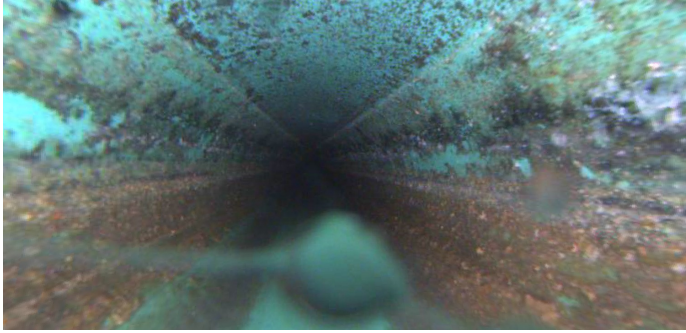
Code: **MWL**
Description: **Water Level**

Distance (ft): **218.2**
Structural Grade: **0**
O&M Grade: **0**
Clock Start/From:
Clock To:
1st Value:
2nd Value:
Value Percent: **5.000**
Continuous Index:
Within 8" of Joint: **NO**
Remarks:

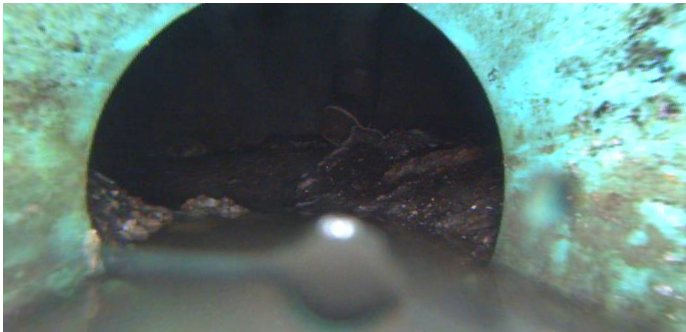
Code: **DAGS**
Description: **Deposits Attached Grease**

Distance (ft): **263.3**
Structural Grade: **0**
O&M Grade: **2**
Clock Start/From: **8**
Clock To: **4**
1st Value:
2nd Value:
Value Percent: **5.000**
Continuous Index: **F01**
Within 8" of Joint: **NO**
Remarks:

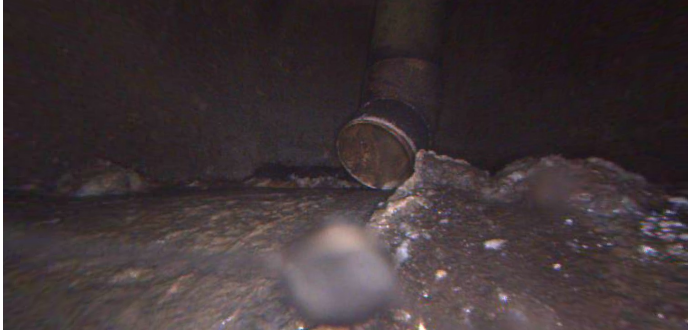
Code:	AMH
Description:	Manhole
Distance (ft):	264.8
Structural Grade:	0
O&M Grade:	0
Clock Start/From:	
Clock To:	
1st Value:	
2nd Value:	
Value Percent:	
Continuous Index:	
Within 8" of Joint:	NO
Remarks:	M-904-066
