Profile/Photo Observation Report

Date:	04/14/2018	Weather:		Coding:	PACP 6.0
Pipe Length (ft):	336.1	Owner:	NA	Pre Clean:	Not Known
P.O.#:		Surveyor:	Jen Costello	PSR:	P-904-068-067
Customer:		Clean Date:	01/01/1900	Shape:	C

Street:	W PEMBROKE DR E	Flow Control:	Not Controlled
City:	Hobart, IN	Year Renewed:	
Location:	Other	Tape/Media #:	
Purpose:	Not Known	Dia/Height:	8"
Use:	Sanitary	Material:	PVC
Drain Area:	NA	Lining:	
Category:	NA		
Comment:

Location Details:		Direction of Survey:	Upstream
US MH:	M-904-068	DS MH:	M-904-067
		Total Length Surveyed (ft):	329.1

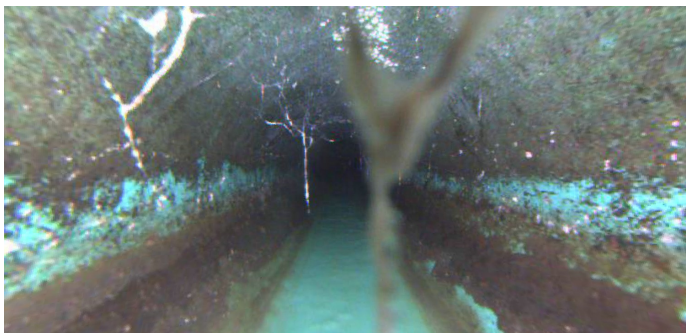
Code: **AMH**
Description: **Manhole**

Distance (ft): **.0**
Structural Grade: **0**
O&M Grade: **0**
Clock Start/From:
Clock To:
1st Value:
2nd Value:
Value Percent:
Continuous Index:
Within 8" of Joint: **NO**
Remarks: **M-904-067**

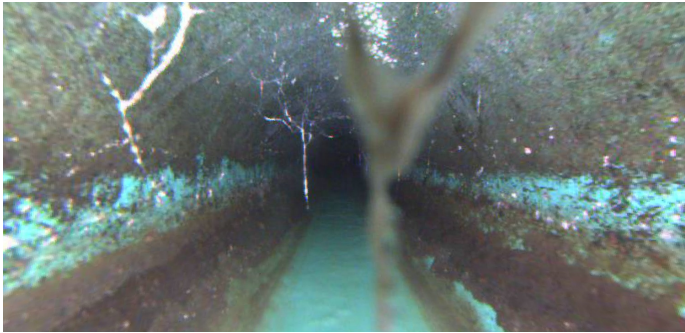
Code:	MWL
Description:	Water Level

Distance (ft):	.0
Structural Grade:	0
O&M Grade:	0
Clock Start/From:	
Clock To:	
1st Value:	
2nd Value:	
Value Percent:	5.000
Continuous Index:	
Within 8" of Joint:	NO
Remarks:

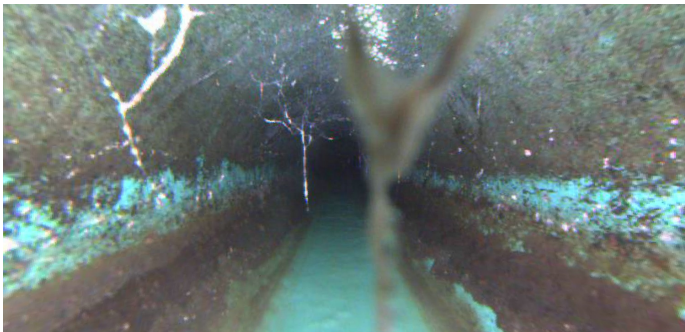
Code:	DAGS
Description:	Deposits Attached Grease

Distance (ft):	.0
Structural Grade:	0
O&M Grade:	2
Clock Start/From:	7
Clock To:	5
1st Value:	
2nd Value:	
Value Percent:	5.000
Continuous Index:	S01
Within 8" of Joint:	NO
Remarks:

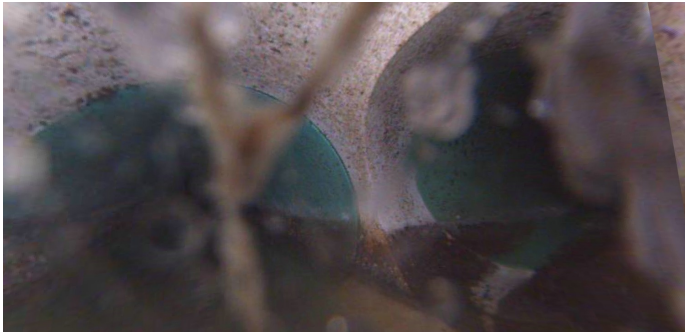
Code: **TFA**
Description: **Tap Factory Active**

Distance (ft): **65.5**
Structural Grade: **0**
O&M Grade: **0**
Clock Start/From: **3**
Clock To:
1st Value: **4.000**
2nd Value:
Value Percent:
Continuous Index:
Within 8" of Joint:
Remarks:

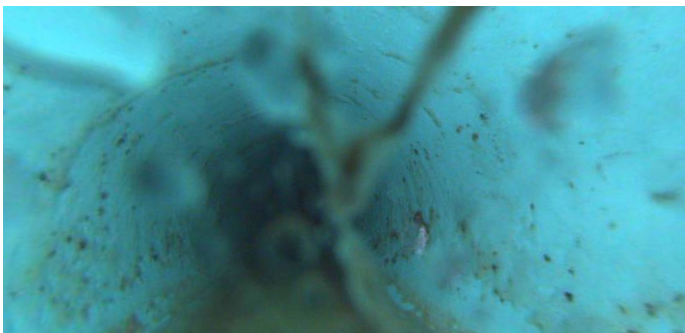
Code: **DAGS**
Description: **Deposits Attached Grease**

Distance (ft): **85.2**
Structural Grade: **0**
O&M Grade: **2**
Clock Start/From: **7**
Clock To: **5**
1st Value:
2nd Value:
Value Percent: **5.000**
Continuous Index: **F01**
Within 8" of Joint: **NO**
Remarks:

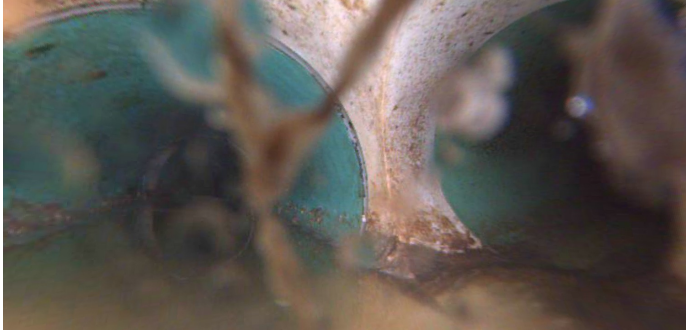
Code: **TFA**
Description: **Tap Factory Active**

Distance (ft): **113.1**
Structural Grade: **0**
O&M Grade: **0**
Clock Start/From: **3**
Clock To:
1st Value: **4.000**
2nd Value:
Value Percent:
Continuous Index:
Within 8" of Joint:
Remarks:

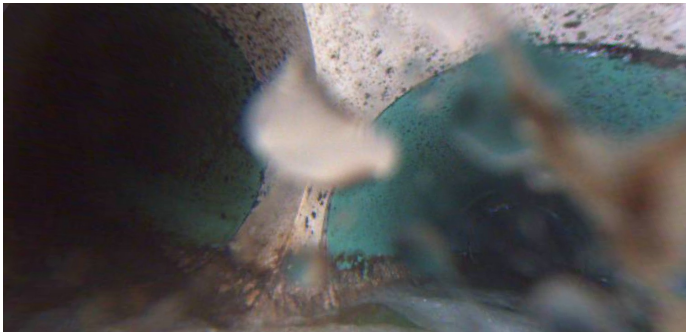
Code: **TFA**
Description: **Tap Factory Active**

Distance (ft): **115.4**
Structural Grade: **0**
O&M Grade: **0**
Clock Start/From: **9**
Clock To:
1st Value: **4.000**
2nd Value:
Value Percent:
Continuous Index:
Within 8" of Joint:
Remarks:

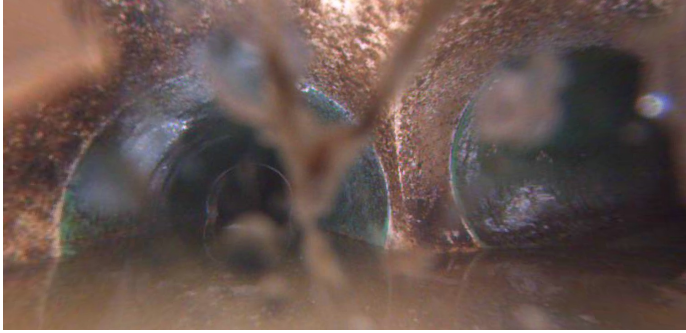
Code: **TFA**
Description: **Tap Factory Active**

Distance (ft): **173.1**
Structural Grade: **0**
O&M Grade: **0**
Clock Start/From: **3**
Clock To:
1st Value: **4.000**
2nd Value:
Value Percent:
Continuous Index:
Within 8" of Joint:
Remarks:

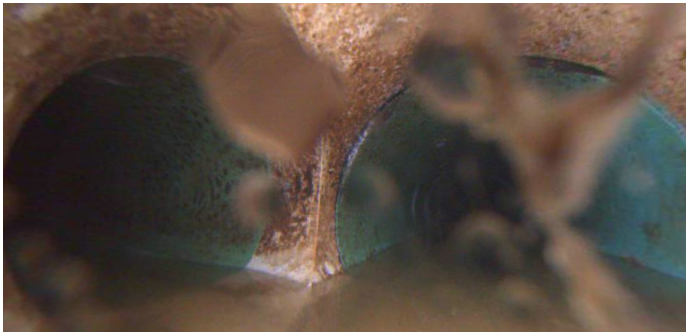
Code: **TFA**
Description: **Tap Factory Active**

Distance (ft): **175.6**
Structural Grade: **0**
O&M Grade: **0**
Clock Start/From: **9**
Clock To:
1st Value: **4.000**
2nd Value:
Value Percent:
Continuous Index:
Within 8" of Joint:
Remarks:

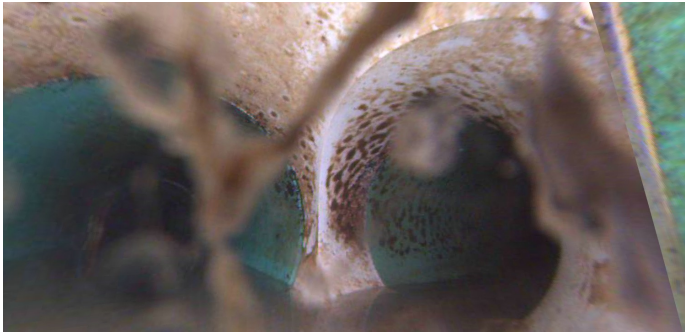
Code: **TFA**
Description: **Tap Factory Active**

Distance (ft): **242.5**
Structural Grade: **0**
O&M Grade: **0**
Clock Start/From: **3**
Clock To:
1st Value: **4.000**
2nd Value:
Value Percent:
Continuous Index:
Within 8" of Joint:
Remarks:

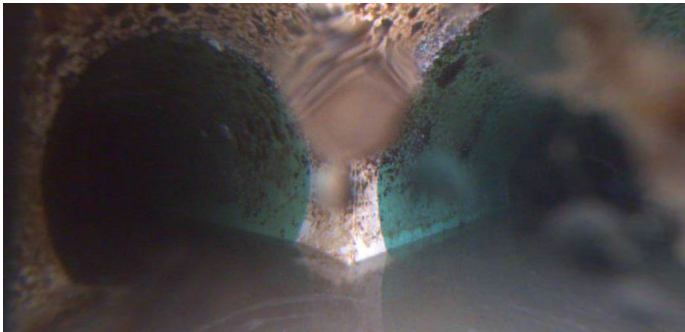
Code: **TFA**
Description: **Tap Factory Active**

Distance (ft): **245.2**
Structural Grade: **0**
O&M Grade: **0**
Clock Start/From: **9**
Clock To:
1st Value: **4.000**
2nd Value:
Value Percent:
Continuous Index:
Within 8" of Joint:
Remarks:

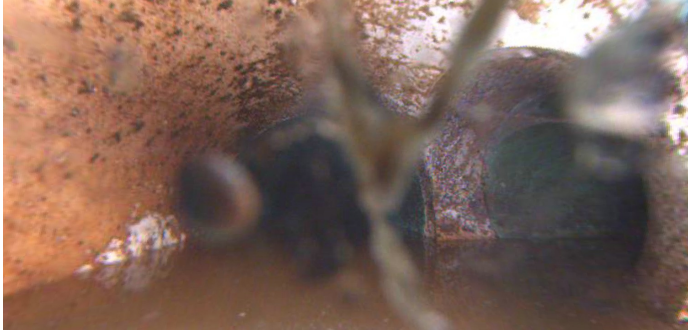
Code: **TFA**
Description: **Tap Factory Active**

Distance (ft): **309.2**
Structural Grade: **0**
O&M Grade: **0**
Clock Start/From: **3**
Clock To:
1st Value: **4.000**
2nd Value:
Value Percent:
Continuous Index:
Within 8" of Joint:
Remarks:

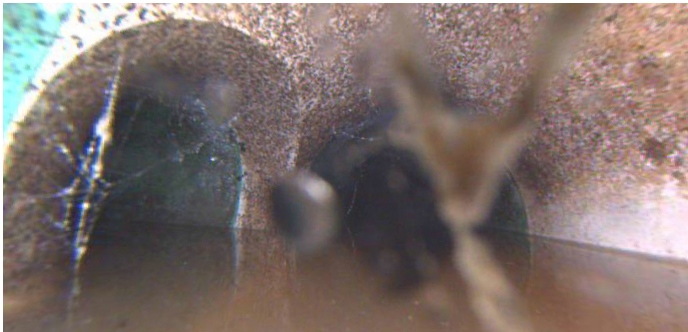
Code: **TFA**
Description: **Tap Factory Active**

Distance (ft): **311.8**
Structural Grade: **0**
O&M Grade: **0**
Clock Start/From: **9**
Clock To:
1st Value: **4.000**
2nd Value:
Value Percent:
Continuous Index:
Within 8" of Joint:
Remarks:

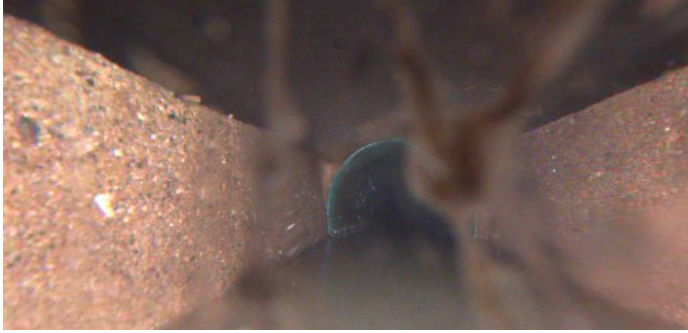
Code:	AMH
Description:	Manhole
Distance (ft):	329.1
Structural Grade:	0
O&M Grade:	0
Clock Start/From:	
Clock To:	
1st Value:	
2nd Value:	
Value Percent:	
Continuous Index:	
Within 8" of Joint:	NO
Remarks:	M-904-068
