Profile/Photo Observation Report

Street:	N Pembroke Dr.	Flow Control:	Not Controlled
City:	Hobart, IN	Year Renewed:	
Location:	Other	Tape/Media #:	
Purpose:	Not Known	Dia/Height:	8"
Use:	Sanitary	Material:	PVC
Drain Area:	NA	Lining:	
Category:	NA		
Comment:

Location Details:		Direction of Survey:	Upstream
US MH:	M-904-068	DS MH:	M-904-067
		Total Length Surveyed (ft):	329.1

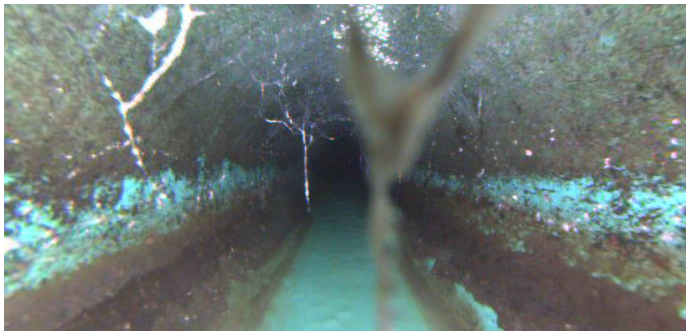
Code: **AMH**
Description: **Manhole**

Distance (ft): **.0**
Structural Grade: **0**
O&M Grade: **0**
Clock Start/From:
Clock To:
1st Value:
2nd Value:
Value Percent:
Continuous Index:
Within 8" of Joint: **NO**
Remarks: **M-904-067**

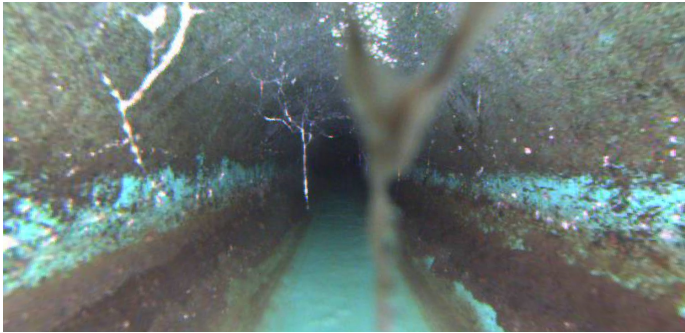
Code:	MWL
Description:	Water Level

Distance (ft):	.0
Structural Grade:	0
O&M Grade:	0
Clock Start/From:	
Clock To:	
1st Value:	
2nd Value:	
Value Percent:	5.000
Continuous Index:	
Within 8" of Joint:	NO
Remarks:

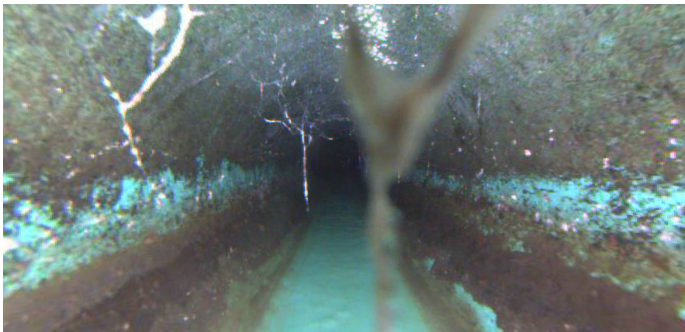
Code:	DAGS
Description:	Deposits Attached Grease

Distance (ft):	.0
Structural Grade:	0
O&M Grade:	2
Clock Start/From:	7
Clock To:	5
1st Value:	
2nd Value:	
Value Percent:	5.000
Continuous Index:	S01
Within 8" of Joint:	NO
Remarks:

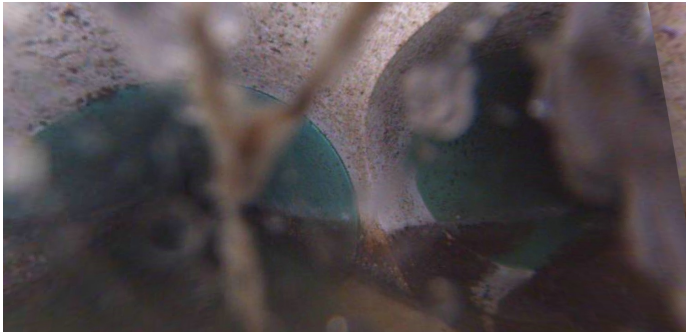
Code: **TFA**
Description: **Tap Factory Active**

Distance (ft): **65.5**
Structural Grade: **0**
O&M Grade: **0**
Clock Start/From: **3**
Clock To:
1st Value: **4.000**
2nd Value:
Value Percent:
Continuous Index:
Within 8" of Joint:
Remarks:

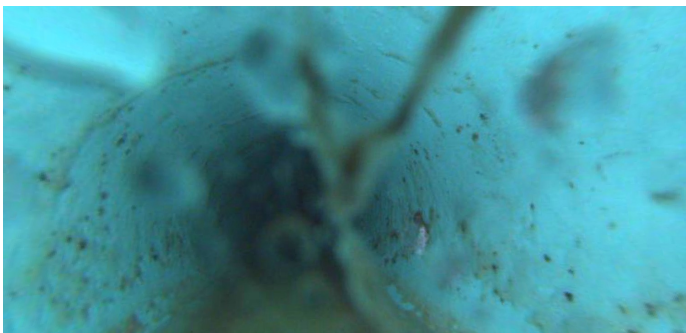
Code: **DAGS**
Description: **Deposits Attached Grease**

Distance (ft): **85.2**
Structural Grade: **0**
O&M Grade: **2**
Clock Start/From: **7**
Clock To: **5**
1st Value:
2nd Value:
Value Percent: **5.000**
Continuous Index: **F01**
Within 8" of Joint: **NO**
Remarks:

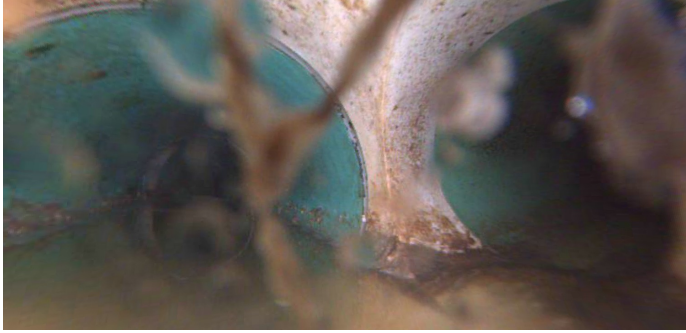
Code: **TFA**
Description: **Tap Factory Active**

Distance (ft): **113.1**
Structural Grade: **0**
O&M Grade: **0**
Clock Start/From: **3**
Clock To:
1st Value: **4.000**
2nd Value:
Value Percent:
Continuous Index:
Within 8" of Joint:
Remarks:

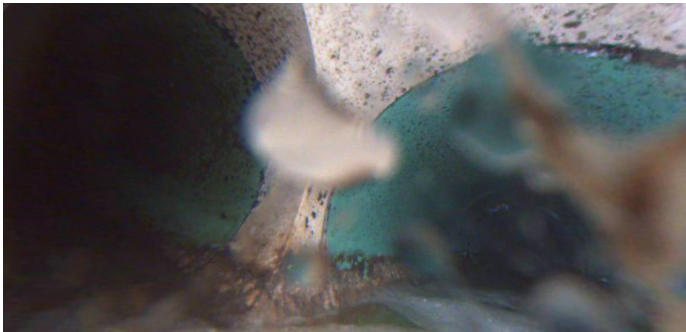
Code: **TFA**
Description: **Tap Factory Active**

Distance (ft): **115.4**
Structural Grade: **0**
O&M Grade: **0**
Clock Start/From: **9**
Clock To:
1st Value: **4.000**
2nd Value:
Value Percent:
Continuous Index:
Within 8" of Joint:
Remarks:

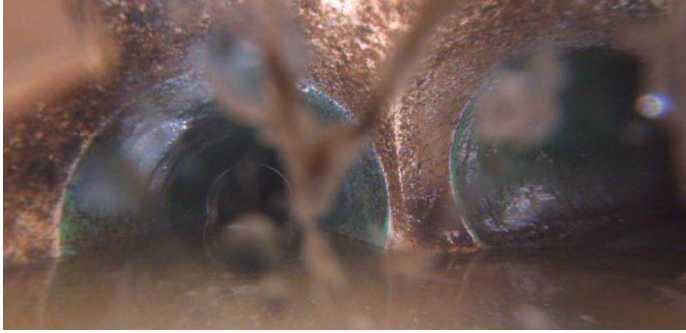
Code: **TFA**
Description: **Tap Factory Active**

Distance (ft): **173.1**
Structural Grade: **0**
O&M Grade: **0**
Clock Start/From: **3**
Clock To:
1st Value: **4.000**
2nd Value:
Value Percent:
Continuous Index:
Within 8" of Joint:
Remarks:

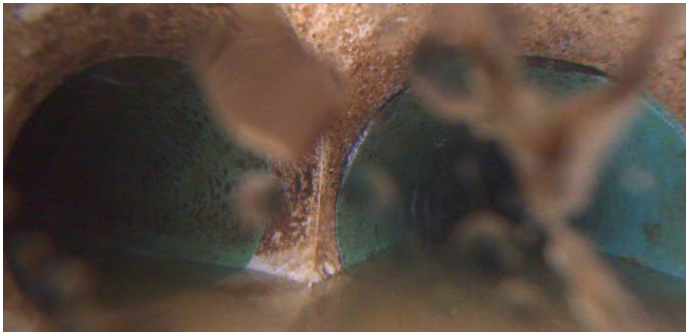
Code: **TFA**
Description: **Tap Factory Active**

Distance (ft): **175.6**
Structural Grade: **0**
O&M Grade: **0**
Clock Start/From: **9**
Clock To:
1st Value: **4.000**
2nd Value:
Value Percent:
Continuous Index:
Within 8" of Joint:
Remarks:

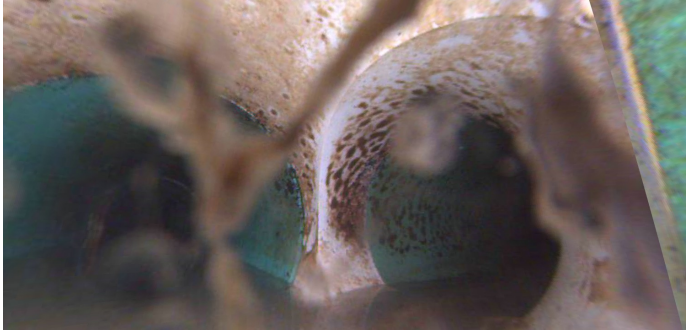
Code: **TFA**
Description: **Tap Factory Active**

Distance (ft): **242.5**
Structural Grade: **0**
O&M Grade: **0**
Clock Start/From: **3**
Clock To:
1st Value: **4.000**
2nd Value:
Value Percent:
Continuous Index:
Within 8" of Joint:
Remarks:

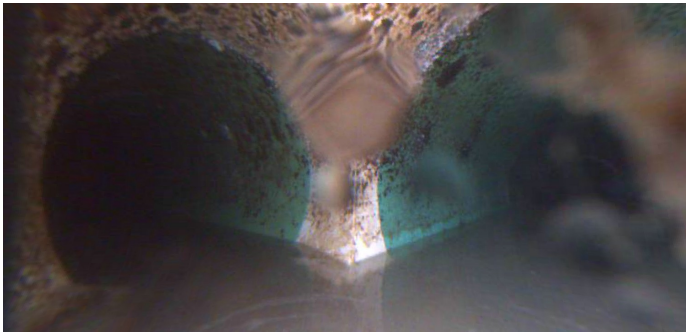
Code: **TFA**
Description: **Tap Factory Active**

Distance (ft): **245.2**
Structural Grade: **0**
O&M Grade: **0**
Clock Start/From: **9**
Clock To:
1st Value: **4.000**
2nd Value:
Value Percent:
Continuous Index:
Within 8" of Joint:
Remarks:

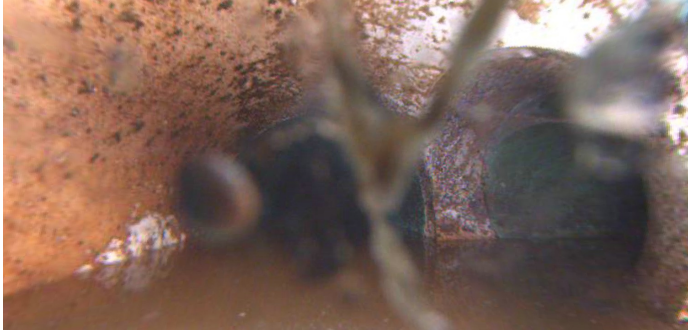
Code: **TFA**
Description: **Tap Factory Active**

Distance (ft): **309.2**
Structural Grade: **0**
O&M Grade: **0**
Clock Start/From: **3**
Clock To:
1st Value: **4.000**
2nd Value:
Value Percent:
Continuous Index:
Within 8" of Joint:
Remarks:

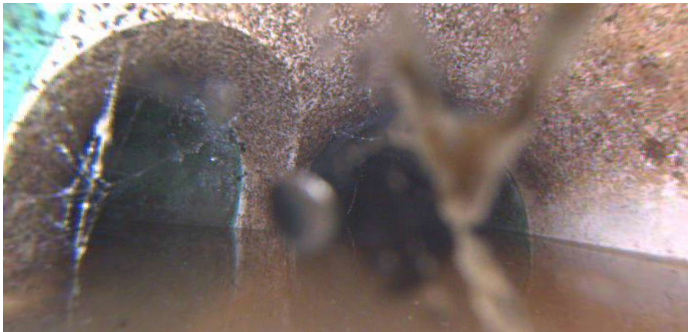
Code: **TFA**
Description: **Tap Factory Active**

Distance (ft): **311.8**
Structural Grade: **0**
O&M Grade: **0**
Clock Start/From: **9**
Clock To:
1st Value: **4.000**
2nd Value:
Value Percent:
Continuous Index:
Within 8" of Joint:
Remarks:

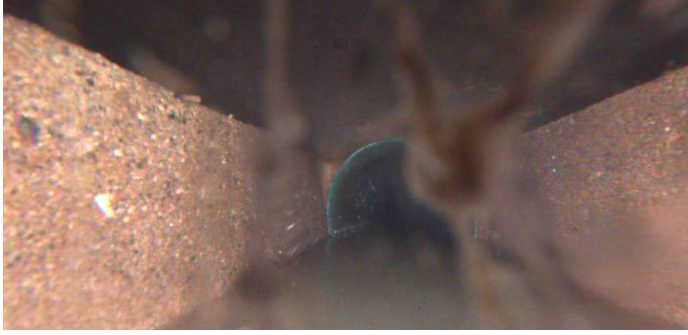
Code:	AMH
Description:	Manhole
Distance (ft):	329.1
Structural Grade:	0
O&M Grade:	0
Clock Start/From:	
Clock To:	
1st Value:	
2nd Value:	
Value Percent:	
Continuous Index:	
Within 8" of Joint:	NO
Remarks:	M-904-068
