Profile/Photo Observation Report

Street:	W PEMBROKE DR E & S PEMBROKE	Flow Control:	Not Controlled
City:	Hobart, IN	Year Renewed:	
Location:	Other	Tape/Media #:	
Purpose:	Not Known	Dia/Height:	8"
Use:	Sanitary	Material:	PVC
Drain Area:	NA	Lining:	
Category:	NA		
Comment:

Location Details:		Direction of Survey:	Upstream
US MH:	M-904-068	DS MH:	M-904-069
		Total Length Surveyed (ft):	346.5

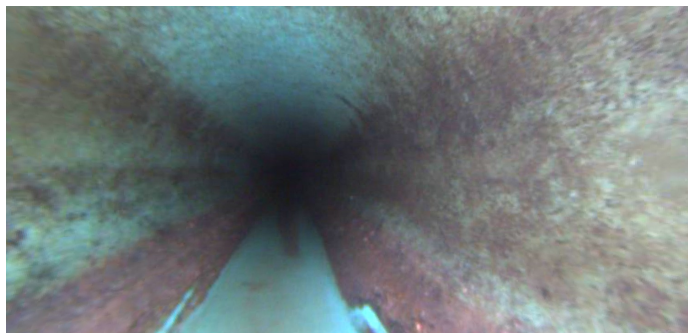
Code: **AMH**
Description: **Manhole**

Distance (ft): **.0**
Structural Grade: **0**
O&M Grade: **0**
Clock Start/From:
Clock To:
1st Value:
2nd Value:
Value Percent:
Continuous Index:
Within 8" of Joint: **NO**
Remarks: **M-904-069**

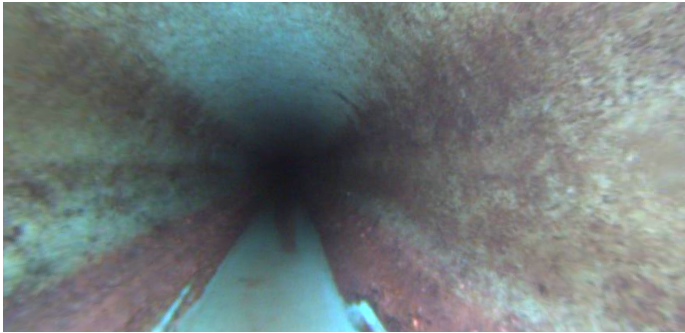
Code:	MWL
Description:	Water Level

Distance (ft):	.0
Structural Grade:	0
O&M Grade:	0
Clock Start/From:	
Clock To:	
1st Value:	
2nd Value:	
Value Percent:	5.000
Continuous Index:	
Within 8" of Joint:	NO
Remarks:

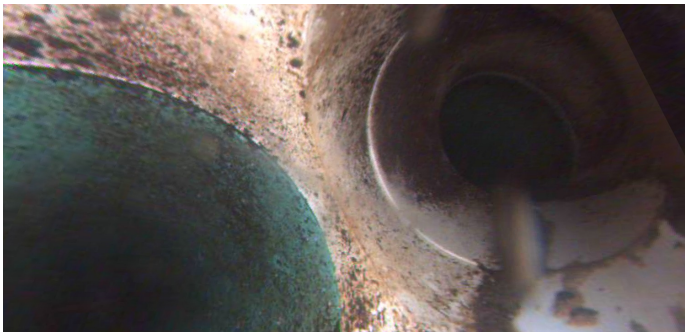
Code:	TF
Description:	Tap Factory

Distance (ft):	11.4
Structural Grade:	0
O&M Grade:	0
Clock Start/From:	10
Clock To:	
1st Value:	4.000
2nd Value:	
Value Percent:	
Continuous Index:	
Within 8" of Joint:	
Remarks:

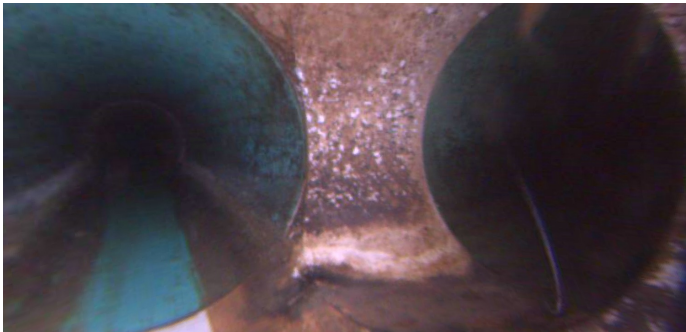
Code: **TFA**
Description: **Tap Factory Active**

Distance (ft): **96.7**
Structural Grade: **0**
O&M Grade: **0**
Clock Start/From: **3**
Clock To:
1st Value: **4.000**
2nd Value:
Value Percent:
Continuous Index:
Within 8" of Joint:
Remarks:

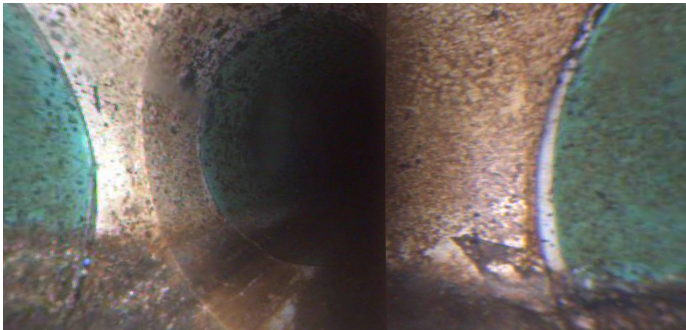
Code: **TF**
Description: **Tap Factory**

Distance (ft): **160.3**
Structural Grade: **0**
O&M Grade: **0**
Clock Start/From: **9**
Clock To:
1st Value: **4.000**
2nd Value:
Value Percent:
Continuous Index:
Within 8" of Joint:
Remarks:

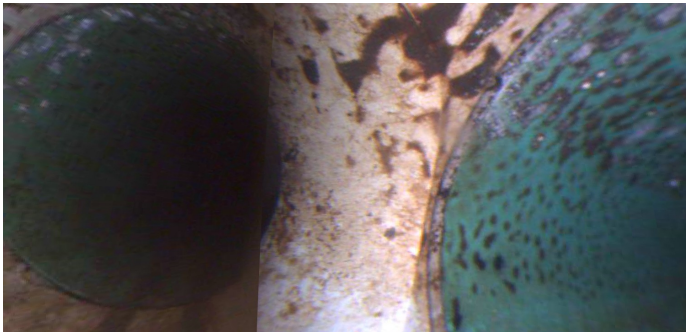
Code: **TF**
Description: **Tap Factory**

Distance (ft): **226.8**
Structural Grade: **0**
O&M Grade: **0**
Clock Start/From: **9**
Clock To:
1st Value: **4.000**
2nd Value:
Value Percent:
Continuous Index:
Within 8" of Joint:
Remarks:

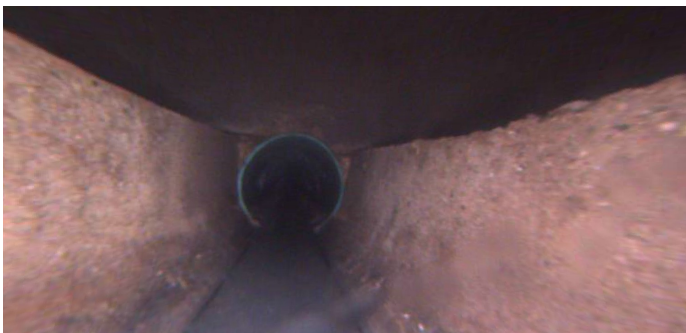
Code: **AMH**
Description: **Manhole**

Distance (ft): **346.5**
Structural Grade: **0**
O&M Grade: **0**
Clock Start/From:
Clock To:
1st Value:
2nd Value:
Value Percent:
Continuous Index:
Within 8" of Joint: **NO**
Remarks: **M-904-068**
