Profile/Photo Observation Report

Street:	N Pembroke Dr.	Flow Control:	Not Controlled
City:	Hobart, IN	Year Renewed:	
Location:	Other	Tape/Media #:	
Purpose:	Not Known	Dia/Height:	8"
Use:	Sanitary	Material:	PVC
Drain Area:	NA	Lining:	
Category:	NA		
Comment:

Location Details:		Direction of Survey:	Upstream
US MH:	M-904-068	DS MH:	M-904-069
		Total Length Surveyed (ft):	346.5

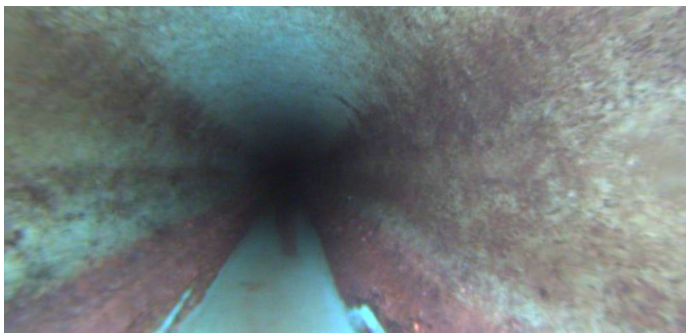
Code: **AMH**
Description: **Manhole**

Distance (ft): **.0**
Structural Grade: **0**
O&M Grade: **0**
Clock Start/From:
Clock To:
1st Value:
2nd Value:
Value Percent:
Continuous Index:
Within 8" of Joint: **NO**
Remarks: **M-904-069**

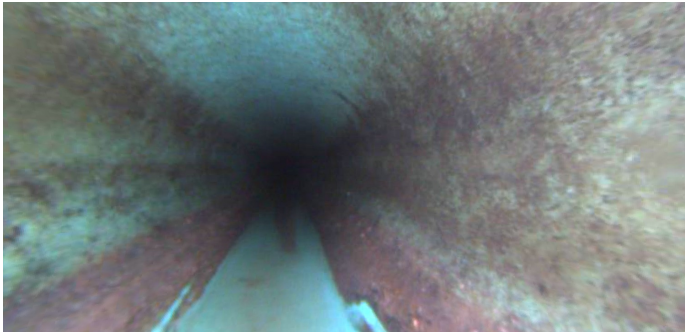
Code:	MWL
Description:	Water Level

Distance (ft):	.0
Structural Grade:	0
O&M Grade:	0
Clock Start/From:	
Clock To:	
1st Value:	
2nd Value:	
Value Percent:	5.000
Continuous Index:	
Within 8" of Joint:	NO
Remarks:

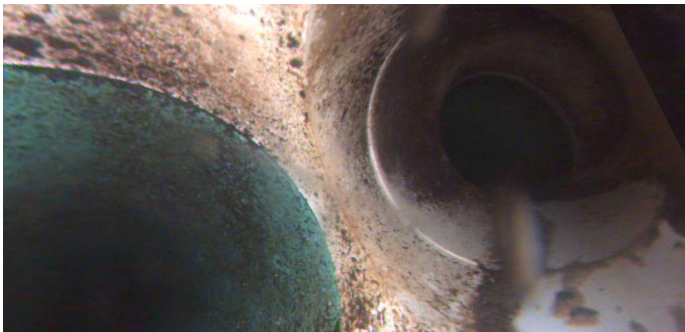
Code:	TF
Description:	Tap Factory

Distance (ft):	11.4
Structural Grade:	0
O&M Grade:	0
Clock Start/From:	10
Clock To:	
1st Value:	4.000
2nd Value:	
Value Percent:	
Continuous Index:	
Within 8" of Joint:	
Remarks:

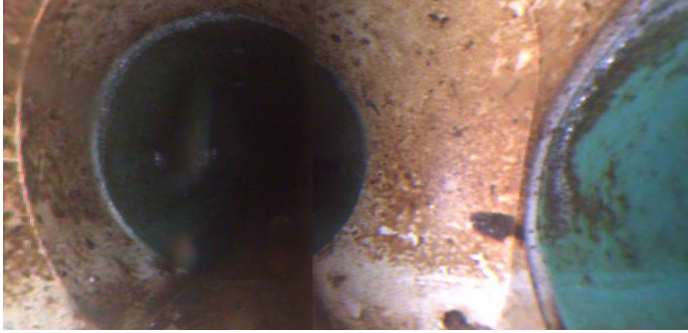
Code: **TF**
Description: **Tap Factory**

Distance (ft): **41.6**
Structural Grade: **0**
O&M Grade: **0**
Clock Start/From: **9**
Clock To:
1st Value: **4.000**
2nd Value:
Value Percent:
Continuous Index:
Within 8" of Joint:
Remarks:

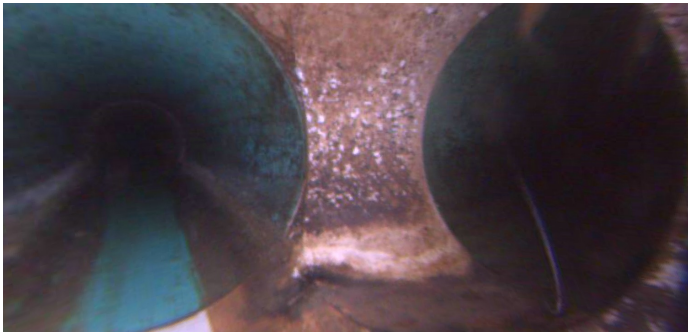
Code: **TFA**
Description: **Tap Factory Active**

Distance (ft): **96.7**
Structural Grade: **0**
O&M Grade: **0**
Clock Start/From: **3**
Clock To:
1st Value: **4.000**
2nd Value:
Value Percent:
Continuous Index:
Within 8" of Joint:
Remarks:

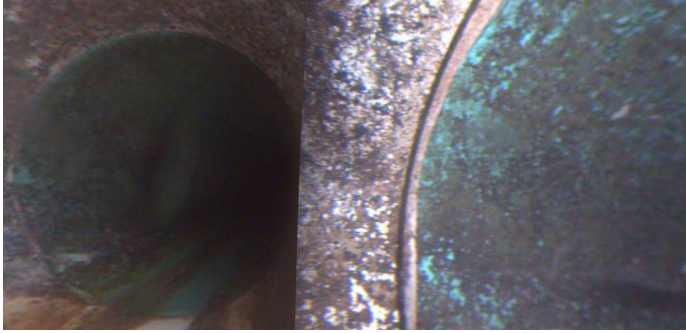
Code: **TFA**
Description: **Tap Factory Active**

Distance (ft): **100.1**
Structural Grade: **0**
O&M Grade: **0**
Clock Start/From: **9**
Clock To:
1st Value: **4.000**
2nd Value:
Value Percent:
Continuous Index:
Within 8" of Joint:
Remarks:

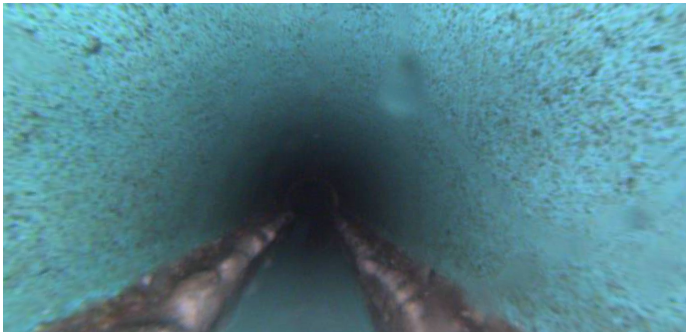
Code: **DAGS**
Description: **Deposits Attached Grease**

Distance (ft): **153.7**
Structural Grade: **0**
O&M Grade: **2**
Clock Start/From: **4**
Clock To: **8**
1st Value:
2nd Value:
Value Percent: **10.000**
Continuous Index: **S01**
Within 8" of Joint: **NO**
Remarks:

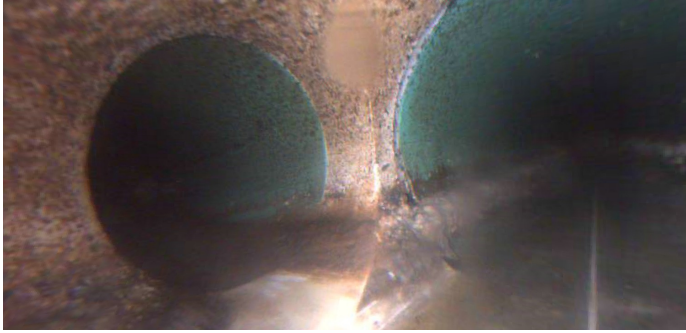
Code: **TFA**
Description: **Tap Factory Active**

Distance (ft): **158.0**
Structural Grade: **0**
O&M Grade: **0**
Clock Start/From: **3**
Clock To:
1st Value: **4.000**
2nd Value:
Value Percent:
Continuous Index:
Within 8" of Joint:
Remarks:

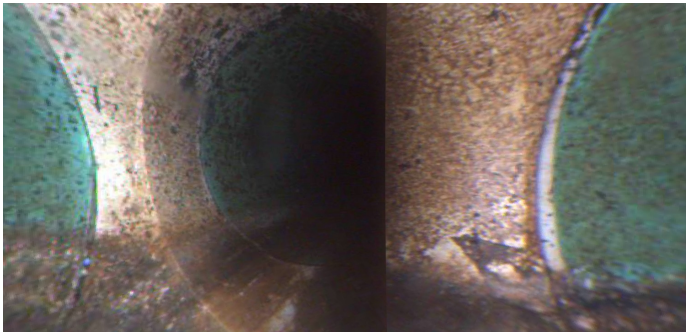
Code: **TF**
Description: **Tap Factory**

Distance (ft): **160.3**
Structural Grade: **0**
O&M Grade: **0**
Clock Start/From: **9**
Clock To:
1st Value: **4.000**
2nd Value:
Value Percent:
Continuous Index:
Within 8" of Joint:
Remarks:

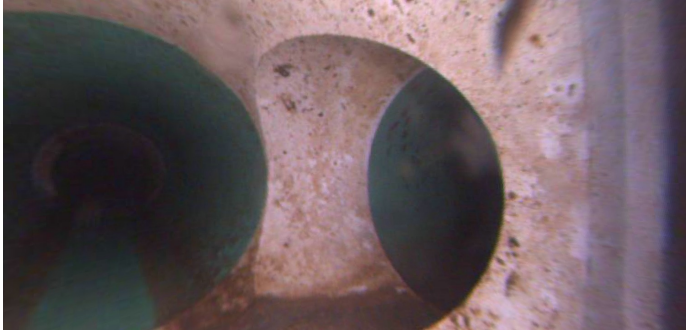
Code: **TFA**
Description: **Tap Factory Active**

Distance (ft): **223.9**
Structural Grade: **0**
O&M Grade: **0**
Clock Start/From: **3**
Clock To:
1st Value: **4.000**
2nd Value:
Value Percent:
Continuous Index:
Within 8" of Joint:
Remarks:

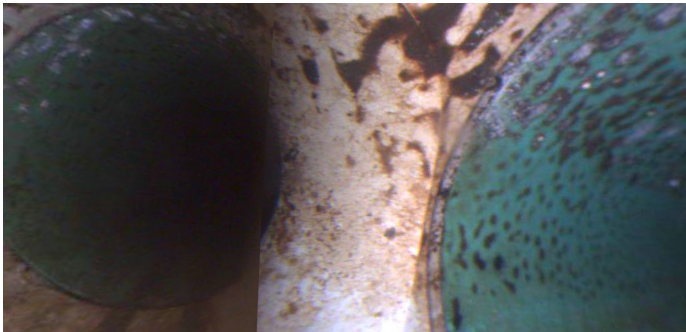
Code: **TF**
Description: **Tap Factory**

Distance (ft): **226.8**
Structural Grade: **0**
O&M Grade: **0**
Clock Start/From: **9**
Clock To:
1st Value: **4.000**
2nd Value:
Value Percent:
Continuous Index:
Within 8" of Joint:
Remarks:

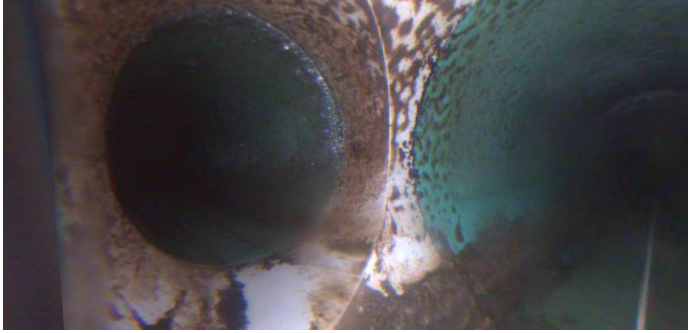
Code: **TF**
Description: **Tap Factory**

Distance (ft): **295.1**
Structural Grade: **0**
O&M Grade: **0**
Clock Start/From: **3**
Clock To:
1st Value: **4.000**
2nd Value:
Value Percent:
Continuous Index:
Within 8" of Joint:
Remarks:

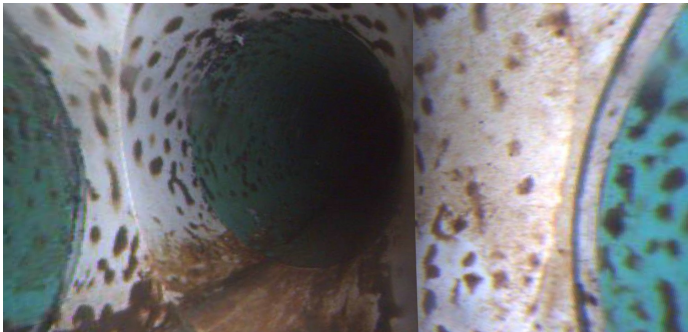
Code: **TF**
Description: **Tap Factory**

Distance (ft): **297.3**
Structural Grade: **0**
O&M Grade: **0**
Clock Start/From: **9**
Clock To:
1st Value: **4.000**
2nd Value:
Value Percent:
Continuous Index:
Within 8" of Joint:
Remarks:

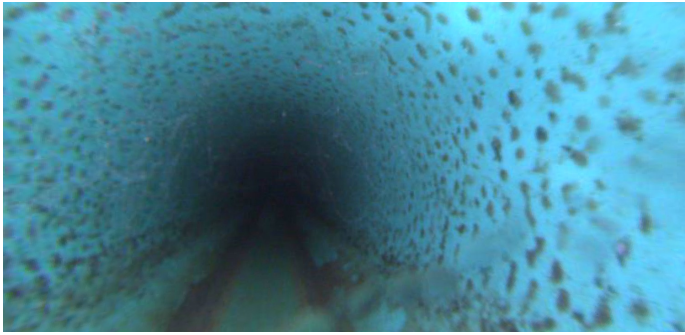
Code: **DAGS**
Description: **Deposits Attached Grease**

Distance (ft): **334.0**
Structural Grade: **0**
O&M Grade: **2**
Clock Start/From: **4**
Clock To: **8**
1st Value:
2nd Value:
Value Percent: **10.000**
Continuous Index: **F01**
Within 8" of Joint: **NO**
Remarks:

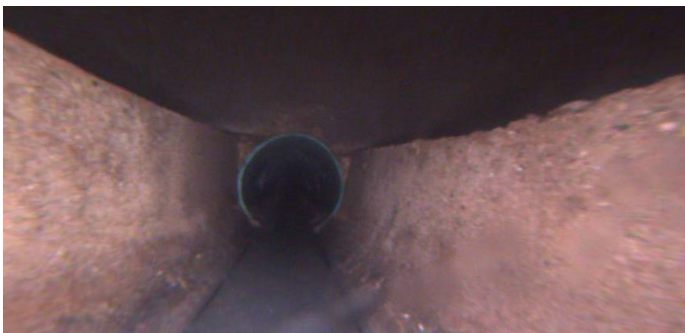
Code: **AMH**
Description: **Manhole**

Distance (ft): **346.5**
Structural Grade: **0**
O&M Grade: **0**
Clock Start/From:
Clock To:
1st Value:
2nd Value:
Value Percent:
Continuous Index:
Within 8" of Joint: **NO**
Remarks: **M-904-068**
