Profile/Photo Observation Report

Street:	S PEMBROKE DR E	Flow Control:	Not Controlled
City:	Hobart, IN	Year Renewed:	
Location:	Other	Tape/Media #:	
Purpose:	Not Known	Dia/Height:	8"
Use:	Sanitary	Material:	PVC
Drain Area:	NA	Lining:	
Category:	NA		
Comment:

Location Details:		Direction of Survey:	Downstream
US MH:	M-904-069	DS MH:	M-904-070
		Total Length Surveyed (ft):	342.5

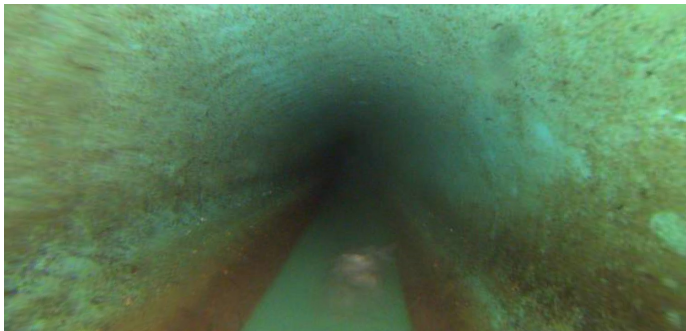
Code: **AMH**
Description: **Manhole**

Distance (ft): **.0**
Structural Grade: **0**
O&M Grade: **0**
Clock Start/From:
Clock To:
1st Value:
2nd Value:
Value Percent:
Continuous Index:
Within 8" of Joint: **NO**
Remarks: **M-904-069**

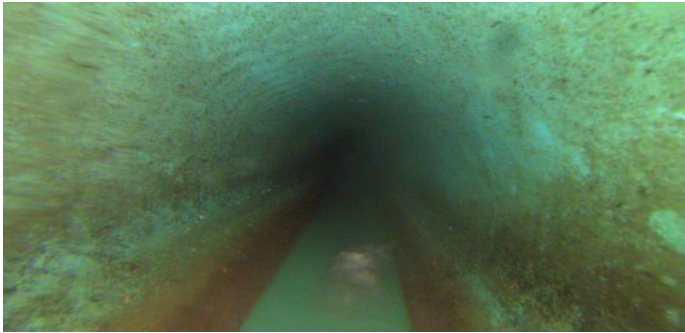
Code:	MWL
Description:	Water Level

Distance (ft):	.0
Structural Grade:	0
O&M Grade:	0
Clock Start/From:	
Clock To:	
1st Value:	
2nd Value:	
Value Percent:	5.000
Continuous Index:	
Within 8" of Joint:	NO
Remarks:

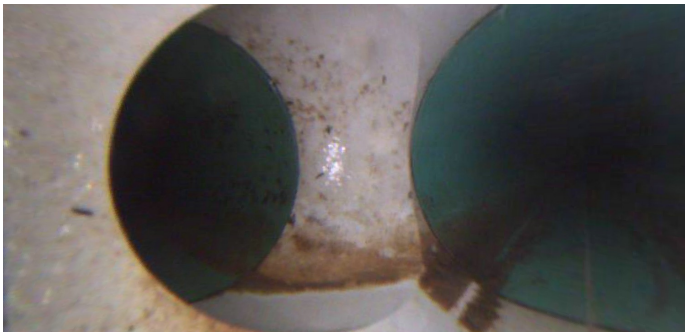
Code:	TFA
Description:	Tap Factory Active

Distance (ft):	66.1
Structural Grade:	0
O&M Grade:	0
Clock Start/From:	3
Clock To:	
1st Value:	4.000
2nd Value:	
Value Percent:	
Continuous Index:	
Within 8" of Joint:	
Remarks:

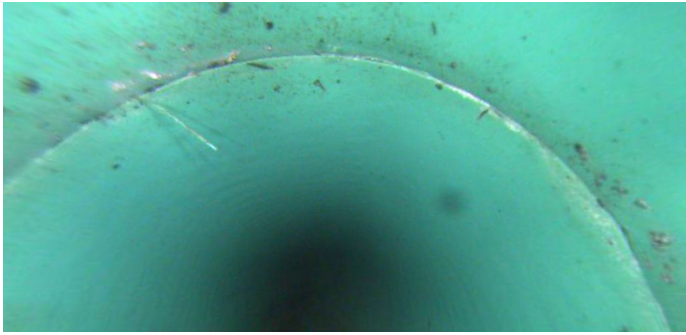
Code: **RFJ**
Description: **Roots Fine Joint**

Distance (ft): **77.2**
Structural Grade: **0**
O&M Grade: **1**
Clock Start/From: **1**
Clock To:
1st Value:
2nd Value:
Value Percent:
Continuous Index:
Within 8" of Joint: **YES**
Remarks:

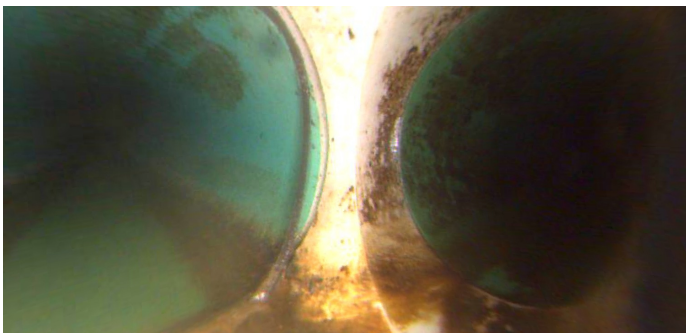
Code: **TFA**
Description: **Tap Factory Active**

Distance (ft): **105.0**
Structural Grade: **0**
O&M Grade: **0**
Clock Start/From: **3**
Clock To:
1st Value: **4.000**
2nd Value:
Value Percent:
Continuous Index:
Within 8" of Joint:
Remarks:

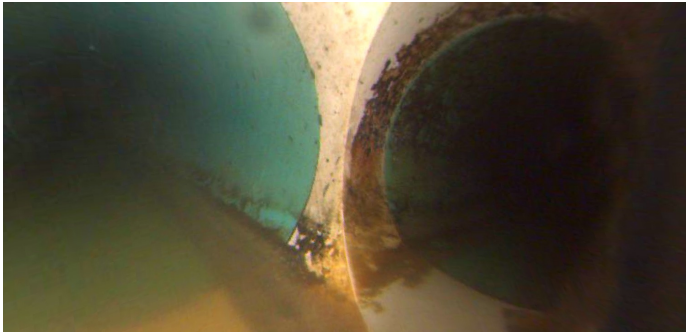
Code: **TFA**
Description: **Tap Factory Active**

Distance (ft): **166.6**
Structural Grade: **0**
O&M Grade: **0**
Clock Start/From: **3**
Clock To:
1st Value: **4.000**
2nd Value:
Value Percent:
Continuous Index:
Within 8" of Joint:
Remarks:

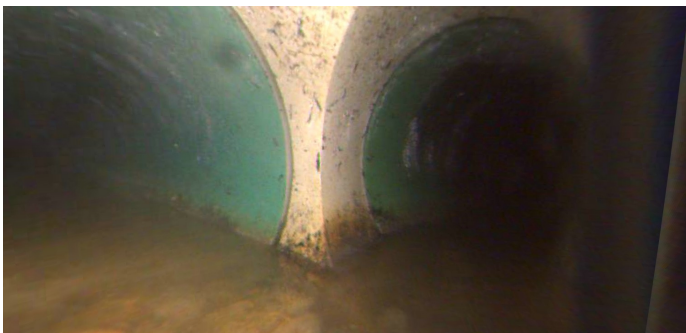
Code: **TFA**
Description: **Tap Factory Active**

Distance (ft): **226.3**
Structural Grade: **0**
O&M Grade: **0**
Clock Start/From: **3**
Clock To:
1st Value: **4.000**
2nd Value:
Value Percent:
Continuous Index:
Within 8" of Joint:
Remarks:

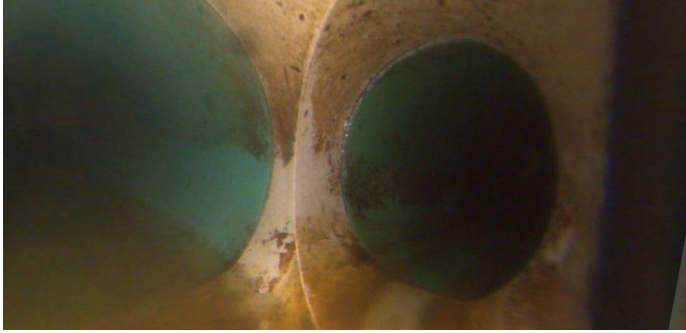
Code: **TFA**
Description: **Tap Factory Active**

Distance (ft): **290.6**
Structural Grade: **0**
O&M Grade: **0**
Clock Start/From: **3**
Clock To:
1st Value: **4.000**
2nd Value:
Value Percent:
Continuous Index:
Within 8" of Joint:
Remarks:

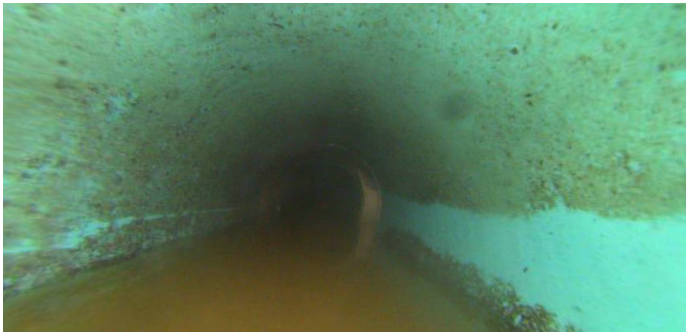
Code: **MWL**
Description: **Water Level**

Distance (ft): **333.1**
Structural Grade: **0**
O&M Grade: **0**
Clock Start/From:
Clock To:
1st Value:
2nd Value:
Value Percent: **30.000**
Continuous Index:
Within 8" of Joint: **NO**
Remarks:

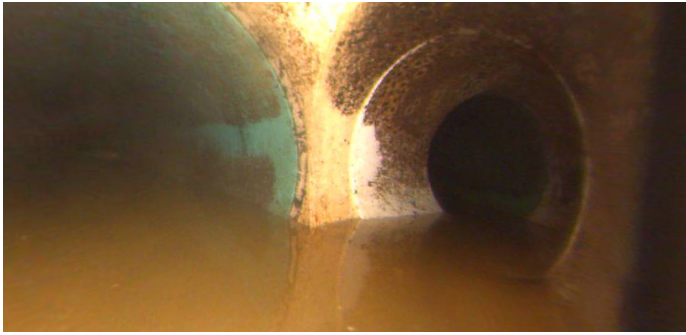
Code: **TFA**
Description: **Tap Factory Active**

Distance (ft): **334.9**
Structural Grade: **0**
O&M Grade: **0**
Clock Start/From: **3**
Clock To:
1st Value: **4.000**
2nd Value:
Value Percent:
Continuous Index:
Within 8" of Joint:
Remarks:

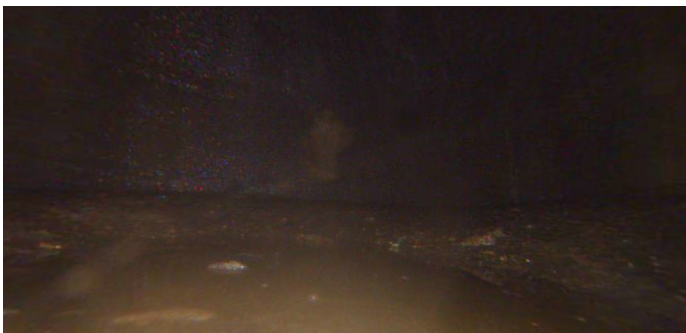
Code: **AMH**
Description: **Manhole**

Distance (ft): **342.5**
Structural Grade: **0**
O&M Grade: **0**
Clock Start/From:
Clock To:
1st Value:
2nd Value:
Value Percent:
Continuous Index:
Within 8" of Joint: **NO**
Remarks: **M-904-070**
