Profile/Photo Observation Report

Street:	N Pembroke Dr.	Flow Control:	Not Controlled
City:	Hobart, IN	Year Renewed:	
Location:	Other	Tape/Media #:	
Purpose:	Not Known	Dia/Height:	8"
Use:	Sanitary	Material:	PVC
Drain Area:	NA	Lining:	
Category:	NA		
Comment:

Location Details:		Direction of Survey:	Downstream
US MH:	M-904-069	DS MH:	M-904-070
		Total Length Surveyed (ft):	342.5

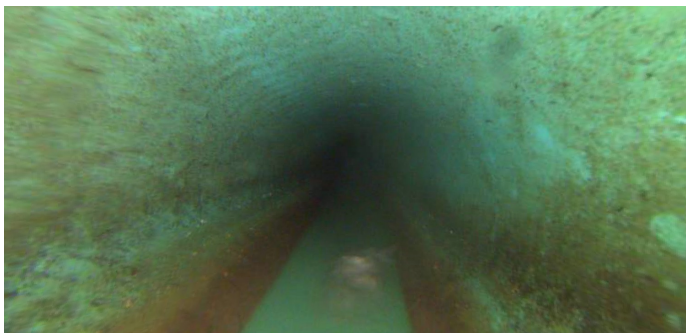
Code: **AMH**
Description: **Manhole**

Distance (ft): **.0**
Structural Grade: **0**
O&M Grade: **0**
Clock Start/From:
Clock To:
1st Value:
2nd Value:
Value Percent:
Continuous Index:
Within 8" of Joint: **NO**
Remarks: **M-904-069**

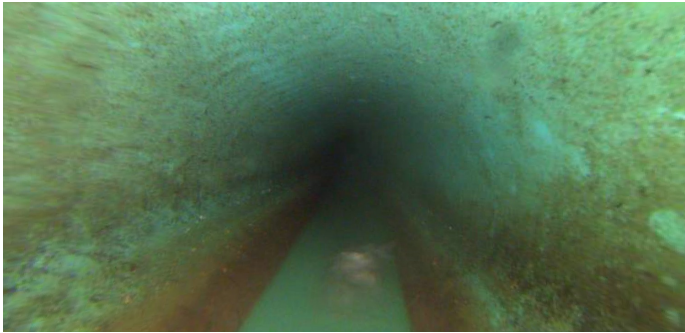
Code:	MWL
Description:	Water Level

Distance (ft):	.0
Structural Grade:	0
O&M Grade:	0
Clock Start/From:	
Clock To:	
1st Value:	
2nd Value:	
Value Percent:	5.000
Continuous Index:	
Within 8" of Joint:	NO
Remarks:

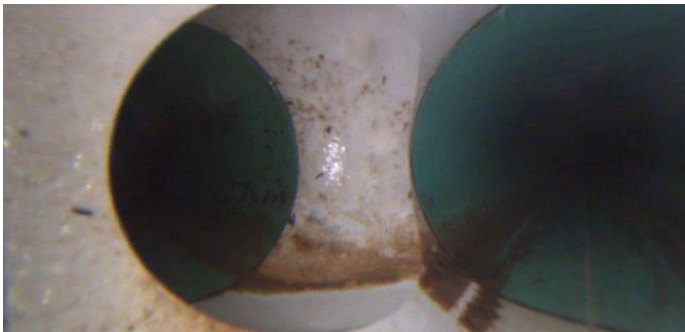
Code:	TFA
Description:	Tap Factory Active

Distance (ft):	66.1
Structural Grade:	0
O&M Grade:	0
Clock Start/From:	3
Clock To:	
1st Value:	4.000
2nd Value:	
Value Percent:	
Continuous Index:	
Within 8" of Joint:	
Remarks:

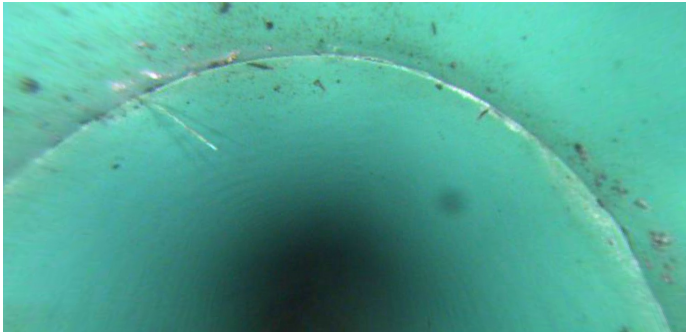
Code: **RFJ**
Description: **Roots Fine Joint**

Distance (ft): **77.2**
Structural Grade: **0**
O&M Grade: **1**
Clock Start/From: **1**
Clock To:
1st Value:
2nd Value:
Value Percent:
Continuous Index:
Within 8" of Joint: **YES**
Remarks:

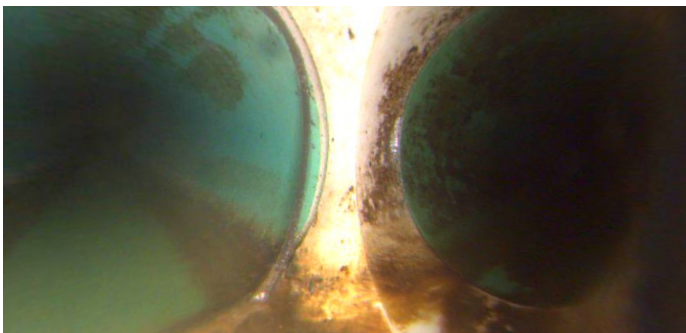
Code: **TFA**
Description: **Tap Factory Active**

Distance (ft): **105.0**
Structural Grade: **0**
O&M Grade: **0**
Clock Start/From: **3**
Clock To:
1st Value: **4.000**
2nd Value:
Value Percent:
Continuous Index:
Within 8" of Joint:
Remarks:

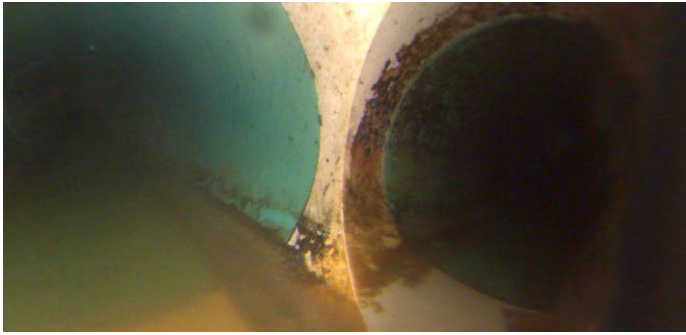
Code: **TFA**
Description: **Tap Factory Active**

Distance (ft): **166.6**
Structural Grade: **0**
O&M Grade: **0**
Clock Start/From: **3**
Clock To:
1st Value: **4.000**
2nd Value:
Value Percent:
Continuous Index:
Within 8" of Joint:
Remarks:

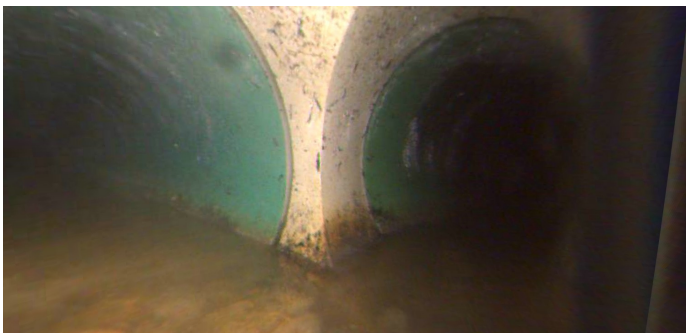
Code: **TFA**
Description: **Tap Factory Active**

Distance (ft): **226.3**
Structural Grade: **0**
O&M Grade: **0**
Clock Start/From: **3**
Clock To:
1st Value: **4.000**
2nd Value:
Value Percent:
Continuous Index:
Within 8" of Joint:
Remarks:

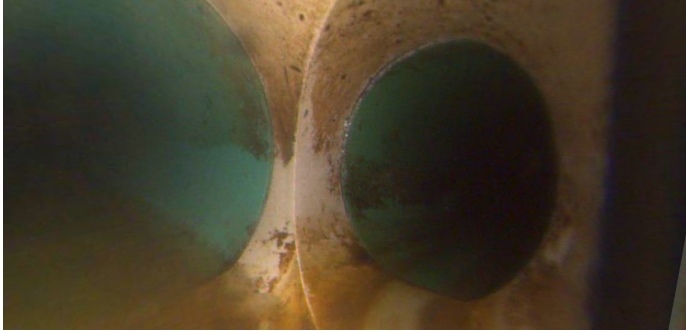
Code: **TFA**
Description: **Tap Factory Active**

Distance (ft): **290.6**
Structural Grade: **0**
O&M Grade: **0**
Clock Start/From: **3**
Clock To:
1st Value: **4.000**
2nd Value:
Value Percent:
Continuous Index:
Within 8" of Joint:
Remarks:

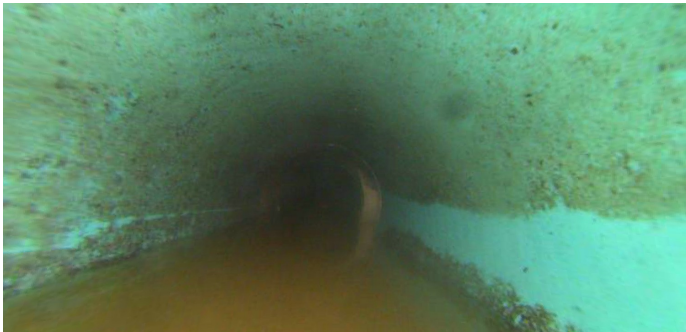
Code: **MWL**
Description: **Water Level**

Distance (ft): **333.1**
Structural Grade: **0**
O&M Grade: **0**
Clock Start/From:
Clock To:
1st Value:
2nd Value:
Value Percent: **30.000**
Continuous Index:
Within 8" of Joint: **NO**
Remarks:

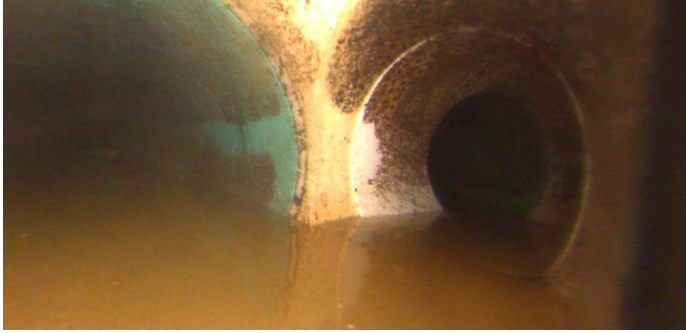
Code: **TFA**
Description: **Tap Factory Active**

Distance (ft): **334.9**
Structural Grade: **0**
O&M Grade: **0**
Clock Start/From: **3**
Clock To:
1st Value: **4.000**
2nd Value:
Value Percent:
Continuous Index:
Within 8" of Joint:
Remarks:

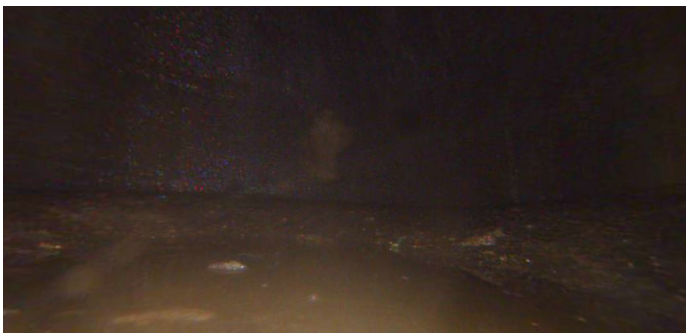
Code: **AMH**
Description: **Manhole**

Distance (ft): **342.5**
Structural Grade: **0**
O&M Grade: **0**
Clock Start/From:
Clock To:
1st Value:
2nd Value:
Value Percent:
Continuous Index:
Within 8" of Joint: **NO**
Remarks: **M-904-070**
