## Profile/Photo Observation Report

Street:	<b>172 W Pembroke Dr</b>	Flow Control:	<b>Not Controlled</b>
City:	<b>Hobart In</b>	Year Renewed:	
Location:	<b>Easement/Right of Way</b>	Tape/Media #:	<b>Deliverable 1</b>
Purpose:	<b>Routine Assessment</b>	Dia/Height:	<b>18"</b>
Use:	<b>Sanitary</b>	Material:	<b>PVC</b>
Drain Area:	<b>Northeast</b>	Lining:	
Category:	<b>NA</b>		
Comment:	<b>448-2</b>		
Location Details:	<b>Edge of field</b>	Direction of Survey:	<b>Upstream</b>
US MH:	<b>M-904-071</b>	DS MH:	<b>M-904-008</b>
		Total Length Surveyed (ft):	<b>143.4</b>

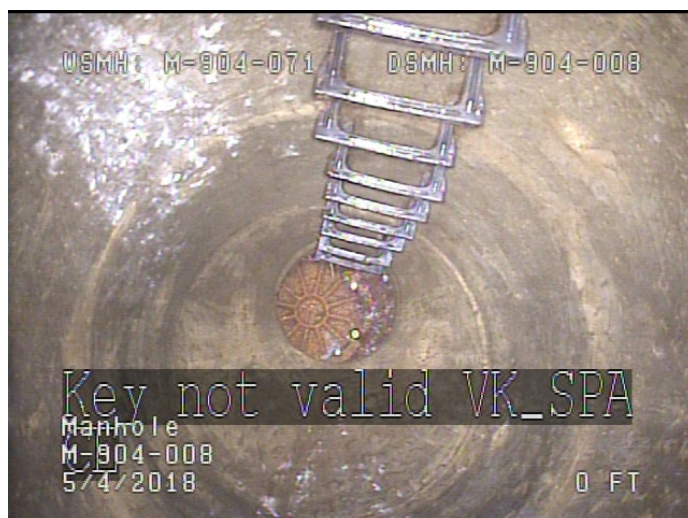
Code: **AMH**  
Description: **Manhole**

Distance (ft): **.0**  
Structural Grade: **0**  
O&M Grade: **0**  
Clock Start/From:  
Clock To:  
1st Value:  
2nd Value:  
Value Percent:  
Continuous Index:  
Within 8" of Joint: **NO**  
Remarks: **M-904-008**

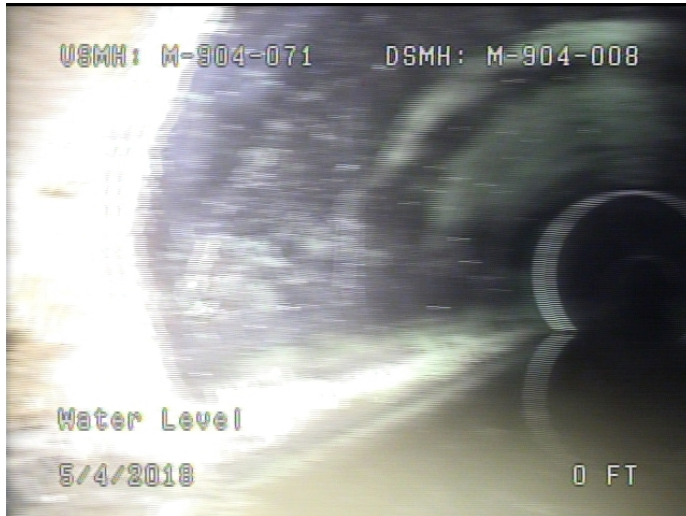
Code:	<b>MWL</b>
Description:	<b>Water Level</b>
Distance (ft):	<b>.0</b>
Structural Grade:	<b>0</b>
O&M Grade:	<b>0</b>
Clock Start/From:	
Clock To:	
1st Value:	
2nd Value:	
Value Percent:	<b>10.000</b>
Continuous Index:	
Within 8" of Joint:	<b>NO</b>
Remarks:

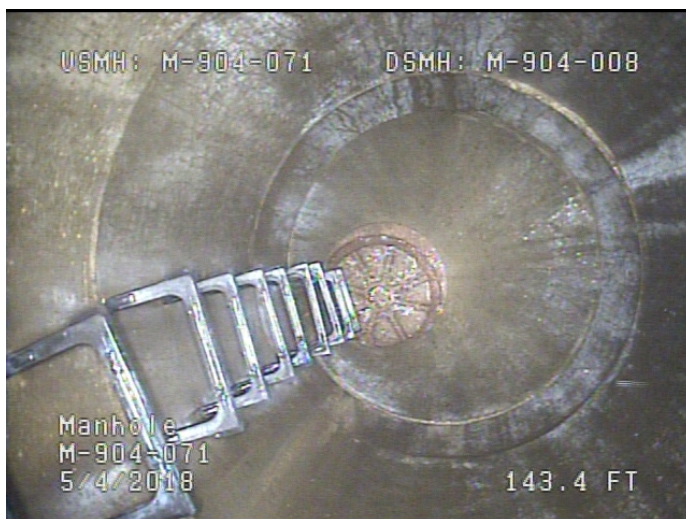
Code:	<b>AMH</b>
Description:	<b>Manhole</b>
Distance (ft):	<b>143.4</b>
Structural Grade:	<b>0</b>
O&M Grade:	<b>0</b>
Clock Start/From:	
Clock To:	
1st Value:	
2nd Value:	
Value Percent:	
Continuous Index:	
Within 8" of Joint:	<b>NO</b>
Remarks:	<b>M-904-071</b>
