Profile/Photo Observation Report

Date:	12/21/2024	Weather:		Coding:	PACP 7.0
Pipe Length (ft):	164.0	Owner:	City of Hobart	Pre Clean:	Heavy Cleaning
P.O.#:	YES502259	Surveyor:	S. Bucklin	PSR:	P-904-067-071
Customer:	City of Hobart	Clean Date:	11/25/2024	Shape:	C

Street:	Pembroke Drive North	Flow Control:	Not Controlled
City:	Hobart, IN	Year Renewed:	
Location:	Easement/Right of Way	Tape/Media #:	
Purpose:	Sewer System Evaluation Survey (SS	Dia/Height:	8"
Use:	Sanitary Sewage Pipe	Material:	PVC
Drain Area:		Lining:	None
Category:	NA		
Comment:			
Location Details:		Direction of Survey:	Downstream
US MH:	M-904-067	DS MH:	M-904-071
		Total Length Surveyed (ft):	165.4

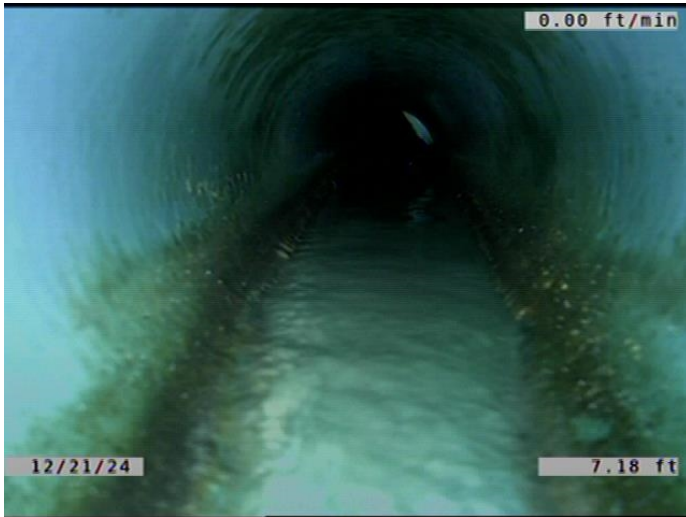
Code: **MWLS**
 Description: **Miscellaneous Water Level Sag**

Distance (ft): **7.2**
 Structural Grade: **2**
 O&M Grade: **0**
 Clock Start/From:
 Clock To:
 1st Value:
 2nd Value:
 Value Percent: **15.000**
 Continuous Index: **S01**
 Within 8" of Joint: **NO**
 Remarks:

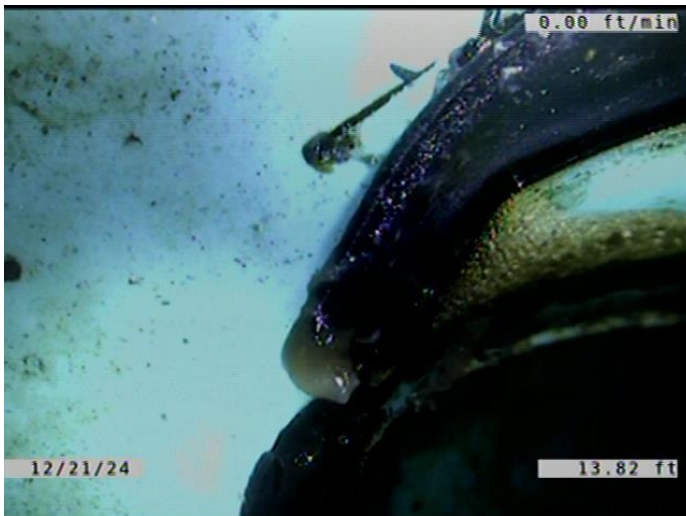
Code: **IWB**
 Description: **Infiltration Weeper Barrel**

Distance (ft): **13.8**
 Structural Grade: **0**
 O&M Grade: **2**
 Clock Start/From: **12**
 Clock To: **1**
 1st Value:
 2nd Value:
 Value Percent:
 Continuous Index:
 Within 8" of Joint: **NO**
 Remarks:

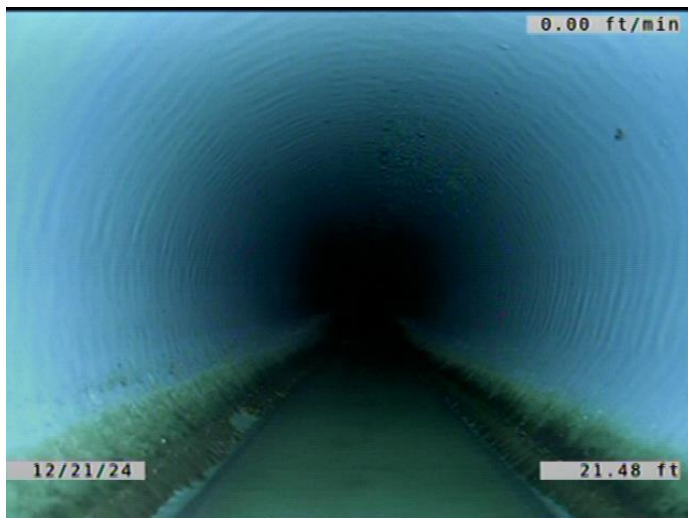
Code: **MWLS**
Description: **Miscellaneous Water Level Sag**

Distance (ft): **21.5**
Structural Grade: **2**
O&M Grade: **0**
Clock Start/From:
Clock To:
1st Value:
2nd Value:
Value Percent: **15.000**
Continuous Index: **F01**
Within 8" of Joint: **NO**
Remarks:

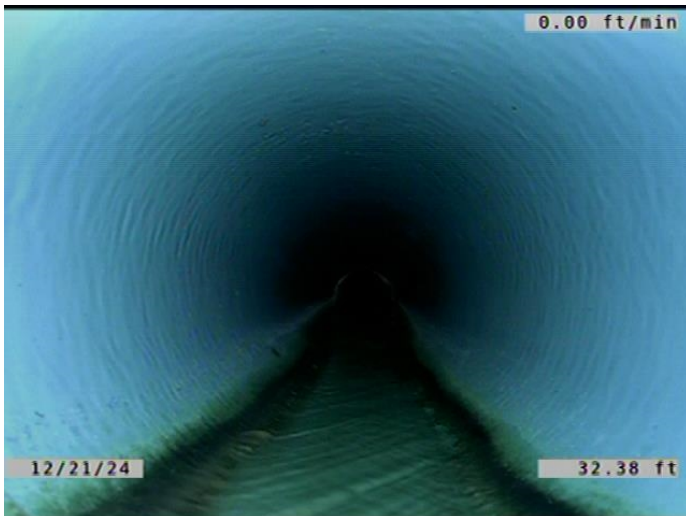
Code: **MWLS**
Description: **Miscellaneous Water Level Sag**

Distance (ft): **32.4**
Structural Grade: **2**
O&M Grade: **0**
Clock Start/From:
Clock To:
1st Value:
2nd Value:
Value Percent: **10.000**
Continuous Index: **F02**
Within 8" of Joint: **NO**
Remarks:

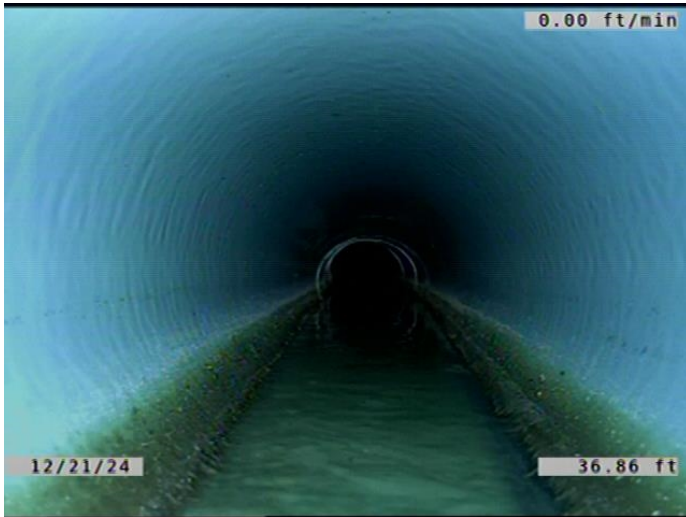
Code: **MWLS**
Description: **Miscellaneous Water Level Sag**

Distance (ft): **36.8**
Structural Grade: **2**
O&M Grade: **0**
Clock Start/From:
Clock To:
1st Value:
2nd Value:
Value Percent: **15.000**
Continuous Index: **S03**
Within 8" of Joint: **NO**
Remarks:

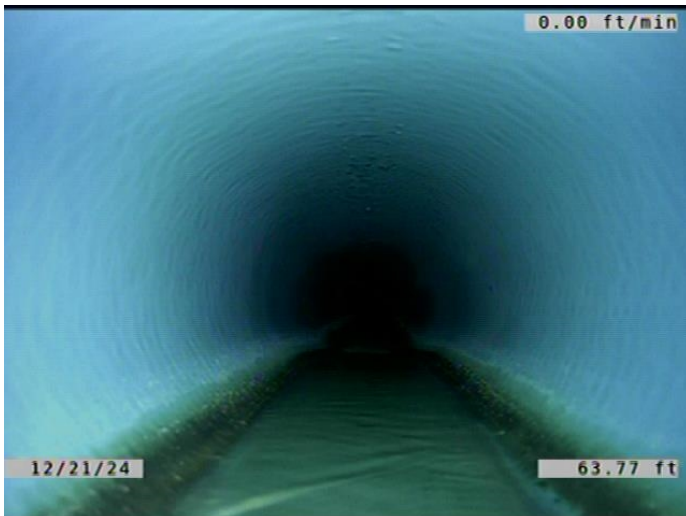
Code: **MWLS**
Description: **Miscellaneous Water Level Sag**

Distance (ft): **63.8**
Structural Grade: **2**
O&M Grade: **0**
Clock Start/From:
Clock To:
1st Value:
2nd Value:
Value Percent: **15.000**
Continuous Index: **F03**
Within 8" of Joint: **NO**
Remarks:

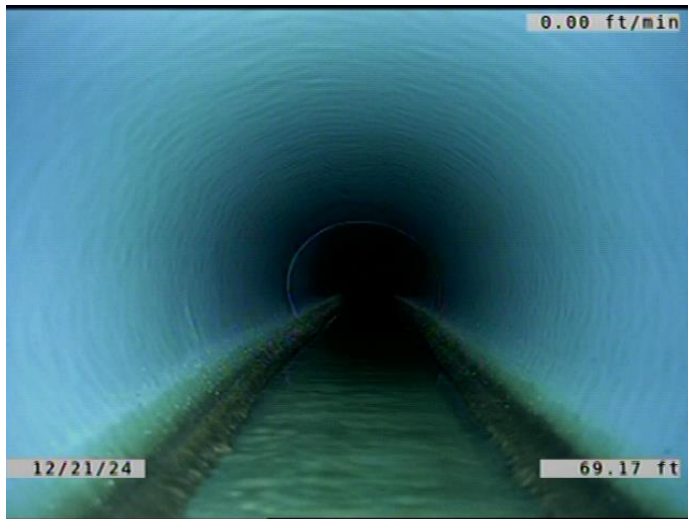
Code: **MWLS**
Description: **Miscellaneous Water Level Sag**

Distance (ft): **69.2**
Structural Grade: **2**
O&M Grade: **0**
Clock Start/From:
Clock To:
1st Value:
2nd Value:
Value Percent: **10.000**
Continuous Index: **S04**
Within 8" of Joint: **NO**
Remarks:

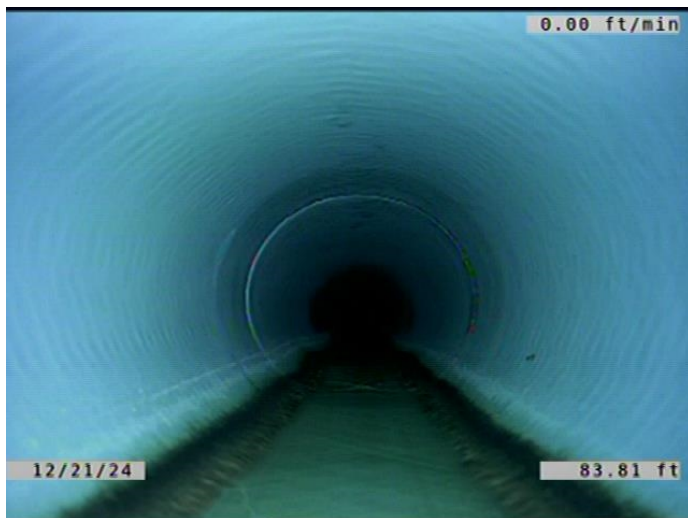
Code: **MWLS**
Description: **Miscellaneous Water Level Sag**

Distance (ft): **83.8**
Structural Grade: **2**
O&M Grade: **0**
Clock Start/From:
Clock To:
1st Value:
2nd Value:
Value Percent: **10.000**
Continuous Index: **F04**
Within 8" of Joint: **NO**
Remarks:

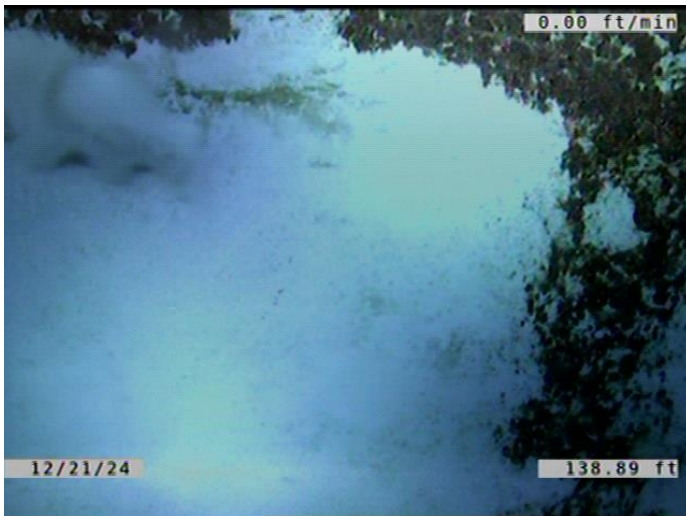
Code:	JSL
Description:	Joint Separated Large
Distance (ft):	138.9
Structural Grade:	4
O&M Grade:	0
Clock Start/From:	
Clock To:	
1st Value:	
2nd Value:	
Value Percent:	
Continuous Index:	
Within 8" of Joint:	YES
Remarks:	JOINT/ PIPES NOT PUSHED TOGETHER WHEN INSTALLED.

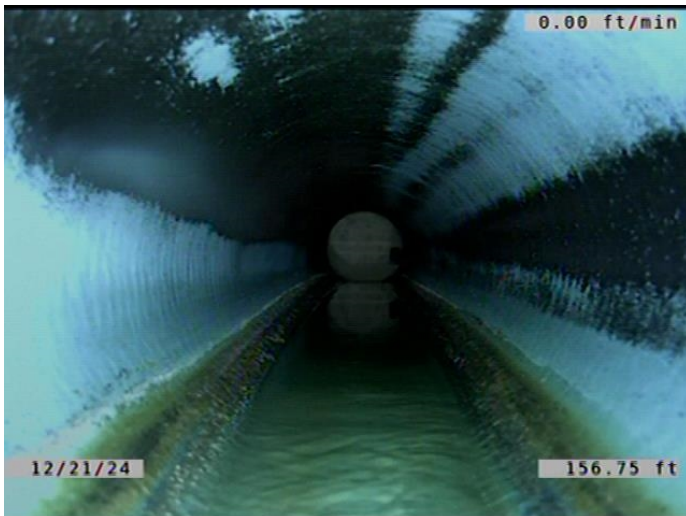
Code: **MWLS**
Description: **Miscellaneous Water Level Sag**

Distance (ft): **156.8**
Structural Grade: **2**
O&M Grade: **0**
Clock Start/From:
Clock To:
1st Value:
2nd Value:
Value Percent: **10.000**
Continuous Index: **S06**
Within 8" of Joint: **NO**
Remarks:
