## Profile/Photo Observation Report

Date:	<b>04/30/2018</b>	Weather:		Coding:	<b>PACP 6.0</b>
Pipe Length (ft):		Owner:	<b>City of Hobart</b>	Pre Clean:	<b>Not Known</b>
P.O.#:	<b>268</b>	Surveyor:	<b>B. Helbling</b>	PSR:	<b>P-1006-014-001</b>
Customer:	<b>City of Hobart</b>	Clean Date:		Shape:	<b>C</b>

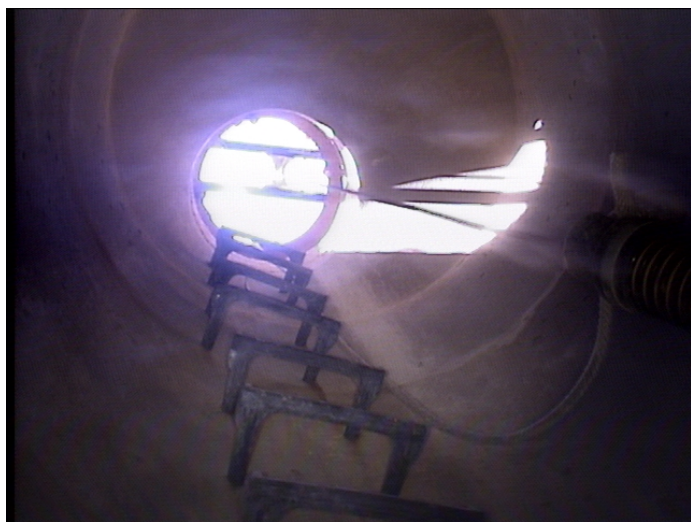
Code: **AMH**  
Description: **Manhole**

Distance (ft): **.0**  
Structural Grade: **0**  
O&M Grade: **0**  
Clock Start/From:  
Clock To:  
1st Value:  
2nd Value:  
Value Percent:  
Continuous Index:  
Within 8" of Joint: **NO**  
Remarks: **M-905-001**

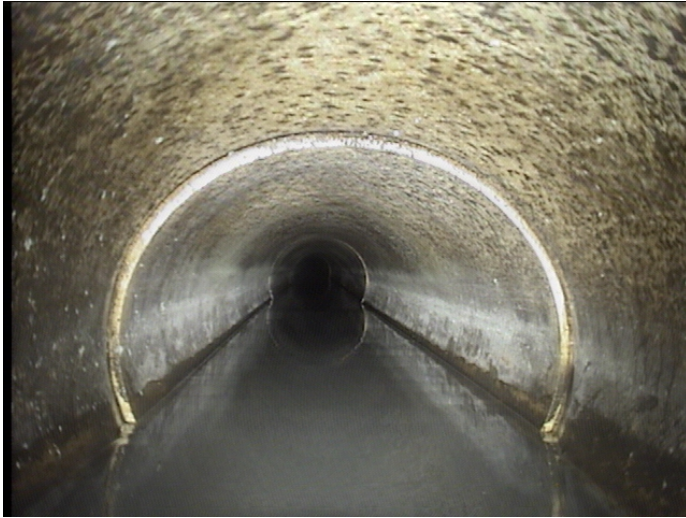
Code: **MWL**  
Description: **Water Level**

Distance (ft): **.0**  
Structural Grade: **0**  
O&M Grade: **0**  
Clock Start/From:  
Clock To:  
1st Value:  
2nd Value:  
Value Percent: **15.000**  
Continuous Index:  
Within 8" of Joint: **NO**  
Remarks:

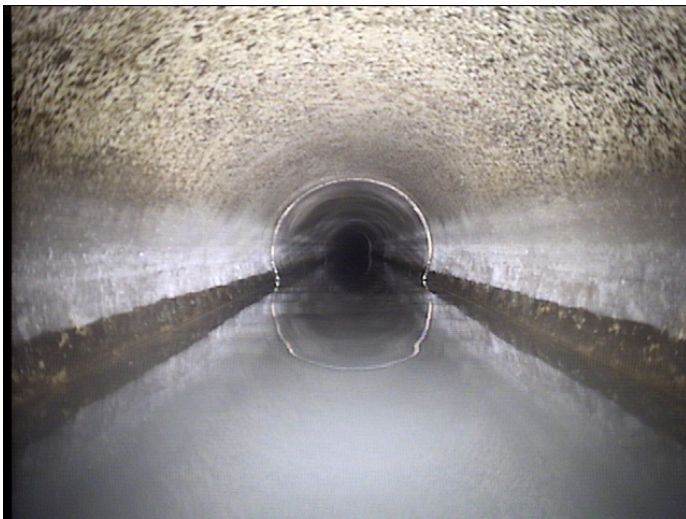
Code: **DSF**  
Description: **Deposits Settled Fine**

Distance (ft): **4.7**  
Structural Grade: **0**  
O&M Grade: **2**  
Clock Start/From: **4**  
Clock To: **8**  
1st Value:  
2nd Value:  
Value Percent: **10.000**  
Continuous Index:  
Within 8" of Joint: **NO**  
Remarks:

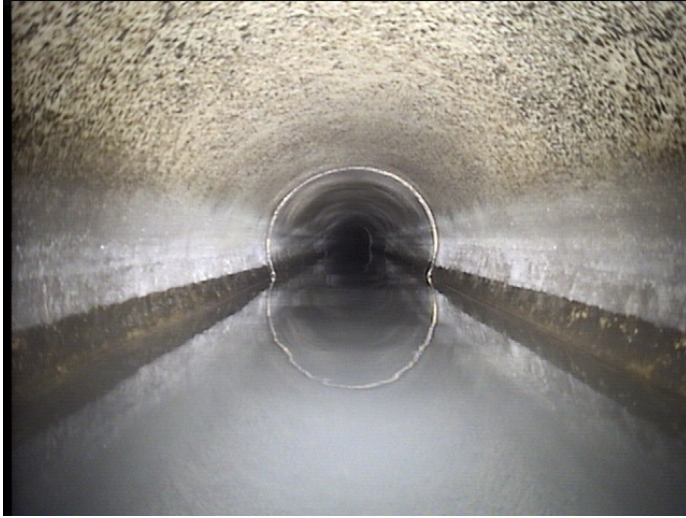
Code:	<b>MSA</b>
Description:	<b>Abandoned Survey</b>
Distance (ft):	<b>5.1</b>
Structural Grade:	<b>0</b>
O&M Grade:	<b>0</b>
Clock Start/From:	
Clock To:	
1st Value:	
2nd Value:	
Value Percent:	
Continuous Index:	
Within 8" of Joint:	<b>NO</b>
Remarks:	<b>Heavy sediment</b>
