Profile/Photo Observation Report

Date:	02/03/2023	Weather:		Coding:	PACP 7.0
Pipe Length (ft):	109.0	Owner:	City of Hobart	Pre Clean:	No Pre-Cleaning
P.O.#:	YES502259	Surveyor:	S. Bucklin	PSR:	P-1006-014-001
Customer:	City of Hobart	Clean Date:		Shape:	C

Location Details:		Direction of Survey:	Upstream
US MH:	M-905-001	DS MH:	M-1006-014
		Total Length Surveyed (ft):	109.0

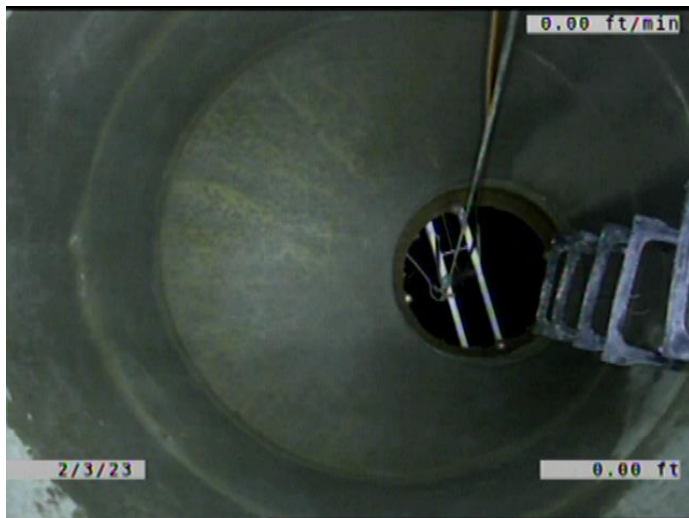
Code: **AMH**
Description: **Manhole**

Distance (ft): **.0**
Structural Grade: **0**
O&M Grade: **0**
Clock Start/From:
Clock To:
1st Value:
2nd Value:
Value Percent:
Continuous Index:
Within 8" of Joint: **NO**
Remarks: **M-1006-014**

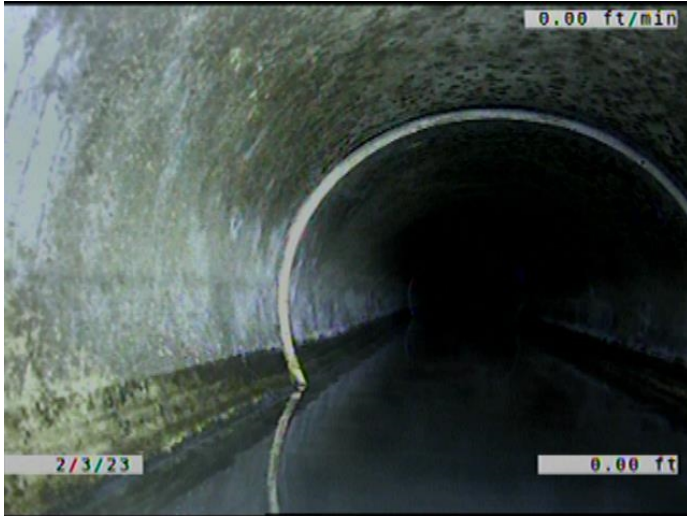
Code:	MWL
Description:	Miscellaneous Water Level
Distance (ft):	.0
Structural Grade:	0
O&M Grade:	0
Clock Start/From:	
Clock To:	
1st Value:	
2nd Value:	
Value Percent:	20.000
Continuous Index:	
Within 8" of Joint:	NO
Remarks:

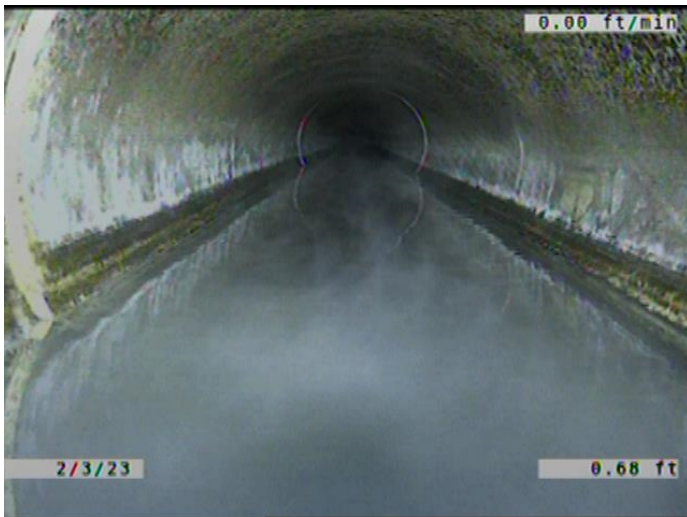
Code:	LD
Description:	Line Down
Distance (ft):	.7
Structural Grade:	0
O&M Grade:	1
Clock Start/From:	
Clock To:	
1st Value:	
2nd Value:	
Value Percent:	10.000
Continuous Index:	
Within 8" of Joint:	NO
Remarks:

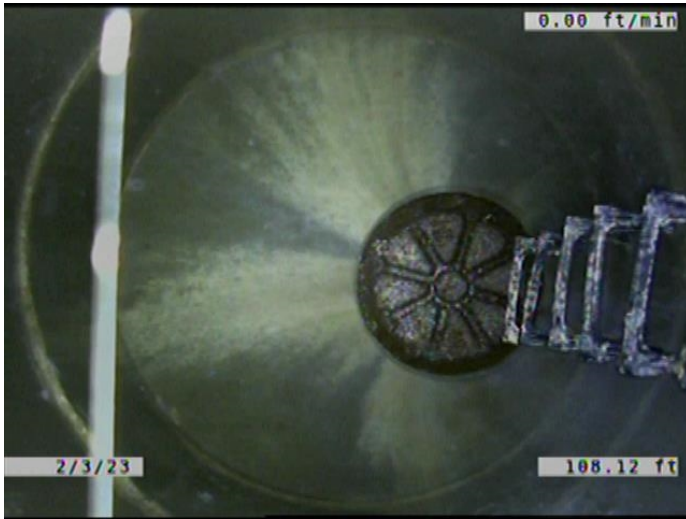
Code:	AMH
Description:	Manhole
Distance (ft):	108.1
Structural Grade:	0
O&M Grade:	0
Clock Start/From:	
Clock To:	
1st Value:	
2nd Value:	
Value Percent:	
Continuous Index:	
Within 8" of Joint:	NO
Remarks:	M-905-001
