Profile/Photo Observation Report

Date:	02/03/2023	Weather:		Coding:	PACP 7.0
Pipe Length (ft):	268.0	Owner:	City of Hobart	Pre Clean:	No Pre-Cleaning
P.O.#:	YES502259	Surveyor:	S. Bucklin	PSR:	P-905-001-003
Customer:	City of Hobart	Clean Date:		Shape:	C

Street:	State Road 130	Flow Control:	Not Controlled
City:	Hobart, IN	Year Renewed:	
Location:	Easement/Right of Way	Tape/Media #:	
Purpose:	Routine Assessment	Dia/Height:	18"
Use:	Sanitary Sewage Pipe	Material:	PVC
Drain Area:		Lining:	None
Category:	NA		
Comment:

Location Details:		Direction of Survey:	Downstream
US MH:	M-905-003	DS MH:	M-905-001
		Total Length Surveyed (ft):	268.8

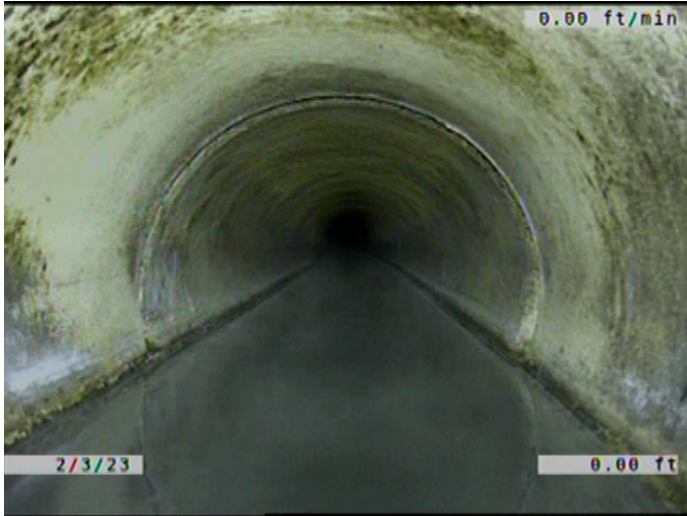
Code: **MWL**
Description: **Miscellaneous Water Level**

Distance (ft): **.0**
Structural Grade: **0**
O&M Grade: **0**
Clock Start/From:
Clock To:
1st Value:
2nd Value:
Value Percent: **15.000**
Continuous Index:
Within 8" of Joint: **NO**
Remarks:

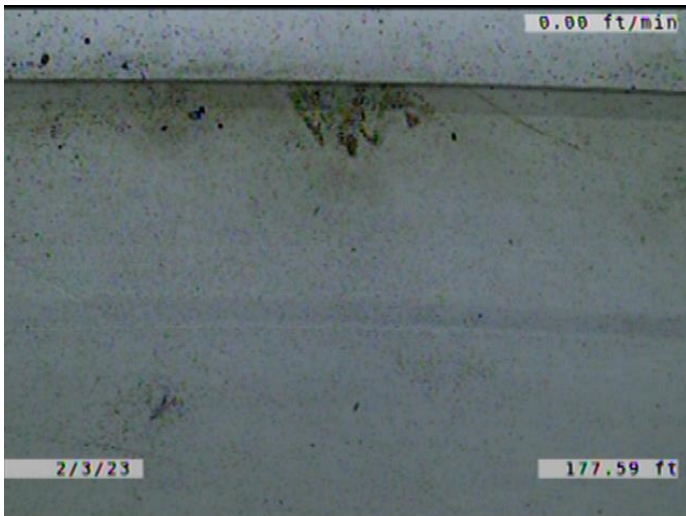
Code: **MGO**
Description: **Miscellaneous General Observation**

Distance (ft): **177.6**
Structural Grade: **0**
O&M Grade: **0**
Clock Start/From:
Clock To:
1st Value:
2nd Value:
Value Percent:
Continuous Index:
Within 8" of Joint: **NO**
Remarks: **JOINT/ PIPES NOT PUSHED ALL THE WAY TOGETHER WHEN INSTALLED**

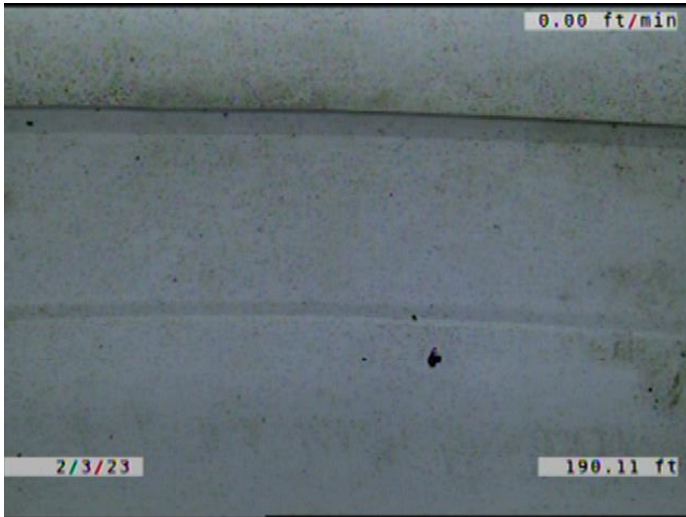
Code: **MGO**
 Description: **Miscellaneous General Observation**

Distance (ft): **190.1**
 Structural Grade: **0**
 O&M Grade: **0**
 Clock Start/From:
 Clock To:
 1st Value:
 2nd Value:
 Value Percent:
 Continuous Index:
 Within 8" of Joint: **NO**
 Remarks: **JOINT/ PIPES NOT PUSHED ALL THE WAY TOGETHER WHEN INSTALLED**

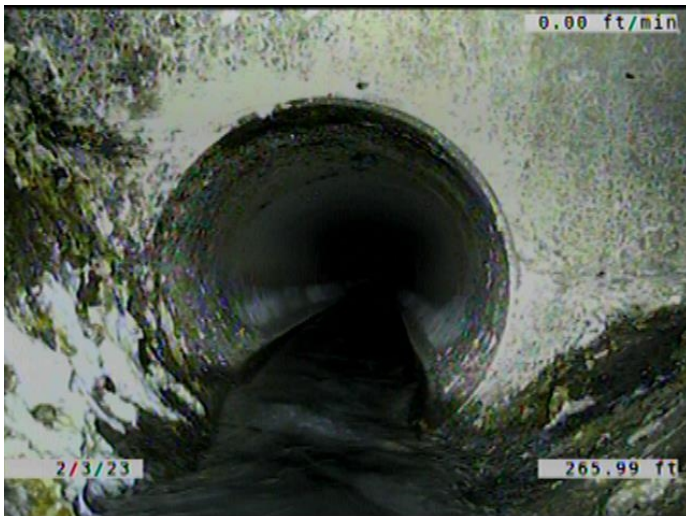
Code: **DSF**
 Description: **Deposits Settled Fine**

Distance (ft): **266.0**
 Structural Grade: **0**
 O&M Grade: **2**
 Clock Start/From: **5**
 Clock To: **7**
 1st Value:
 2nd Value:
 Value Percent: **10.000**
 Continuous Index: **F01**
 Within 8" of Joint: **YES**
 Remarks:
