## Profile/Photo Observation Report

Date:	<b>05/06/2018</b>	Weather:		Coding:	<b>PACP 6.0</b>
Pipe Length (ft):		Owner:	<b>City of Hobart</b>	Pre Clean:	<b>No Pre-Cleaning</b>
P.O.#:	<b>608</b>	Surveyor:	<b>M. Pielacha</b>	PSR:	<b>P-905-003-004</b>
Customer:	<b>City of Hobart</b>	Clean Date:		Shape:	<b>C</b>

Location Details:		Direction of Survey:	<b>Upstream</b>
US MH:	<b>M-905-004</b>	DS MH:	<b>M-905-003</b>
		Total Length Surveyed (ft):	<b>268.7</b>

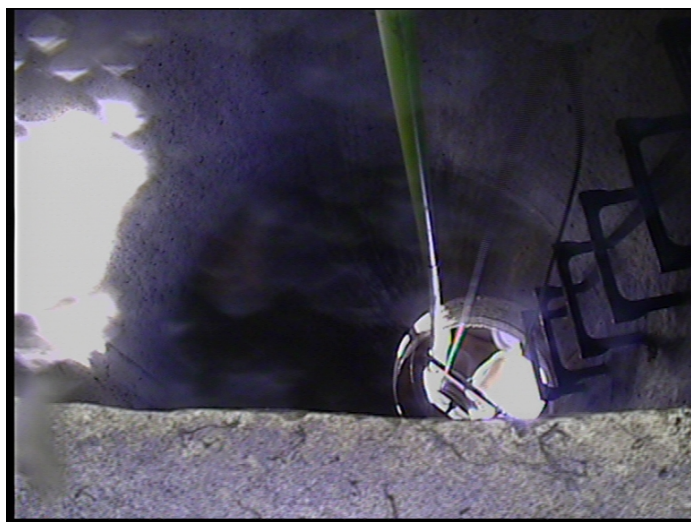
Code: **AMH**  
 Description: **Manhole**

Distance (ft): **.0**  
 Structural Grade: **0**  
 O&M Grade: **0**  
 Clock Start/From:  
 Clock To:  
 1st Value:  
 2nd Value:  
 Value Percent:  
 Continuous Index:  
 Within 8" of Joint: **NO**  
 Remarks: **M-905-003**

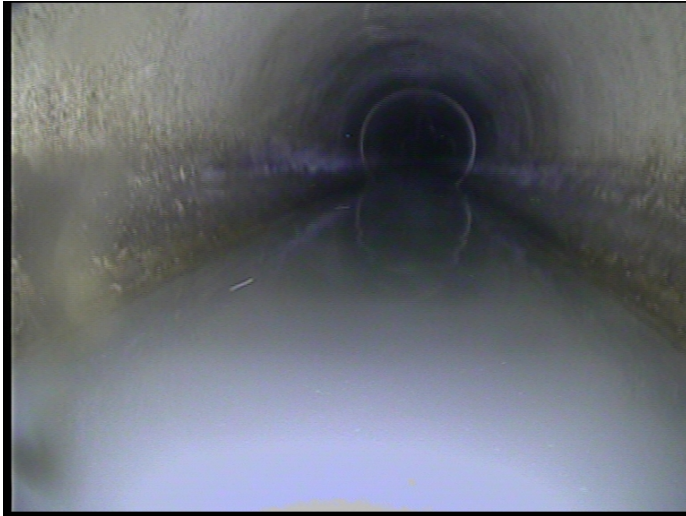
Code:	<b>MWL</b>
Description:	<b>Water Level</b>
Distance (ft):	<b>.0</b>
Structural Grade:	<b>0</b>
O&M Grade:	<b>0</b>
Clock Start/From:	
Clock To:	
1st Value:	
2nd Value:	
Value Percent:	<b>15.000</b>
Continuous Index:	
Within 8" of Joint:	<b>NO</b>
Remarks:

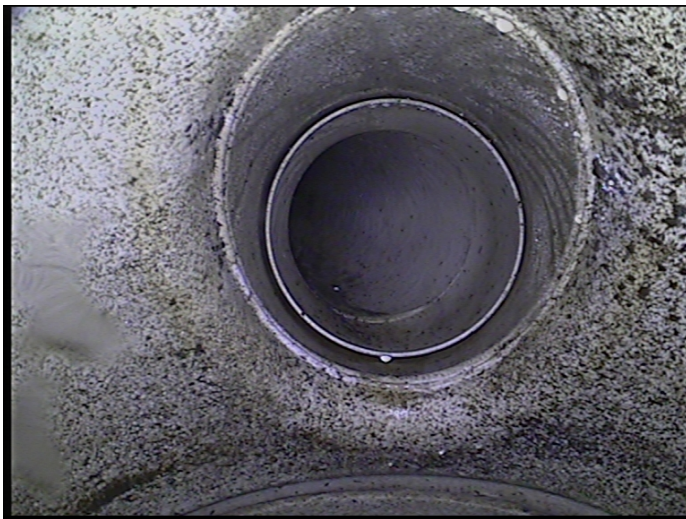
Code:	<b>TF</b>
Description:	<b>Tap Factory</b>
Distance (ft):	<b>126.0</b>
Structural Grade:	<b>0</b>
O&M Grade:	<b>0</b>
Clock Start/From:	<b>12</b>
Clock To:	
1st Value:	<b>4.000</b>
2nd Value:	
Value Percent:	
Continuous Index:	
Within 8" of Joint:	<b>NO</b>
Remarks:

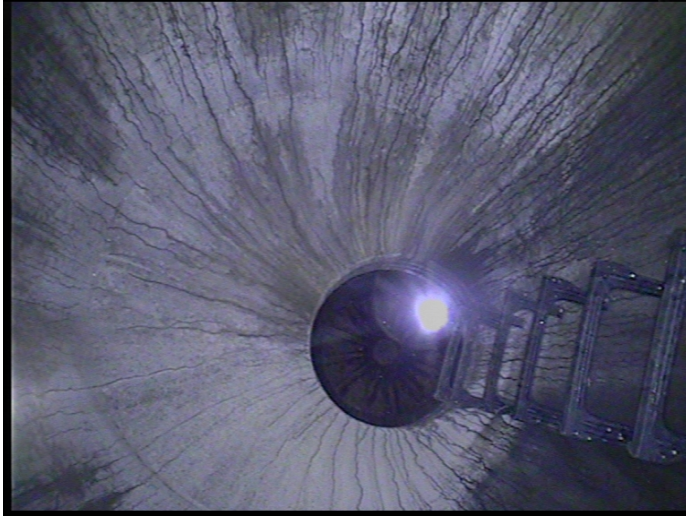
Code:	<b>AMH</b>
Description:	<b>Manhole</b>
Distance (ft):	<b>268.7</b>
Structural Grade:	<b>0</b>
O&M Grade:	<b>0</b>
Clock Start/From:	
Clock To:	
1st Value:	
2nd Value:	
Value Percent:	
Continuous Index:	
Within 8" of Joint:	<b>NO</b>
Remarks:	<b>M-905-003</b>
