Profile/Photo Observation Report

Street:	Off State Road 130	Flow Control:	Not Controlled
City:	Hobart, IN	Year Renewed:	
Location:	Light Highway	Tape/Media #:	DEP 607
Purpose:	Routine Assessment	Dia/Height:	18"
Use:	Sanitary	Material:	PVC
Drain Area:		Lining:	
Category:	NA		
Comment:	5-21-2018

Location Details:		Direction of Survey:	Downstream
US MH:	M-905-004	DS MH:	M-905-005
		Total Length Surveyed (ft):	127.5

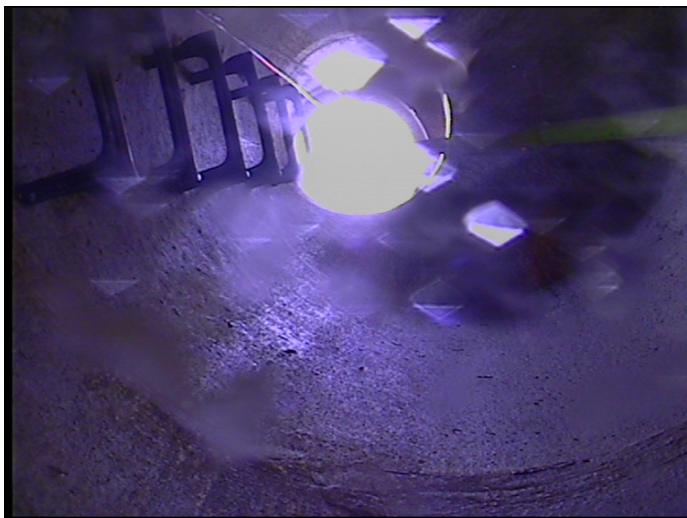
Code: **AMH**
 Description: **Manhole**

Distance (ft): **.0**
 Structural Grade: **0**
 O&M Grade: **0**
 Clock Start/From:
 Clock To:
 1st Value:
 2nd Value:
 Value Percent:
 Continuous Index:
 Within 8" of Joint: **NO**
 Remarks: **M-905-004**

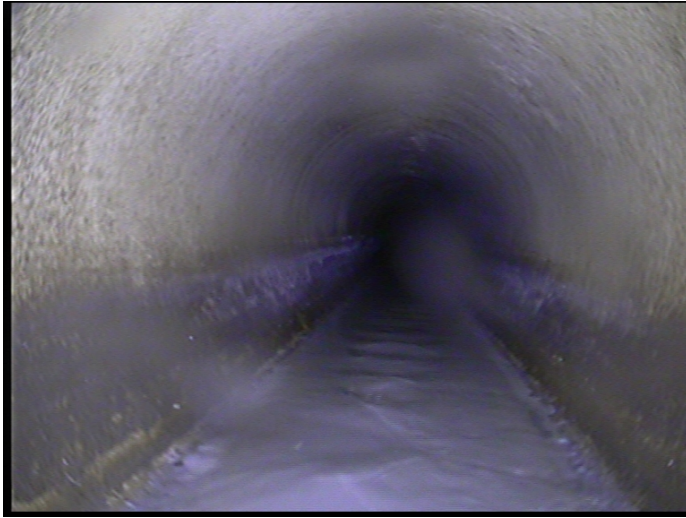
Code: **MWL**
Description: **Water Level**

Distance (ft): **.0**
Structural Grade: **0**
O&M Grade: **0**
Clock Start/From:
Clock To:
1st Value:
2nd Value:
Value Percent: **10.000**
Continuous Index:
Within 8" of Joint: **NO**
Remarks:

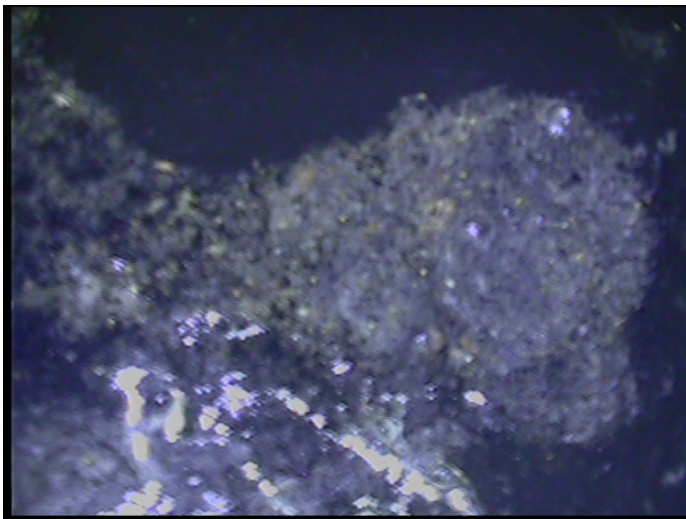
Code: **DSF**
Description: **Deposits Settled Fine**

Distance (ft): **126.0**
Structural Grade: **0**
O&M Grade: **3**
Clock Start/From: **5**
Clock To: **8**
1st Value:
2nd Value:
Value Percent: **15.000**
Continuous Index:
Within 8" of Joint: **YES**
Remarks:

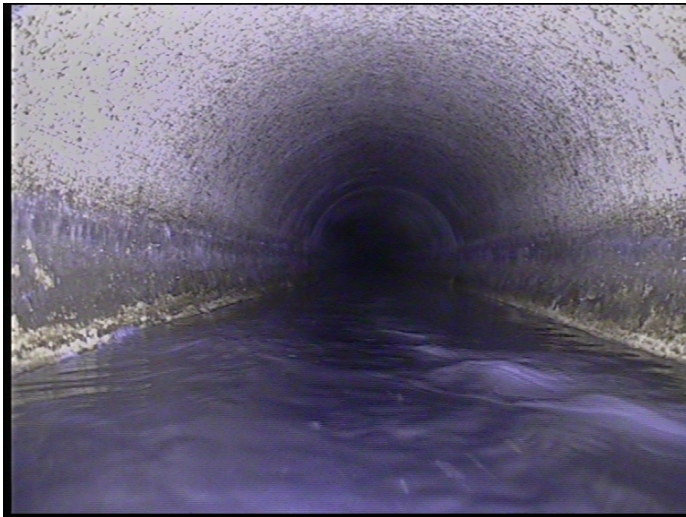
Code:	MSA
Description:	Abandoned Survey
Distance (ft):	127.5
Structural Grade:	0
O&M Grade:	0
Clock Start/From:	
Clock To:	
1st Value:	
2nd Value:	
Value Percent:	
Continuous Index:	
Within 8" of Joint:	NO
Remarks:	sediment
