Profile/Photo Observation Report

| Street: | Sullivan Street | Flow Control: | Not Controlled |
| Use: | Sanitary Sewage Pipe | Material: | PVC |
| US MH: | M-905-005 | DS MH: | M-905-004 |

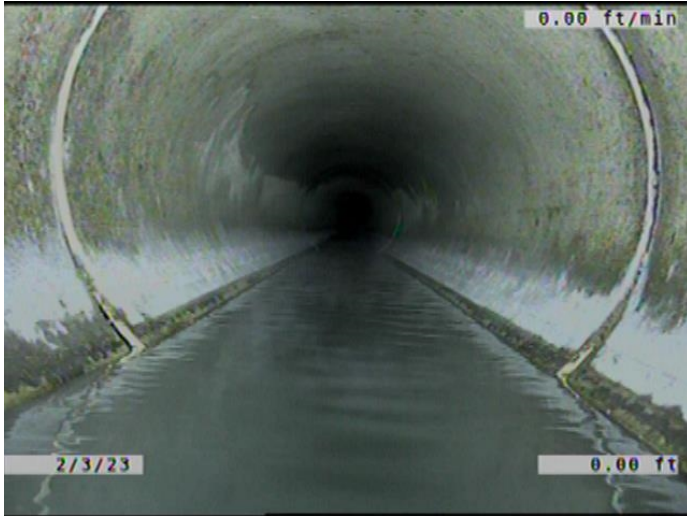
Code: **MWL**
Description: **Miscellaneous Water Level**

Distance (ft): **.0**
Structural Grade: **0**
O&M Grade: **0**
Clock Start/From:
Clock To:
1st Value:
2nd Value:
Value Percent: **10.000**
Continuous Index:
Within 8" of Joint: **NO**
Remarks:

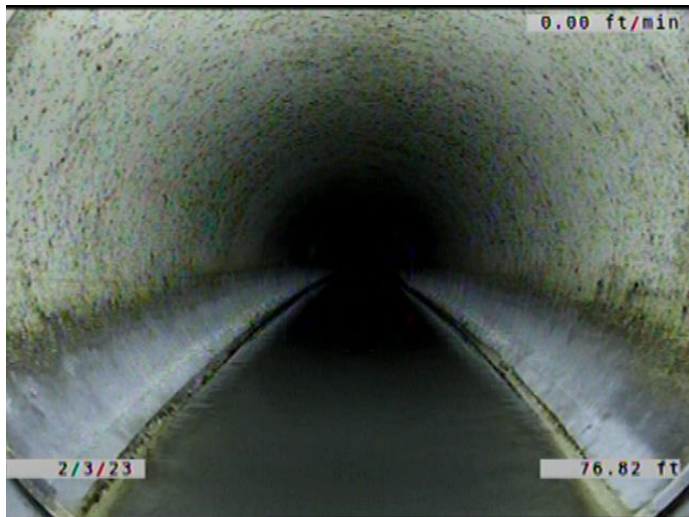
Code: **MWLS**
Description: **Miscellaneous Water Level Sag**

Distance (ft): **76.8**
Structural Grade: **3**
O&M Grade: **0**
Clock Start/From:
Clock To:
1st Value:
2nd Value:
Value Percent: **35.000**
Continuous Index: **S01**
Within 8" of Joint: **NO**
Remarks:

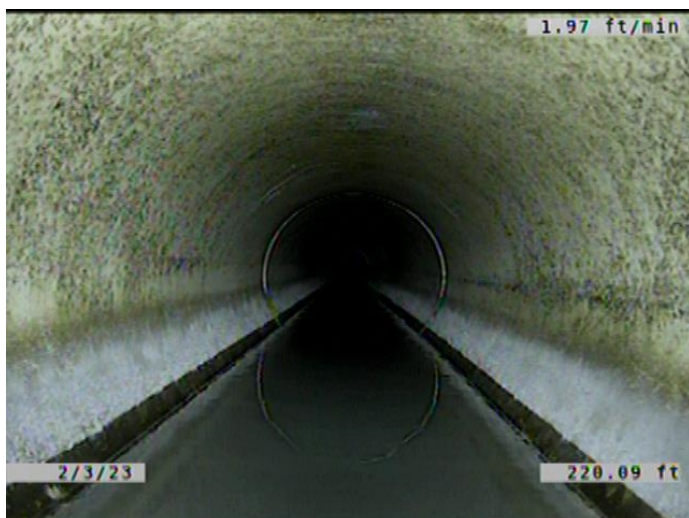
Code: **MWLS**
Description: **Miscellaneous Water Level Sag**

Distance (ft): **220.0**
Structural Grade: **3**
O&M Grade: **0**
Clock Start/From:
Clock To:
1st Value:
2nd Value:
Value Percent: **35.000**
Continuous Index: **F01**
Within 8" of Joint: **NO**
Remarks:
