## Profile/Photo Observation Report

Date:	<b>01/14/2023</b>	Weather:		Coding:	<b>PACP 7.0</b>
Pipe Length (ft):	<b>310.2</b>	Owner:	<b>City of Hobart</b>	Pre Clean:	<b>Heavy Cleaning</b>
P.O.#:	<b>YES502259</b>	Surveyor:	<b>S. Bucklin</b>	PSR:	<b>M-905-006-M-905-007</b>
Customer:	<b>City of Hobart</b>	Clean Date:	<b>10/15/2022</b>	Shape:	<b>C</b>

Street:	<b>Sullivan Street</b>	Flow Control:	<b>Not Controlled</b>
City:	<b>Hobart, IN</b>	Year Renewed:	
Location:	<b>Easement/Right of Way</b>	Tape/Media #:	
Purpose:	<b>Routine Assessment</b>	Dia/Height:	<b>10"</b>
Use:	<b>Sanitary Sewage Pipe</b>	Material:	<b>PVC</b>
Drain Area:		Lining:	<b>None</b>
Category:	<b>NA</b>

US MH:	<b>M-905-006</b>	DS MH:	<b>M-905-007</b>	Total Length Surveyed (ft):	<b>309.5</b>
--------	------------------	--------	------------------	-----------------------------	--------------

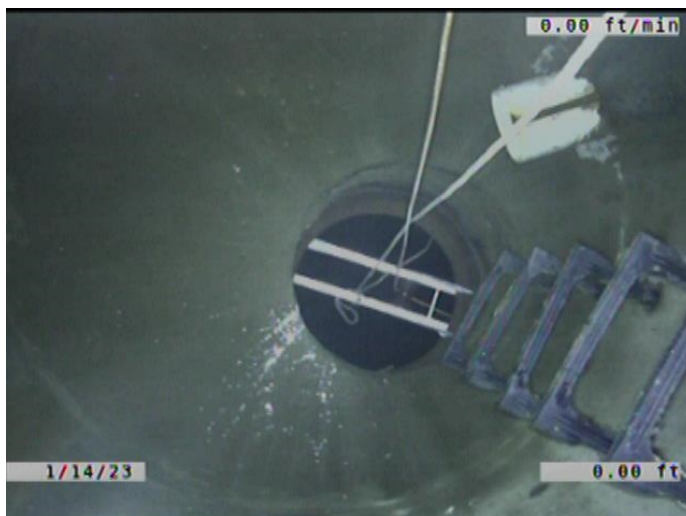
Code: **AMH**  
Description: **Manhole**

Distance (ft): **.0**  
Structural Grade: **0**  
O&M Grade: **0**  
Clock Start/From:  
Clock To:  
1st Value:  
2nd Value:  
Value Percent:  
Continuous Index:  
Within 8" of Joint: **NO**  
Remarks: **M-905-006**

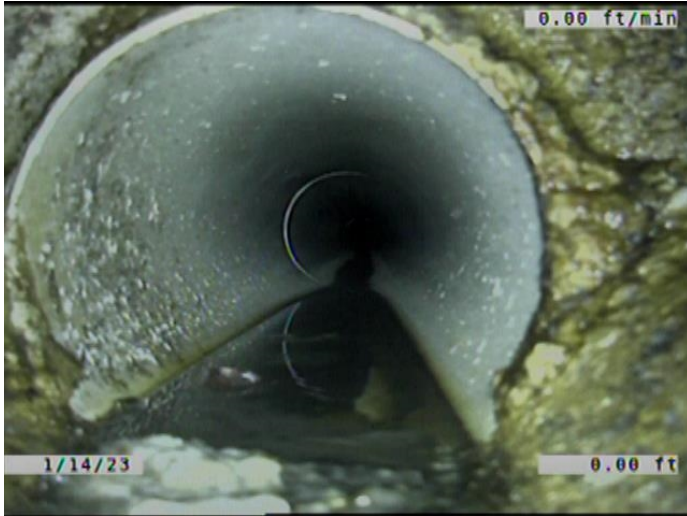
Code:	<b>MWL</b>
Description:	<b>Miscellaneous Water Level</b>
Distance (ft):	<b>.0</b>
Structural Grade:	<b>0</b>
O&M Grade:	<b>0</b>
Clock Start/From:	
Clock To:	
1st Value:	
2nd Value:	
Value Percent:	<b>5.000</b>
Continuous Index:	
Within 8" of Joint:	<b>NO</b>
Remarks:

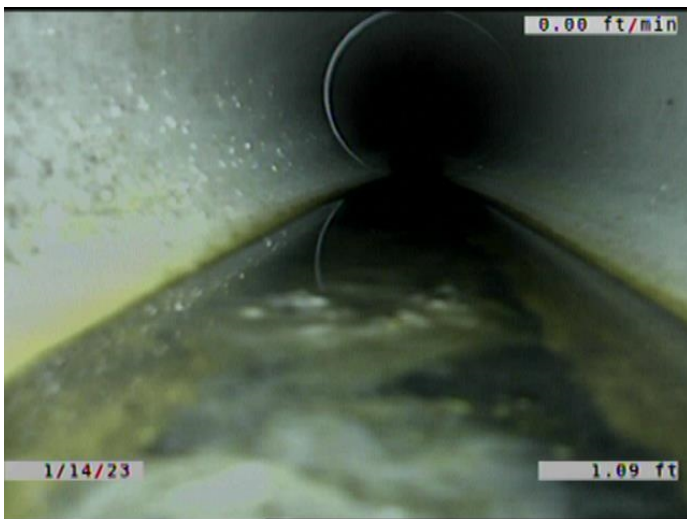
Code:	<b>DSF</b>
Description:	<b>Deposits Settled Fine</b>
Distance (ft):	<b>1.1</b>
Structural Grade:	<b>0</b>
O&M Grade:	<b>2</b>
Clock Start/From:	<b>5</b>
Clock To:	<b>7</b>
1st Value:	
2nd Value:	
Value Percent:	<b>5.000</b>
Continuous Index:	
Within 8" of Joint:	<b>YES</b>
Remarks:

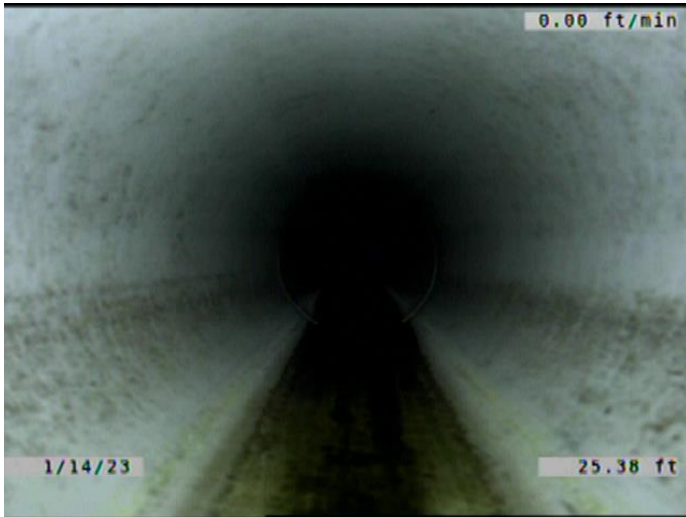
Code: **MWLS**  
Description: **Miscellaneous Water Level Sag**

Distance (ft): **25.4**  
Structural Grade: **2**  
O&M Grade: **0**  
Clock Start/From:  
Clock To:  
1st Value:  
2nd Value:  
Value Percent: **10.000**  
Continuous Index: **S01**  
Within 8" of Joint: **NO**  
Remarks:

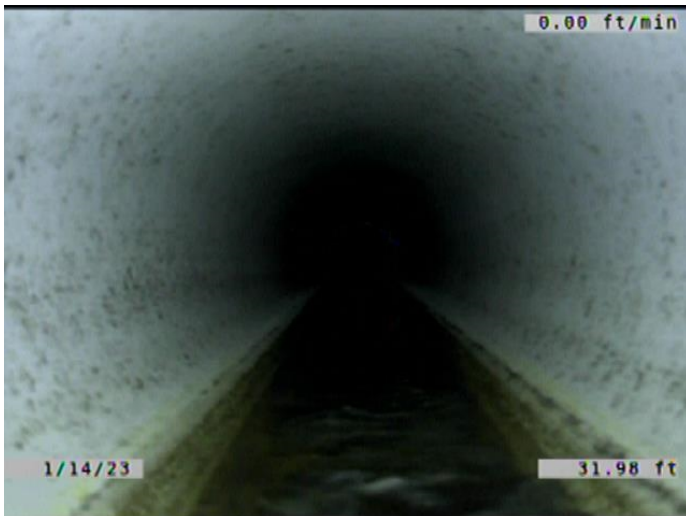
Code: **DSF**  
Description: **Deposits Settled Fine**

Distance (ft): **32.0**  
Structural Grade: **0**  
O&M Grade: **2**  
Clock Start/From: **5**  
Clock To: **7**  
1st Value:  
2nd Value:  
Value Percent: **5.000**  
Continuous Index: **S02**  
Within 8" of Joint: **YES**  
Remarks:

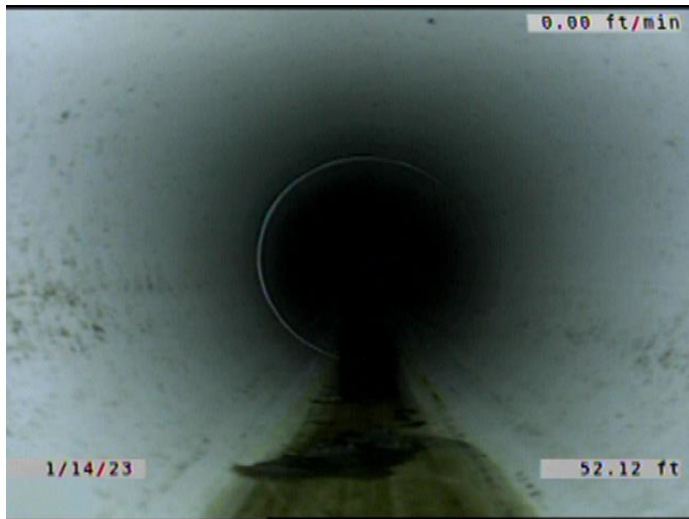
Code: **MWLS**  
Description: **Miscellaneous Water Level Sag**

Distance (ft): **52.1**  
Structural Grade: **2**  
O&M Grade: **0**  
Clock Start/From:  
Clock To:  
1st Value:  
2nd Value:  
Value Percent: **10.000**  
Continuous Index: **F01**  
Within 8" of Joint: **NO**  
Remarks:

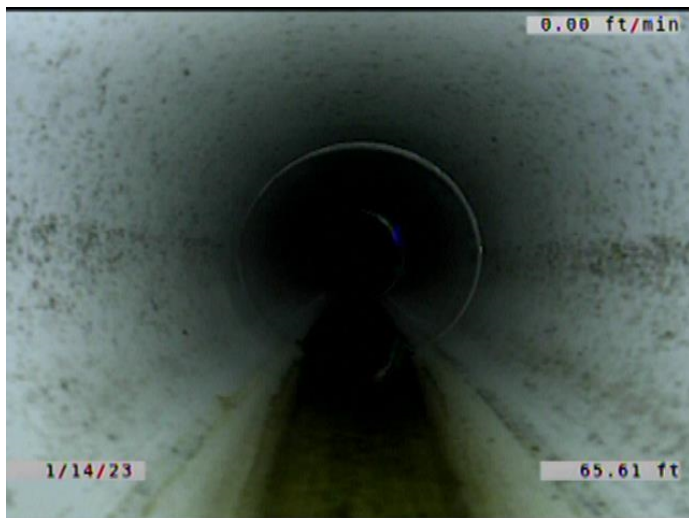
Code: **MWLS**  
Description: **Miscellaneous Water Level Sag**

Distance (ft): **65.6**  
Structural Grade: **2**  
O&M Grade: **0**  
Clock Start/From:  
Clock To:  
1st Value:  
2nd Value:  
Value Percent: **5.000**  
Continuous Index: **S03**  
Within 8" of Joint: **NO**  
Remarks:

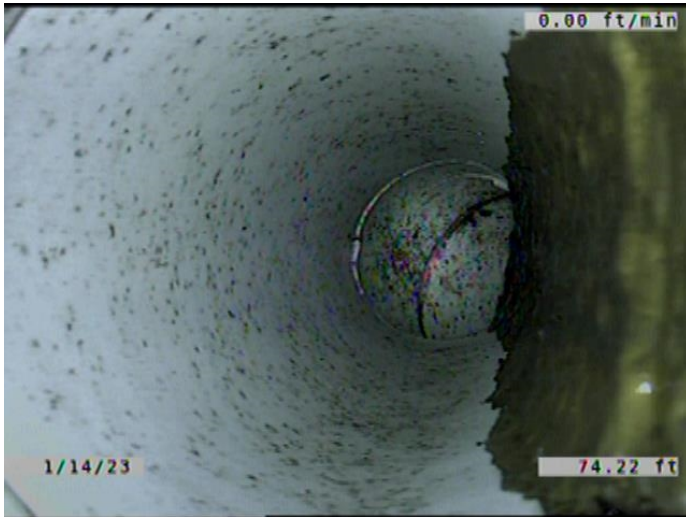
Code:	<b>TF</b>
Description:	<b>Tap Factory</b>
Distance (ft):	<b>74.2</b>
Structural Grade:	<b>0</b>
O&M Grade:	<b>0</b>
Clock Start/From:	<b>1</b>
Clock To:	
1st Value:	<b>6.000</b>
2nd Value:	
Value Percent:	
Continuous Index:	
Within 8" of Joint:	<b>YES</b>
Remarks:	<b>ENCrustATION COMING FROM THE SERVICE INTO THE MAIN.</b>

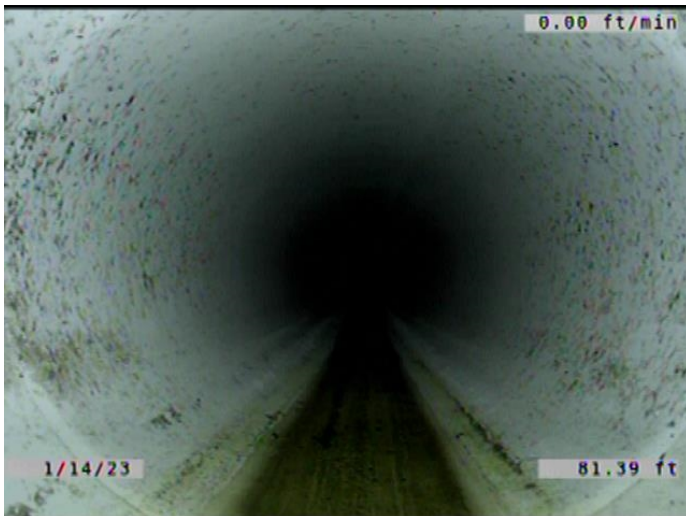
Code:	<b>MWLS</b>
Description:	<b>Miscellaneous Water Level Sag</b>
Distance (ft):	<b>81.4</b>
Structural Grade:	<b>2</b>
O&M Grade:	<b>0</b>
Clock Start/From:	
Clock To:	
1st Value:	
2nd Value:	
Value Percent:	<b>5.000</b>
Continuous Index:	<b>F03</b>
Within 8" of Joint:	<b>NO</b>
Remarks:

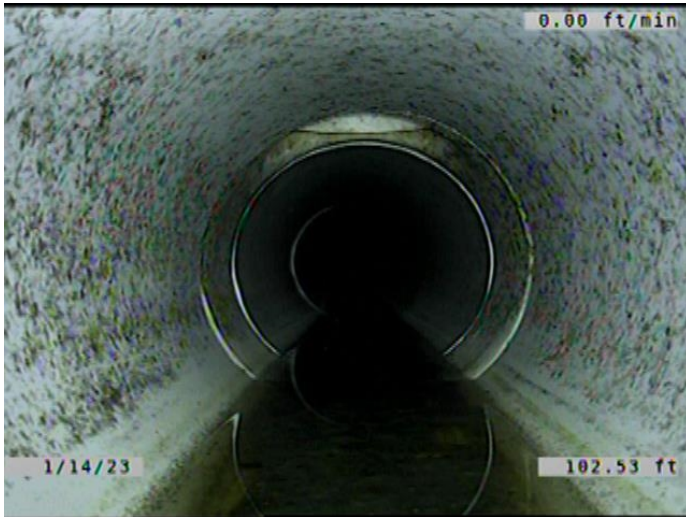
Code: **MWLS**  
Description: **Miscellaneous Water Level Sag**

Distance (ft): **102.5**  
Structural Grade: **2**  
O&M Grade: **0**  
Clock Start/From:  
Clock To:  
1st Value:  
2nd Value:  
Value Percent: **10.000**  
Continuous Index: **S04**  
Within 8" of Joint: **NO**  
Remarks:

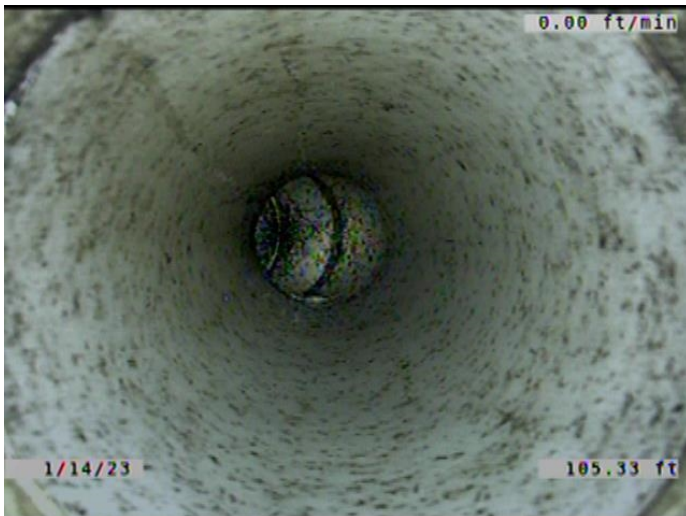
Code: **TF**  
Description: **Tap Factory**

Distance (ft): **105.3**  
Structural Grade: **0**  
O&M Grade: **0**  
Clock Start/From: **12**  
Clock To:  
1st Value: **6.000**  
2nd Value:  
Value Percent:  
Continuous Index:  
Within 8" of Joint: **YES**  
Remarks:

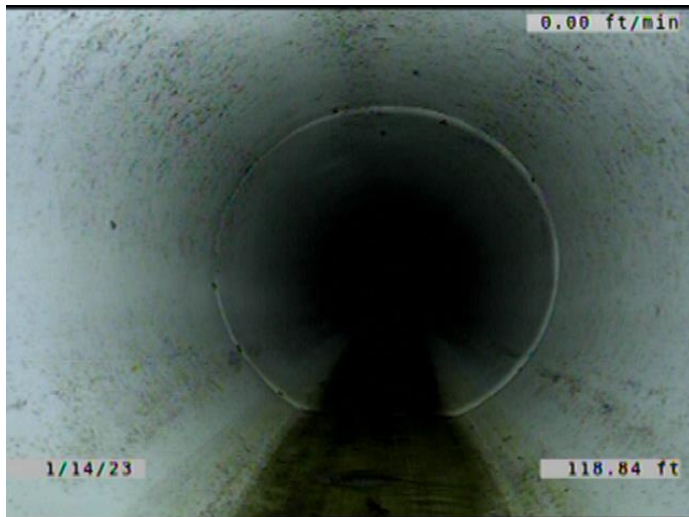
Code: **MWLS**  
Description: **Miscellaneous Water Level Sag**

Distance (ft): **118.8**  
Structural Grade: **2**  
O&M Grade: **0**  
Clock Start/From:  
Clock To:  
1st Value:  
2nd Value:  
Value Percent: **10.000**  
Continuous Index: **F04**  
Within 8" of Joint: **NO**  
Remarks:

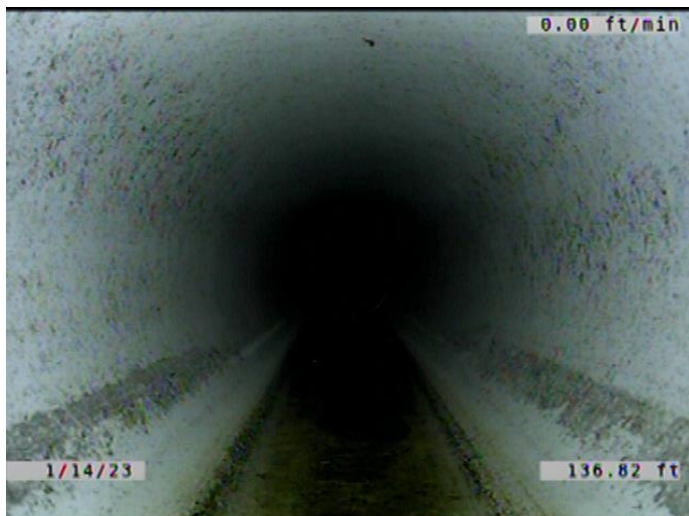
Code: **MWLS**  
Description: **Miscellaneous Water Level Sag**

Distance (ft): **136.8**  
Structural Grade: **2**  
O&M Grade: **0**  
Clock Start/From:  
Clock To:  
1st Value:  
2nd Value:  
Value Percent: **10.000**  
Continuous Index: **S05**  
Within 8" of Joint: **NO**  
Remarks:

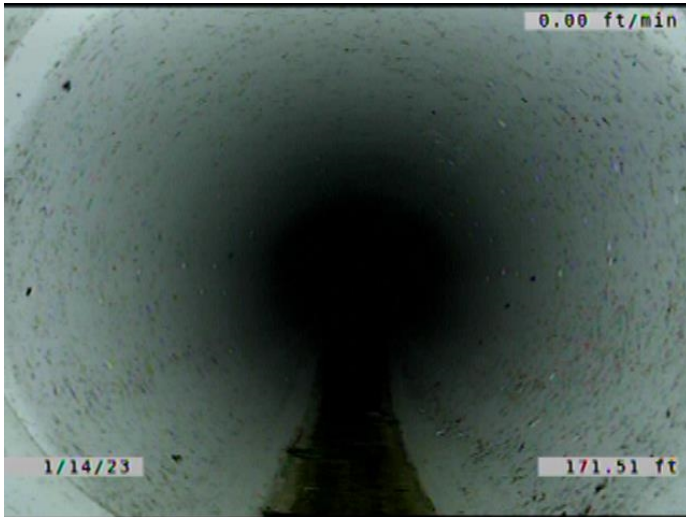
Code: **MWLS**  
Description: **Miscellaneous Water Level Sag**

Distance (ft): **171.5**  
Structural Grade: **2**  
O&M Grade: **0**  
Clock Start/From:  
Clock To:  
1st Value:  
2nd Value:  
Value Percent: **10.000**  
Continuous Index: **F05**  
Within 8" of Joint: **NO**  
Remarks:

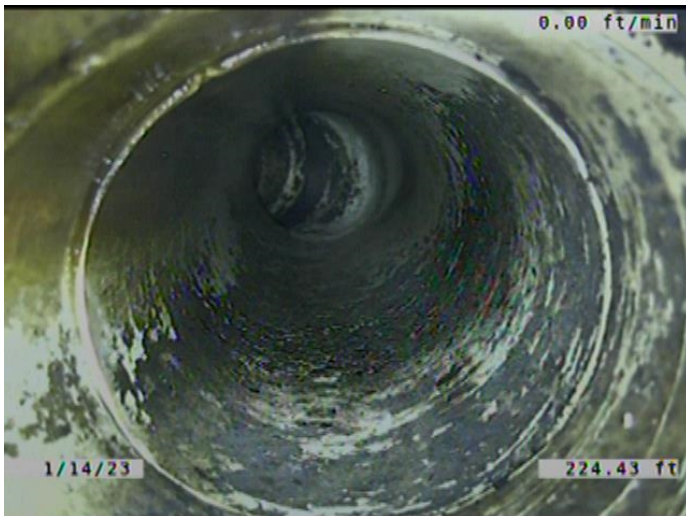
Code: **TF**  
Description: **Tap Factory**

Distance (ft): **224.4**  
Structural Grade: **0**  
O&M Grade: **0**  
Clock Start/From: **11**  
Clock To:  
1st Value: **6.000**  
2nd Value:  
Value Percent:  
Continuous Index:  
Within 8" of Joint: **YES**  
Remarks: **CONSTANTLY RUNNING WATER.**

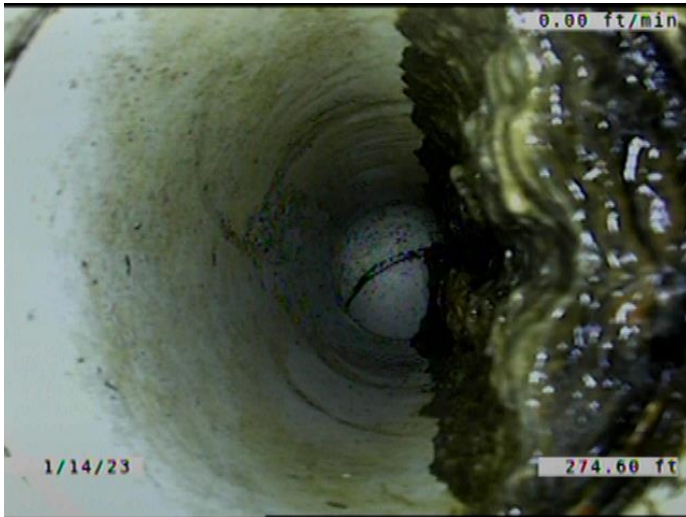
Code: **TF**  
 Description: **Tap Factory**

Distance (ft): **274.6**  
 Structural Grade: **0**  
 O&M Grade: **0**  
 Clock Start/From: **1**  
 Clock To:  
 1st Value: **6.000**

2nd Value:  
 Value Percent:  
 Continuous Index:  
 Within 8" of Joint: **YES**  
 Remarks: **CONSTANTLY RUNNING WATER.  
 ENCRUSTATION COMING FROM THE**

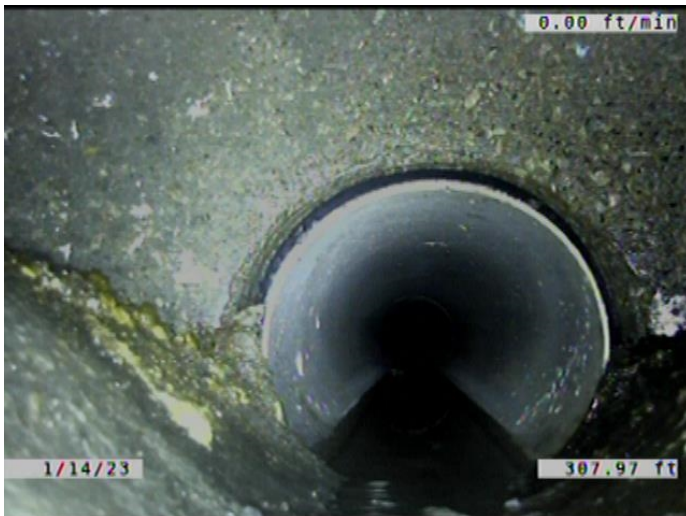
Code: **DSF**  
 Description: **Deposits Settled Fine**

Distance (ft): **308.0**  
 Structural Grade: **0**  
 O&M Grade: **2**  
 Clock Start/From: **5**  
 Clock To: **7**

1st Value:  
 2nd Value:  
 Value Percent: **5.000**  
 Continuous Index: **F02**  
 Within 8" of Joint: **YES**  
 Remarks:

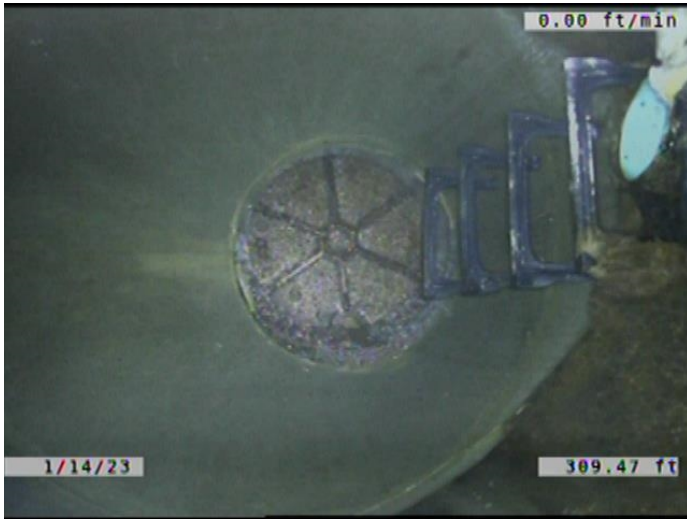
Code:	AMH
Description:	Manhole
Distance (ft):	309.5
Structural Grade:	0
O&M Grade:	0
Clock Start/From:	
Clock To:	
1st Value:	
2nd Value:	
Value Percent:	
Continuous Index:	
Within 8" of Joint:	NO
Remarks:	M-905-007
