Profile/Photo Observation Report

Date:	05/06/2018	Weather:		Coding:	PACP 6.0
Pipe Length (ft):		Owner:	City of Hobart	Pre Clean:	No Pre-Cleaning
P.O.#:	605	Surveyor:	M. Pielacha	PSR:	P-905-005-010
Customer:	City of Hobart	Clean Date:		Shape:	C

Street:	Off State Road 130	Flow Control:	Not Controlled
City:	Hobart, IN	Year Renewed:	
Location:	Sidewalk	Tape/Media #:	DEP 605
Purpose:	Routine Assessment	Dia/Height:	18"
Use:	Sanitary	Material:	PVC
Drain Area:		Lining:	
Category:	NA		
Comment:	5-21-2018		
Location Details:		Direction of Survey:	Downstream
US MH:	M-905-010	DS MH:	M-905-005
		Total Length Surveyed (ft):	364.7

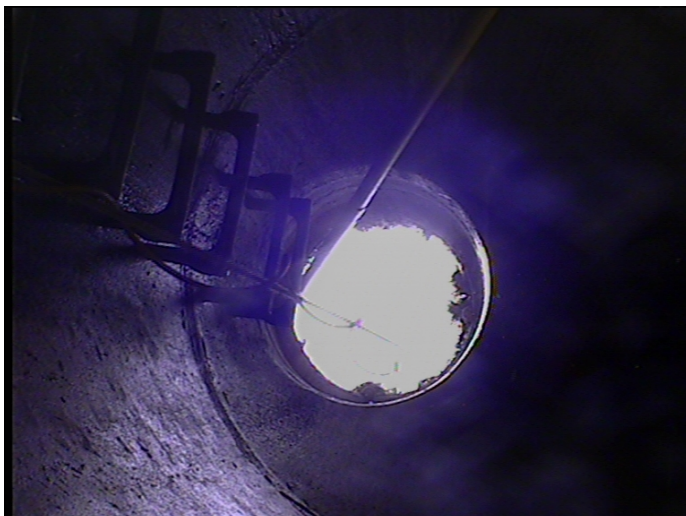
Code: **AMH**
Description: **Manhole**

Distance (ft): **.0**
Structural Grade: **0**
O&M Grade: **0**
Clock Start/From:
Clock To:
1st Value:
2nd Value:
Value Percent:
Continuous Index:
Within 8" of Joint: **NO**
Remarks: **M-905-005**

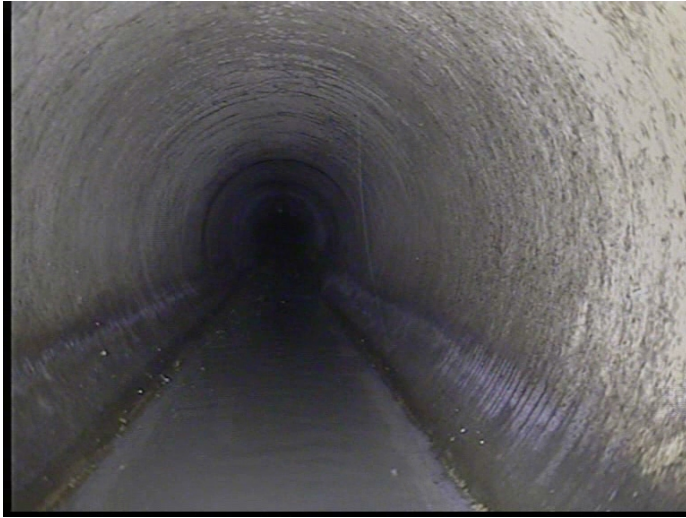
Code:	MWL
Description:	Water Level
Distance (ft):	.0
Structural Grade:	0
O&M Grade:	0
Clock Start/From:	
Clock To:	
1st Value:	
2nd Value:	
Value Percent:	10.000
Continuous Index:	
Within 8" of Joint:	NO
Remarks:

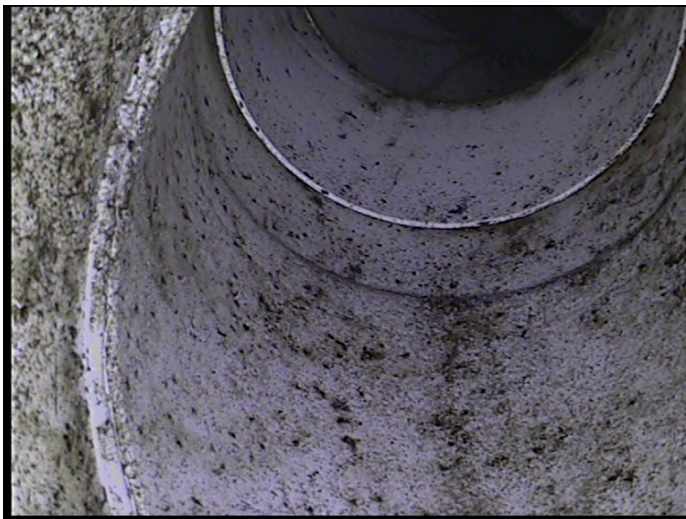
Code:	TF
Description:	Tap Factory
Distance (ft):	162.4
Structural Grade:	0
O&M Grade:	0
Clock Start/From:	12
Clock To:	
1st Value:	4.000
2nd Value:	
Value Percent:	
Continuous Index:	
Within 8" of Joint:	NO
Remarks:

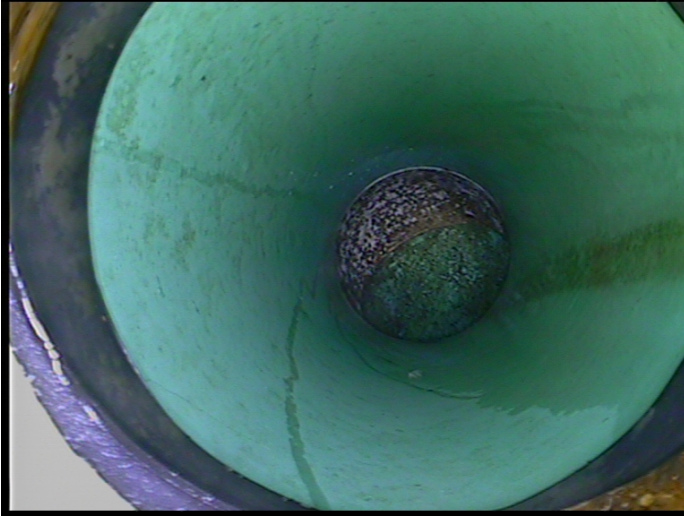
Code: **TF**
Description: **Tap Factory**

Distance (ft): **172.7**
Structural Grade: **0**
O&M Grade: **0**
Clock Start/From: **12**
Clock To:
1st Value: **4.000**
2nd Value:
Value Percent:
Continuous Index:
Within 8" of Joint: **NO**
Remarks:

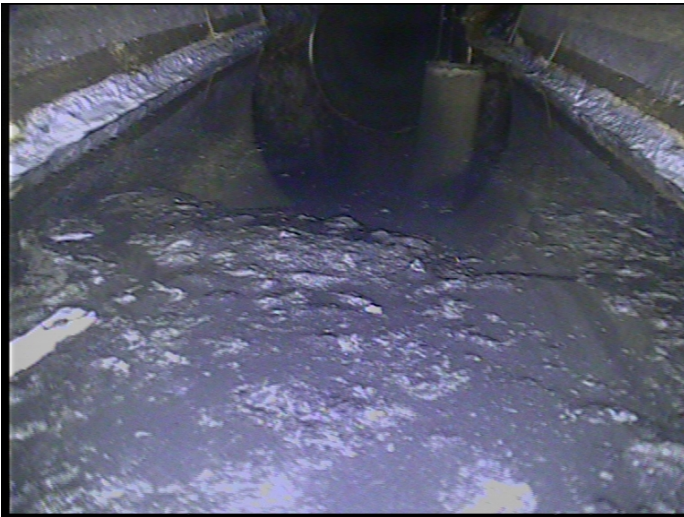
Code: **DSF**
Description: **Deposits Settled Fine**

Distance (ft): **361.5**
Structural Grade: **0**
O&M Grade: **3**
Clock Start/From: **4**
Clock To: **8**
1st Value:
2nd Value:
Value Percent: **20.000**
Continuous Index: **S01**
Within 8" of Joint: **YES**
Remarks:

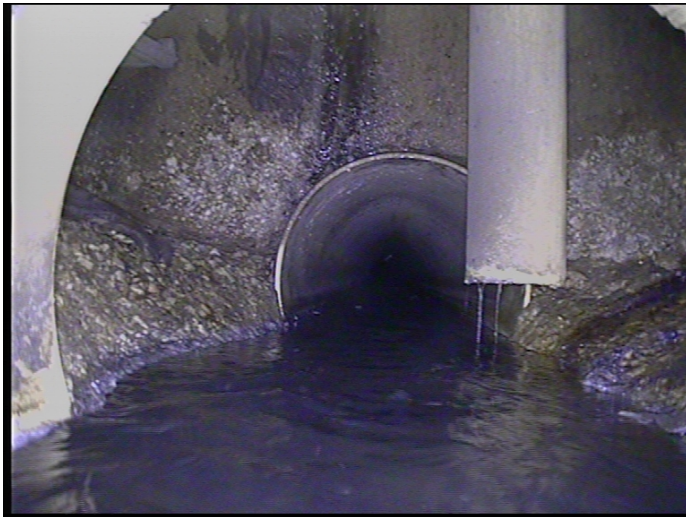
Code: **DSF**
Description: **Deposits Settled Fine**

Distance (ft): **364.7**
Structural Grade: **0**
O&M Grade: **3**
Clock Start/From: **4**
Clock To: **8**
1st Value:
2nd Value:
Value Percent: **20.000**
Continuous Index: **F01**
Within 8" of Joint: **NO**
Remarks:

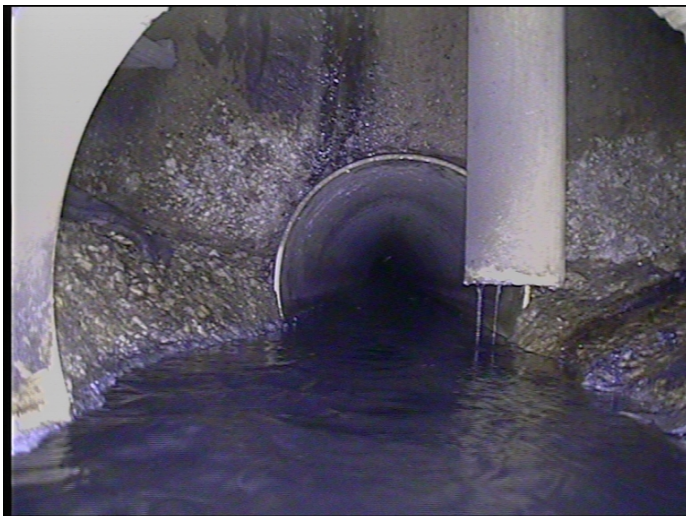
Code: **AMH**
Description: **Manhole**

Distance (ft): **364.7**
Structural Grade: **0**
O&M Grade: **0**
Clock Start/From:
Clock To:
1st Value:
2nd Value:
Value Percent:
Continuous Index:
Within 8" of Joint: **NO**
Remarks: **M-905-005**
