Profile/Photo Observation Report

Date:	05/06/2018	Weather:		Coding:	PACP 6.0
Pipe Length (ft):		Owner:	City of Hobart	Pre Clean:	No Pre-Cleaning
P.O.#:	604	Surveyor:	M. Pielacha	PSR:	P-905-010-011
Customer:	City of Hobart	Clean Date:		Shape:	C

Street:	Off State Road 130	Flow Control:	Not Controlled
City:	Hobart, IN	Year Renewed:	
Location:	Easement/Right of Way	Tape/Media #:	DEP 604
Purpose:	Routine Assessment	Dia/Height:	18"
Use:	Sanitary	Material:	PVC
Drain Area:		Lining:	
Category:	NA		
Comment:	5-21-2018		
Location Details:		Direction of Survey:	Upstream
US MH:	M-905-011	DS MH:	M-905-010
		Total Length Surveyed (ft):	328.5

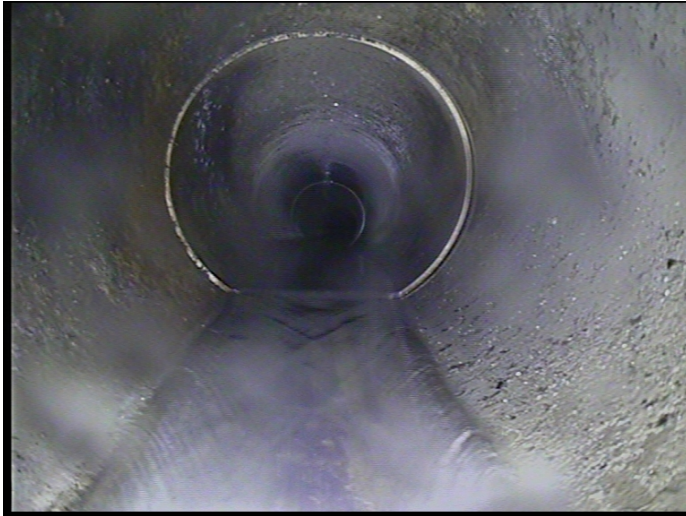
Code:	AMH
Description:	Manhole
Distance (ft):	.0
Structural Grade:	0
O&M Grade:	0
Clock Start/From:	
Clock To:	
1st Value:	
2nd Value:	
Value Percent:	
Continuous Index:	
Within 8" of Joint:	NO
Remarks:	M-905-011

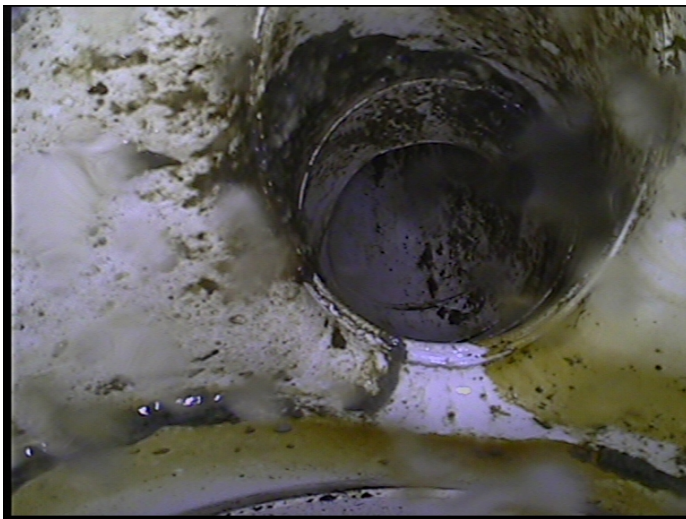
Code:	MWL
Description:	Water Level
Distance (ft):	.0
Structural Grade:	0
O&M Grade:	0
Clock Start/From:	
Clock To:	
1st Value:	
2nd Value:	
Value Percent:	10.000
Continuous Index:	
Within 8" of Joint:	NO
Remarks:

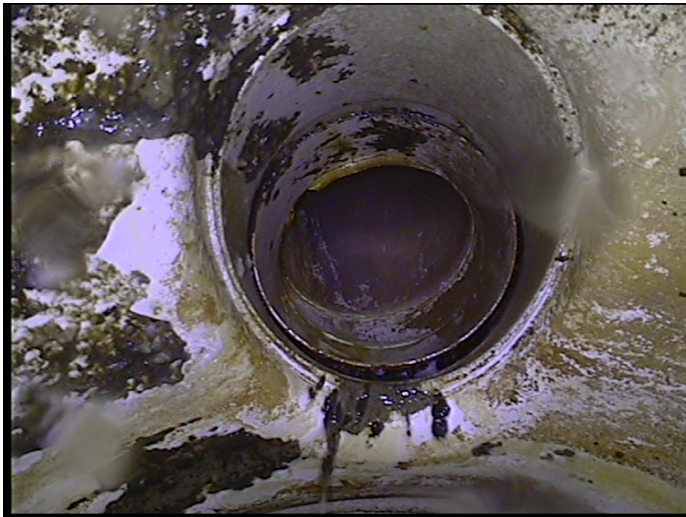
Code:	TF
Description:	Tap Factory
Distance (ft):	70.9
Structural Grade:	0
O&M Grade:	0
Clock Start/From:	12
Clock To:	
1st Value:	4.000
2nd Value:	
Value Percent:	
Continuous Index:	
Within 8" of Joint:	NO
Remarks:

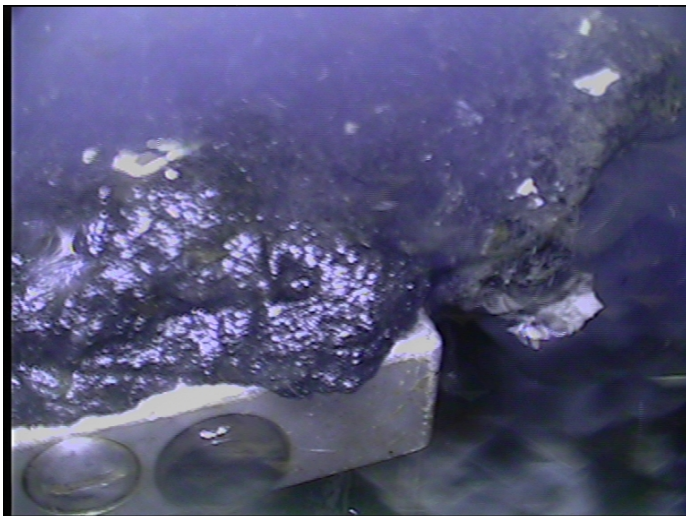
Code: **TF**
Description: **Tap Factory**

Distance (ft): **242.9**
Structural Grade: **0**
O&M Grade: **0**
Clock Start/From: **12**
Clock To:
1st Value: **4.000**
2nd Value:
Value Percent:
Continuous Index:
Within 8" of Joint: **NO**
Remarks:

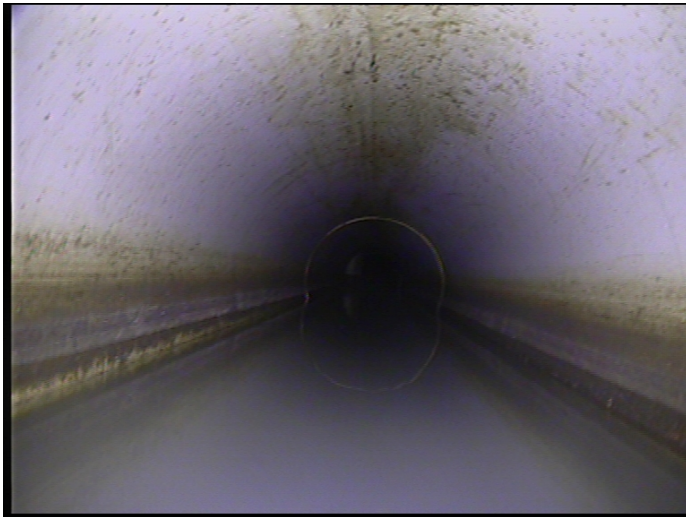
Code: **DSF**
Description: **Deposits Settled Fine**

Distance (ft): **281.2**
Structural Grade: **0**
O&M Grade: **3**
Clock Start/From: **5**
Clock To: **7**
1st Value:
2nd Value:
Value Percent: **15.000**
Continuous Index: **S01**
Within 8" of Joint: **YES**
Remarks:

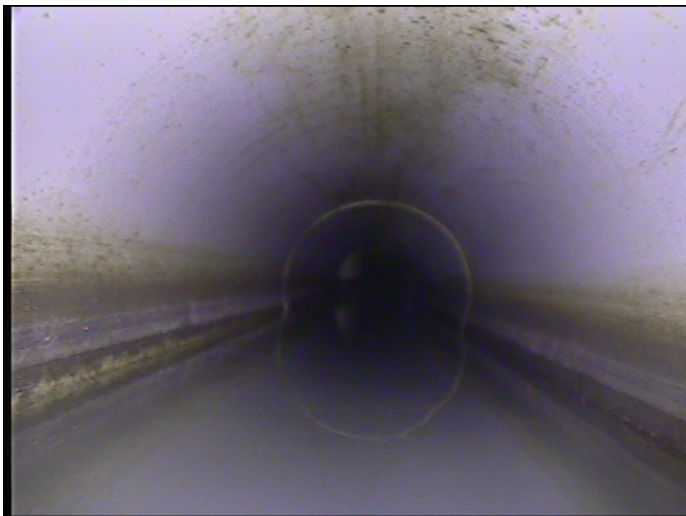
Code: **DSF**
Description: **Deposits Settled Fine**

Distance (ft): **328.4**
Structural Grade: **0**
O&M Grade: **3**
Clock Start/From: **5**
Clock To: **7**
1st Value:
2nd Value:
Value Percent: **15.000**
Continuous Index: **F01**
Within 8" of Joint: **NO**
Remarks:
