## Profile/Photo Observation Report

Street:	<b>Shelby Street</b>	Flow Control:	<b>Not Controlled</b>
City:	<b>Hobart, IN</b>	Year Renewed:	
Location:	<b>Light Highway</b>	Tape/Media #:	<b>Dep 603</b>
Purpose:	<b>Routine Assessment</b>	Dia/Height:	<b>18"</b>
Use:	<b>Sanitary</b>	Material:	<b>CP</b>
Drain Area:		Lining:	
Category:	<b>NA</b>		
Comment:	<b>5-21-2018</b>

Location Details:		Direction of Survey:	<b>Downstream</b>
US MH:	<b>M-905-011</b>	DS MH:	<b>M-905-012</b>
		Total Length Surveyed (ft):	<b>217.6</b>

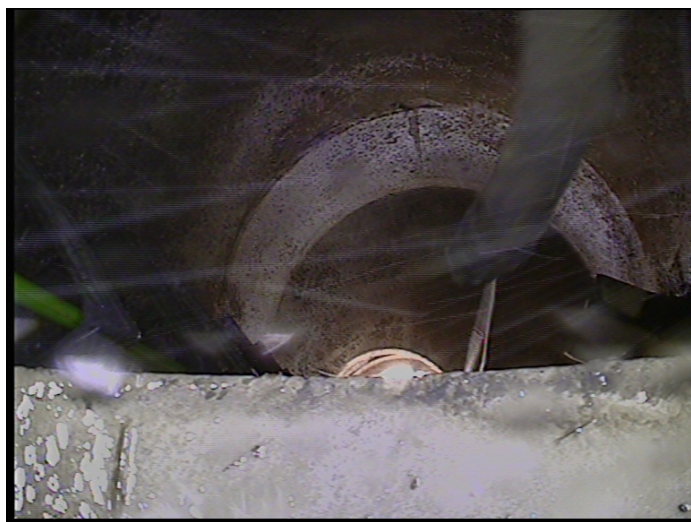
Code: **AMH**  
Description: **Manhole**

Distance (ft): **.0**  
Structural Grade: **0**  
O&M Grade: **0**  
Clock Start/From:  
Clock To:  
1st Value:  
2nd Value:  
Value Percent:  
Continuous Index:  
Within 8" of Joint: **NO**  
Remarks: **M-905-011**

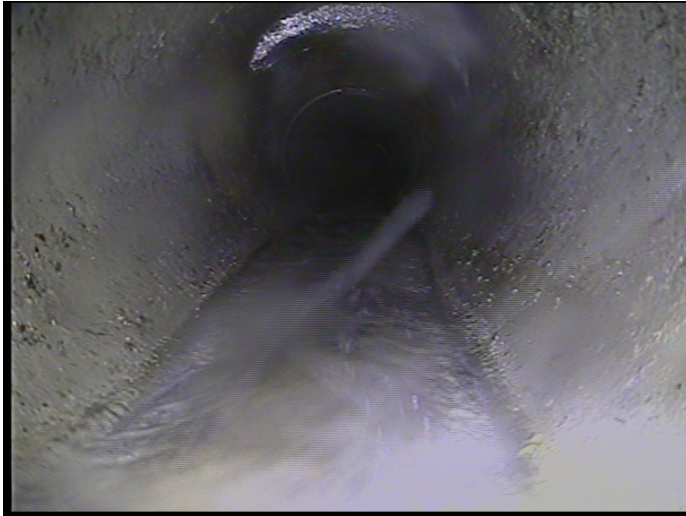
Code:	<b>MWL</b>
Description:	<b>Water Level</b>
Distance (ft):	<b>.0</b>
Structural Grade:	<b>0</b>
O&M Grade:	<b>0</b>
Clock Start/From:	
Clock To:	
1st Value:	
2nd Value:	
Value Percent:	<b>10.000</b>
Continuous Index:	
Within 8" of Joint:	<b>NO</b>
Remarks:

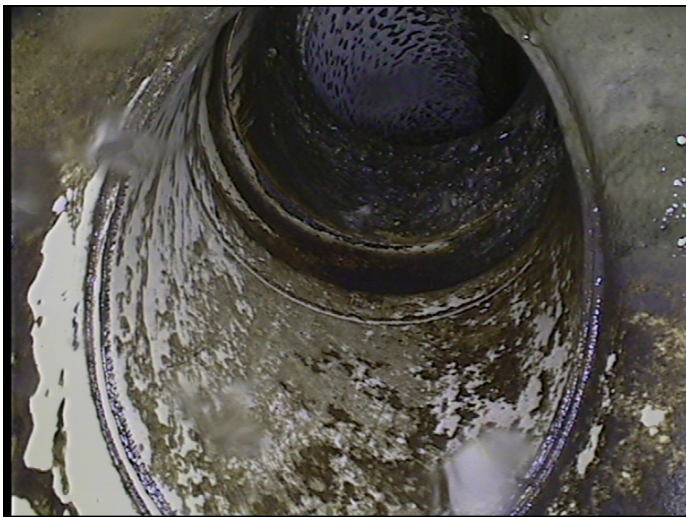
Code:	<b>TF</b>
Description:	<b>Tap Factory</b>
Distance (ft):	<b>199.7</b>
Structural Grade:	<b>0</b>
O&M Grade:	<b>0</b>
Clock Start/From:	<b>2</b>
Clock To:	
1st Value:	<b>4.000</b>
2nd Value:	
Value Percent:	
Continuous Index:	
Within 8" of Joint:	<b>NO</b>
Remarks:

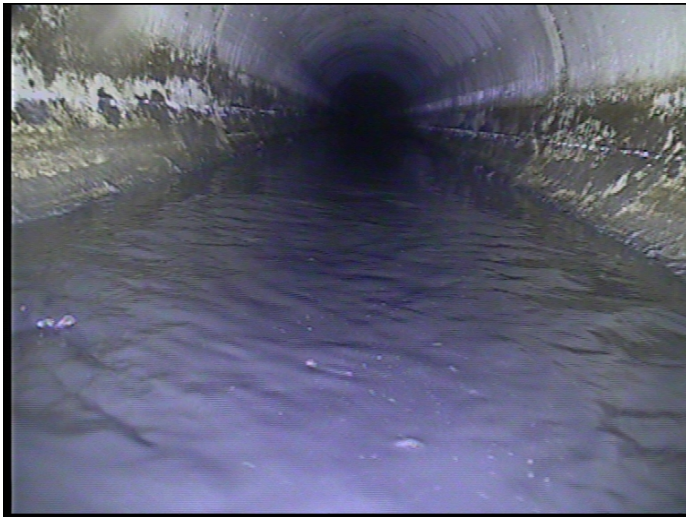
Code: **DSF**  
Description: **Deposits Settled Fine**

Distance (ft): **216.8**  
Structural Grade: **0**  
O&M Grade: **3**  
Clock Start/From: **4**  
Clock To: **8**  
1st Value:  
2nd Value:  
Value Percent: **15.000**  
Continuous Index:  
Within 8" of Joint: **NO**  
Remarks:

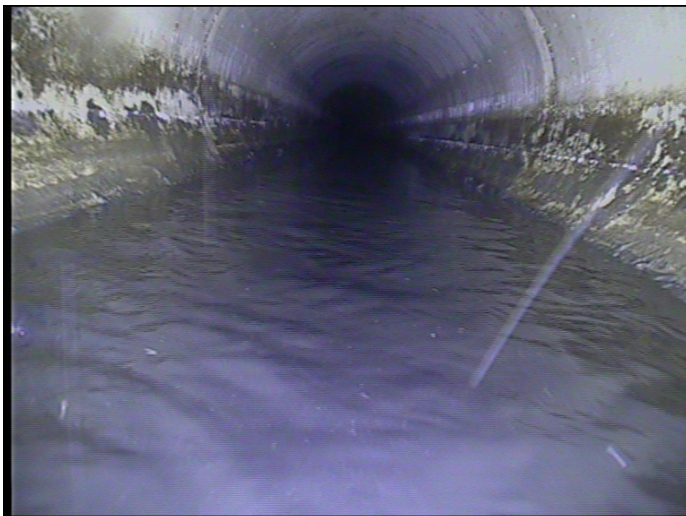
Code: **MSA**  
Description: **Abandoned Survey**

Distance (ft): **216.8**  
Structural Grade: **0**  
O&M Grade: **0**  
Clock Start/From:  
Clock To:  
1st Value:  
2nd Value:  
Value Percent:  
Continuous Index:  
Within 8" of Joint: **NO**  
Remarks: **sediment**
