## Profile/Photo Observation Report

Date:	<b>05/06/2018</b>	Weather:		Coding:	<b>PACP 6.0</b>
Pipe Length (ft):		Owner:	<b>City of Hobart</b>	Pre Clean:	<b>No Pre-Cleaning</b>
P.O.#:	<b>600</b>	Surveyor:	<b>M. Pielacha</b>	PSR:	<b>P-905-012-013</b>
Customer:	<b>City of Hobart</b>	Clean Date:		Shape:	<b>C</b>

Street:	<b>Off State Road 130</b>	Flow Control:	<b>Not Controlled</b>
City:	<b>Hobart, IN</b>	Year Renewed:	
Location:	<b>Other</b>	Tape/Media #:	<b>DEP 600</b>
Purpose:	<b>Routine Assessment</b>	Dia/Height:	<b>18"</b>
Use:	<b>Sanitary</b>	Material:	<b>PVC</b>
Drain Area:		Lining:	
Category:	<b>NA</b>		
Comment:	<b>5-21-2018</b>		
Location Details:		Direction of Survey:	<b>Upstream</b>
US MH:	<b>M-905-013</b>	DS MH:	<b>M-905-012</b>
		Total Length Surveyed (ft):	<b>125.9</b>

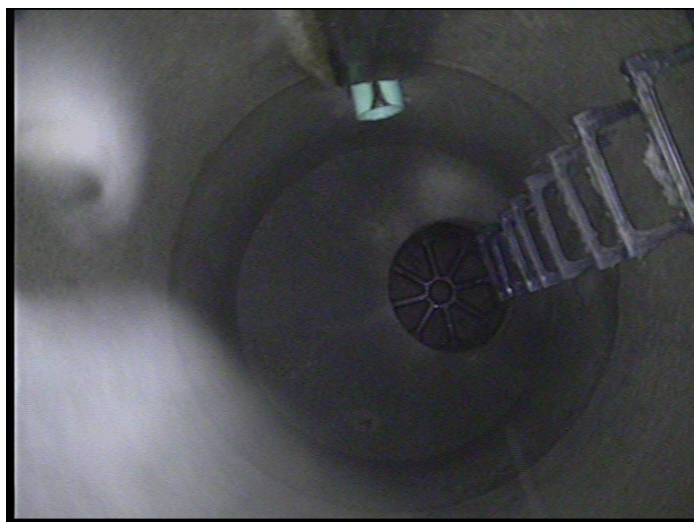
Code: **AMH**  
 Description: **Manhole**

Distance (ft): **.0**  
 Structural Grade: **0**  
 O&M Grade: **0**  
 Clock Start/From:  
 Clock To:  
 1st Value:  
 2nd Value:  
 Value Percent:  
 Continuous Index:  
 Within 8" of Joint: **NO**  
 Remarks: **M-905-013**

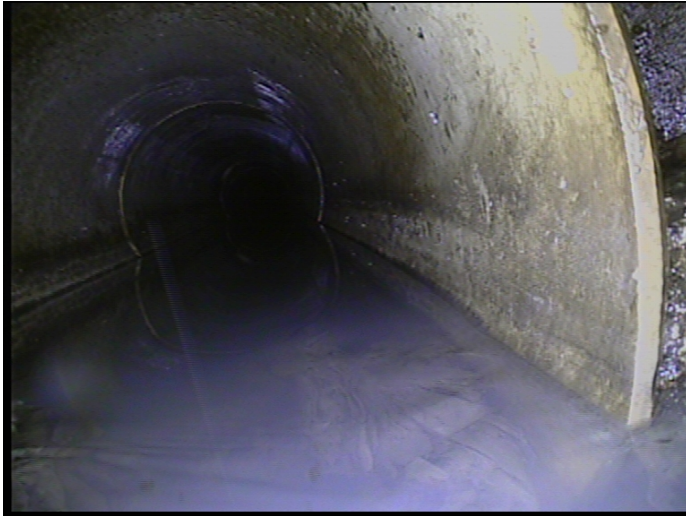
Code:	<b>MWL</b>
Description:	<b>Water Level</b>
Distance (ft):	<b>.0</b>
Structural Grade:	<b>0</b>
O&M Grade:	<b>0</b>
Clock Start/From:	
Clock To:	
1st Value:	
2nd Value:	
Value Percent:	<b>15.000</b>
Continuous Index:	
Within 8" of Joint:	<b>NO</b>
Remarks:

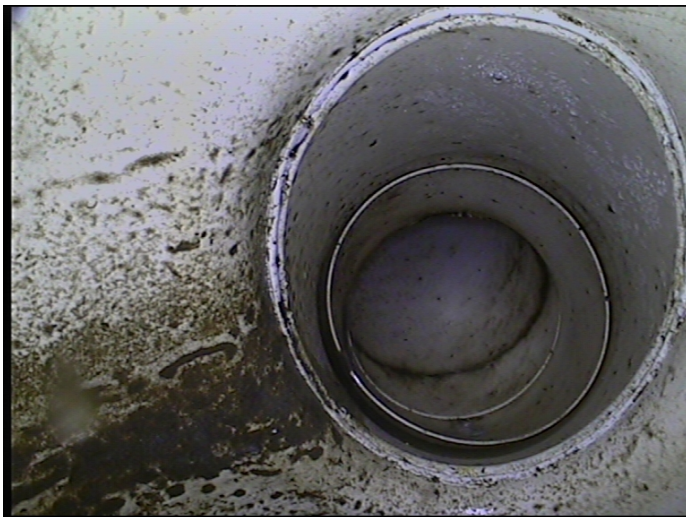
Code:	<b>TF</b>
Description:	<b>Tap Factory</b>
Distance (ft):	<b>16.6</b>
Structural Grade:	<b>0</b>
O&M Grade:	<b>0</b>
Clock Start/From:	<b>10</b>
Clock To:	
1st Value:	<b>4.000</b>
2nd Value:	
Value Percent:	
Continuous Index:	
Within 8" of Joint:	<b>NO</b>
Remarks:

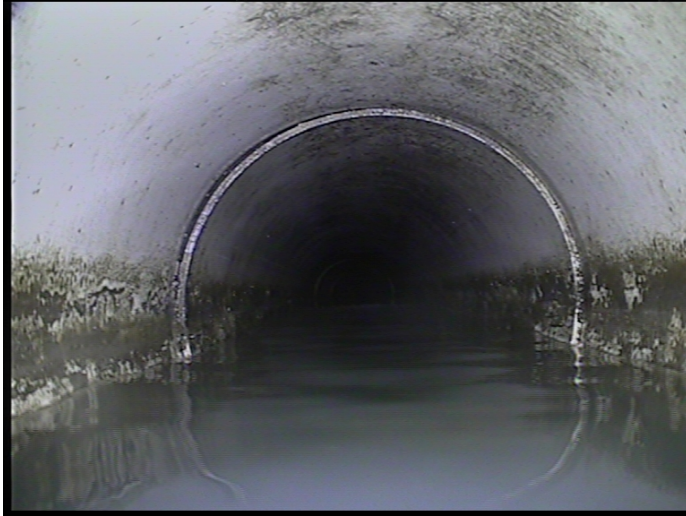
Code:	<b>MSA</b>
Description:	<b>Abandoned Survey</b>
Distance (ft):	<b>125.9</b>
Structural Grade:	<b>0</b>
O&M Grade:	<b>0</b>
Clock Start/From:	
Clock To:	
1st Value:	
2nd Value:	
Value Percent:	
Continuous Index:	
Within 8" of Joint:	<b>NO</b>
Remarks:	<b>underwater debris/sediment</b>
