Profile/Photo Observation Report

Date:	05/06/2018	Weather:		Coding:	PACP 6.0
Pipe Length (ft):		Owner:	City of Hobart	Pre Clean:	No Pre-Cleaning
P.O.#:	197	Surveyor:	M. Pielacha	PSR:	P-905-015-016
Customer:	City of Hobart	Clean Date:		Shape:	C

Street:	Off State Road 130	Flow Control:	Not Controlled
City:	Hobart, IN	Year Renewed:	
Location:	Parking Lot	Tape/Media #:	DEP 197
Purpose:	Routine Assessment	Dia/Height:	18"
Use:	Sanitary	Material:	PVC
Drain Area:		Lining:	
Category:	NA		
Comment:	5-21-2018		
Location Details:		Direction of Survey:	Upstream
US MH:	M-905-016	DS MH:	M-905-015
		Total Length Surveyed (ft):	61.7

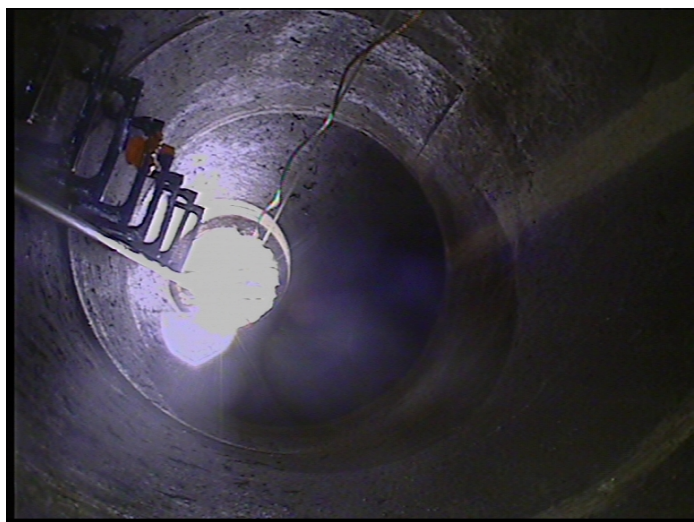
Code: **AMH**
Description: **Manhole**

Distance (ft): **.0**
Structural Grade: **0**
O&M Grade: **0**
Clock Start/From:
Clock To:
1st Value:
2nd Value:
Value Percent:
Continuous Index:
Within 8" of Joint: **NO**
Remarks: **M-905-016**

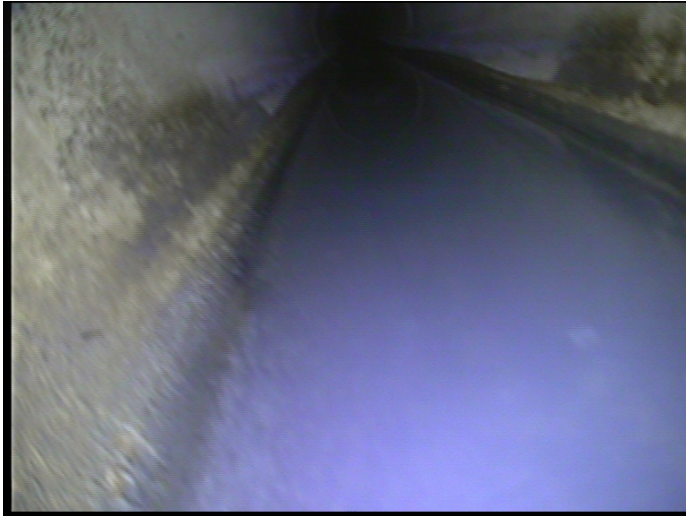
Code: **MWL**
Description: **Water Level**

Distance (ft): **.0**
Structural Grade: **0**
O&M Grade: **0**
Clock Start/From:
Clock To:
1st Value:
2nd Value:
Value Percent: **10.000**
Continuous Index:
Within 8" of Joint: **NO**
Remarks:

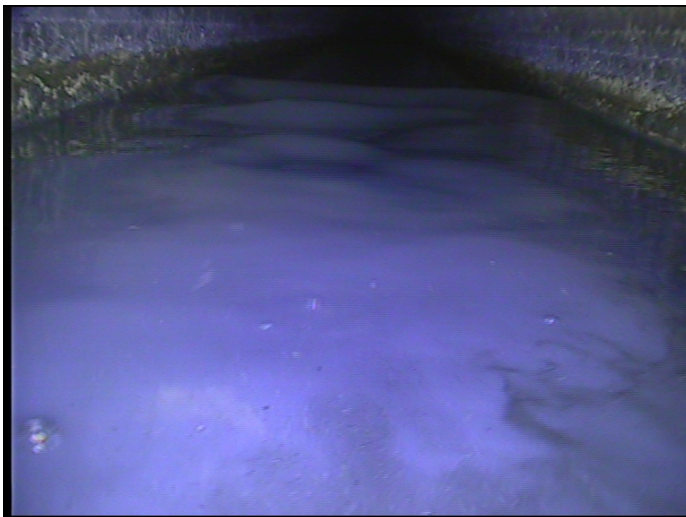
Code: **DSF**
Description: **Deposits Settled Fine**

Distance (ft): **59.8**
Structural Grade: **0**
O&M Grade: **3**
Clock Start/From: **4**
Clock To: **8**
1st Value:
2nd Value:
Value Percent: **15.000**
Continuous Index:
Within 8" of Joint: **YES**
Remarks:

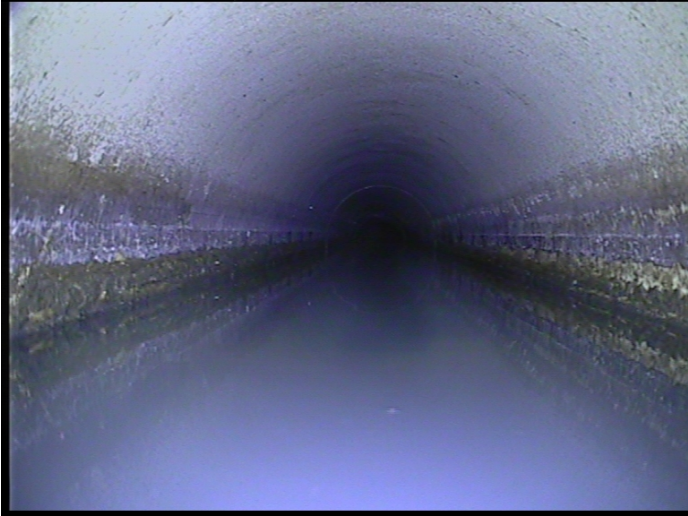
Code:	MSA
Description:	Abandoned Survey
Distance (ft):	61.5
Structural Grade:	0
O&M Grade:	0
Clock Start/From:	
Clock To:	
1st Value:	
2nd Value:	
Value Percent:	
Continuous Index:	
Within 8" of Joint:	NO
Remarks:	deep sediment
