Profile/Photo Observation Report

Street:	Off State Road 130	Flow Control:	Not Controlled
City:	Hobart, IN	Year Renewed:	
Location:	Light Highway	Tape/Media #:	DEP 198
Purpose:	Routine Assessment	Dia/Height:	18"
Use:	Sanitary	Material:	VCP
Drain Area:		Lining:	
Category:	NA		
Comment:	5-21-2018		
Location Details:		Direction of Survey:	Downstream
US MH:	M-905-015	DS MH:	M-905-016
		Total Length Surveyed (ft):	.1

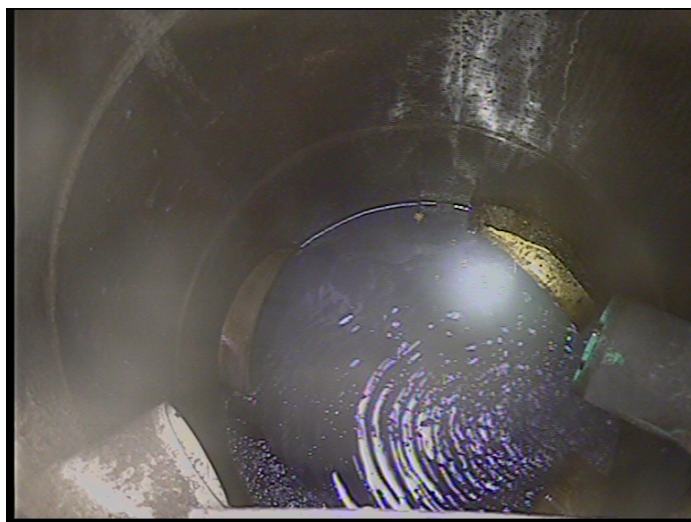
Code: **AMH**
 Description: **Manhole**

Distance (ft): **.0**
 Structural Grade: **0**
 O&M Grade: **0**
 Clock Start/From:
 Clock To:
 1st Value:
 2nd Value:
 Value Percent:
 Continuous Index:
 Within 8" of Joint: **NO**
 Remarks: **M-905-015**

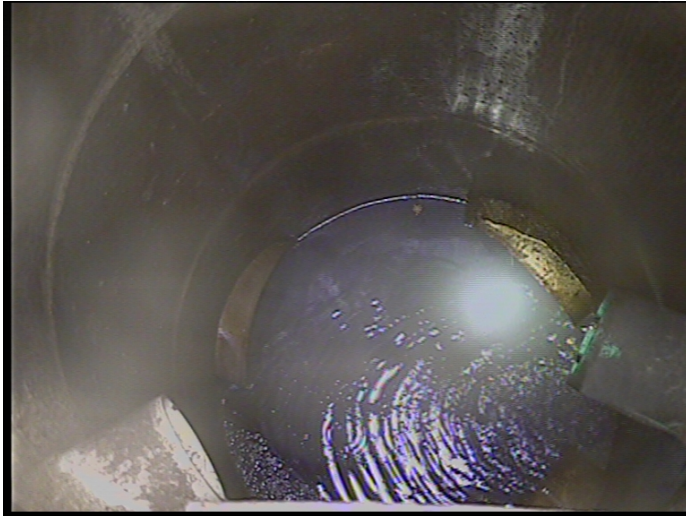
Code: **MWL**
Description: **Water Level**

Distance (ft): **.0**
Structural Grade: **0**
O&M Grade: **0**
Clock Start/From:
Clock To:
1st Value:
2nd Value:
Value Percent: **30.000**
Continuous Index:
Within 8" of Joint: **NO**
Remarks:

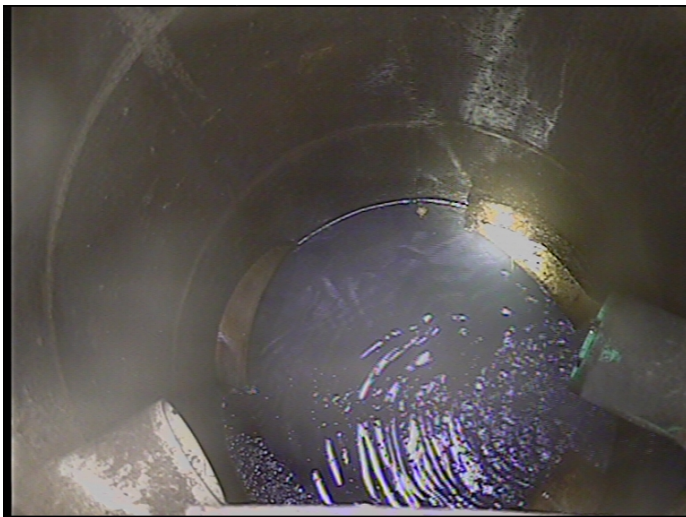
Code: **DSF**
Description: **Deposits Settled Fine**

Distance (ft): **.0**
Structural Grade: **0**
O&M Grade: **5**
Clock Start/From: **3**
Clock To: **9**
1st Value:
2nd Value:
Value Percent: **35.000**
Continuous Index:
Within 8" of Joint: **NO**
Remarks:

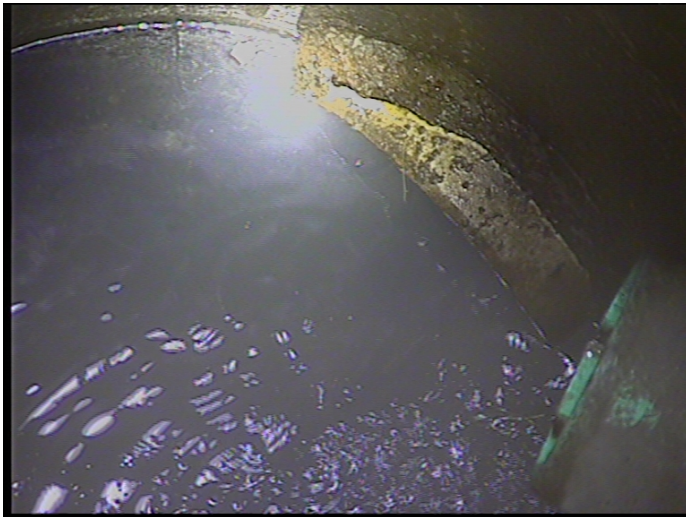
Code:	MSA
Description:	Abandoned Survey
Distance (ft):	.0
Structural Grade:	0
O&M Grade:	0
Clock Start/From:	
Clock To:	
1st Value:	
2nd Value:	
Value Percent:	
Continuous Index:	
Within 8" of Joint:	NO
Remarks:	high water level and very deep sediment
