## Profile/Photo Observation Report

Street:	<b>Off state Road 130</b>	Flow Control:	<b>Not Controlled</b>
City:	<b>Hobart, IN</b>	Year Renewed:	
Location:	<b>Other</b>	Tape/Media #:	<b>DEP 196</b>
Purpose:	<b>Routine Assessment</b>	Dia/Height:	<b>18"</b>
Use:	<b>Sanitary</b>	Material:	<b>PVC</b>
Drain Area:		Lining:	
Category:	<b>NA</b>		
Comment:	<b>5-21-2018</b>

Location Details:		Direction of Survey:	<b>Downstream</b>
US MH:	<b>M-905-017</b>	DS MH:	<b>M-905-016</b>
		Total Length Surveyed (ft):	<b>160.2</b>

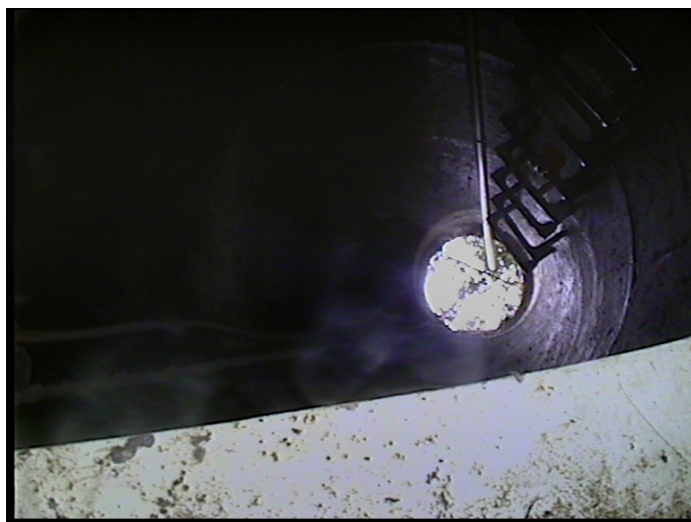
Code: **AMH**  
Description: **Manhole**

Distance (ft): **.0**  
Structural Grade: **0**  
O&M Grade: **0**  
Clock Start/From:  
Clock To:  
1st Value:  
2nd Value:  
Value Percent:  
Continuous Index:  
Within 8" of Joint: **NO**  
Remarks: **M-905-016**

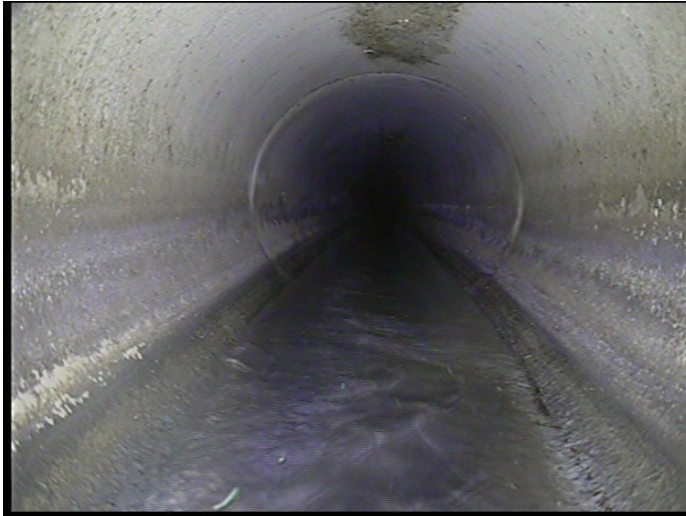
Code:	<b>MWL</b>
Description:	<b>Water Level</b>
Distance (ft):	<b>.0</b>
Structural Grade:	<b>0</b>
O&M Grade:	<b>0</b>
Clock Start/From:	
Clock To:	
1st Value:	
2nd Value:	
Value Percent:	<b>10.000</b>
Continuous Index:	
Within 8" of Joint:	<b>NO</b>
Remarks:

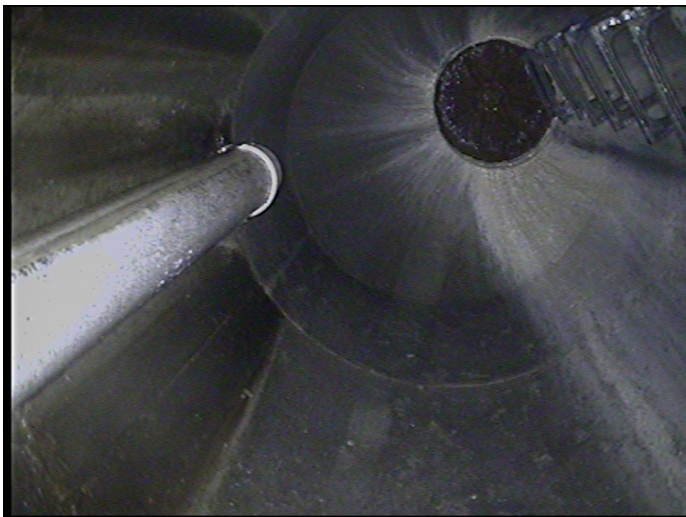
Code:	<b>AMH</b>
Description:	<b>Manhole</b>
Distance (ft):	<b>160.2</b>
Structural Grade:	<b>0</b>
O&M Grade:	<b>0</b>
Clock Start/From:	
Clock To:	
1st Value:	
2nd Value:	
Value Percent:	
Continuous Index:	
Within 8" of Joint:	<b>NO</b>
Remarks:	<b>M-905-017</b>
