## Profile/Photo Observation Report

Date:	<b>05/03/2018</b>	Weather:		Coding:	<b>PACP 6.0</b>
Pipe Length (ft):		Owner:	<b>City of Hobart</b>	Pre Clean:	<b>No Pre-Cleaning</b>
P.O.#:	<b>178</b>	Surveyor:	<b>M. Pielacha</b>	PSR:	<b>P-905-020-066</b>
Customer:	<b>City of Hobart</b>	Clean Date:		Shape:	<b>C</b>

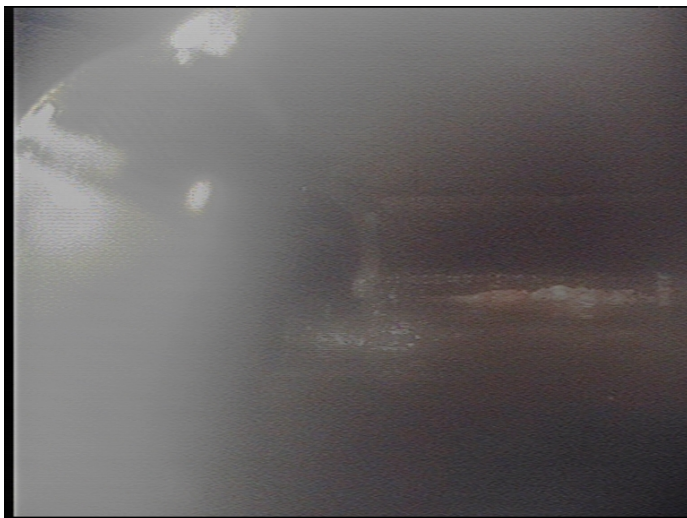
Code: **AMH**  
 Description: **Manhole**

Distance (ft): **.0**  
 Structural Grade: **0**  
 O&M Grade: **0**  
 Clock Start/From:  
 Clock To:  
 1st Value:  
 2nd Value:  
 Value Percent:  
 Continuous Index:  
 Within 8" of Joint: **NO**  
 Remarks: **M-905-066**

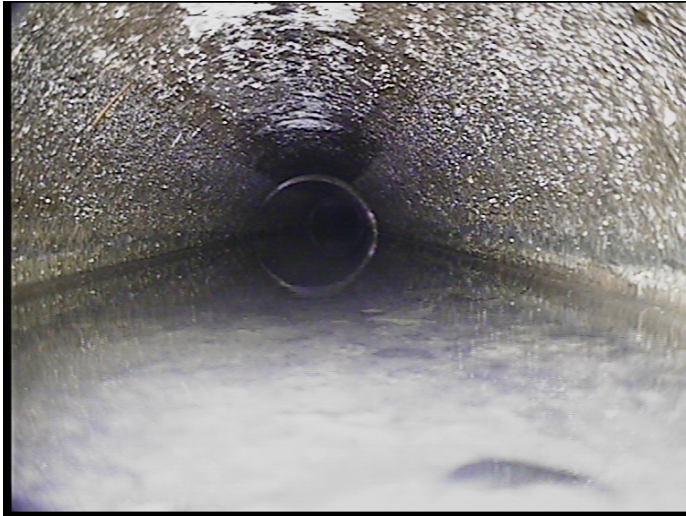
Code: **MWL**  
Description: **Water Level**

Distance (ft): **.0**  
Structural Grade: **0**  
O&M Grade: **0**  
Clock Start/From:  
Clock To:  
1st Value:  
2nd Value:  
Value Percent: **10.000**  
Continuous Index:  
Within 8" of Joint: **NO**  
Remarks:

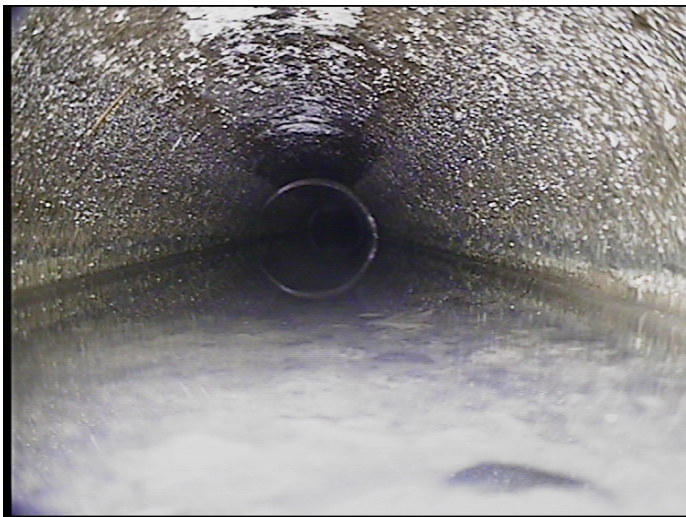
Code: **DSF**  
Description: **Deposits Settled Fine**

Distance (ft): **.0**  
Structural Grade: **0**  
O&M Grade: **3**  
Clock Start/From: **4**  
Clock To: **8**  
1st Value:  
2nd Value:  
Value Percent: **20.000**  
Continuous Index:  
Within 8" of Joint: **NO**  
Remarks:

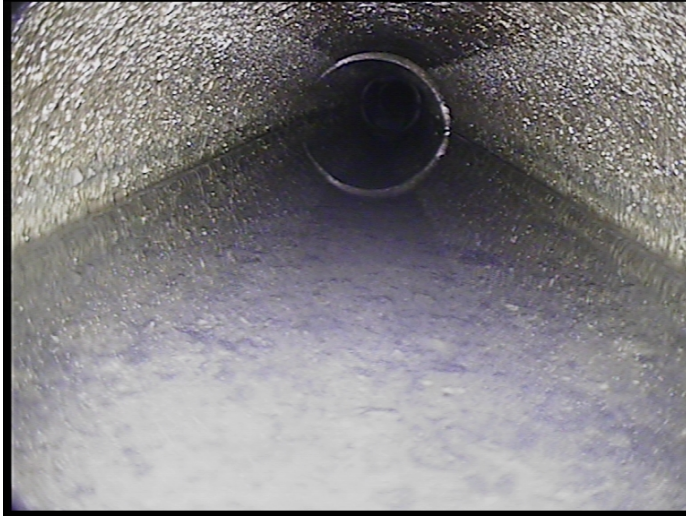
Code:	<b>MSA</b>
Description:	<b>Abandoned Survey</b>
Distance (ft):	<b>1.5</b>
Structural Grade:	<b>0</b>
O&M Grade:	<b>0</b>
Clock Start/From:	
Clock To:	
1st Value:	
2nd Value:	
Value Percent:	
Continuous Index:	
Within 8" of Joint:	<b>NO</b>
Remarks:	<b>sediment</b>
