## Profile/Photo Observation Report

| P.O.#: | <b>182</b> | Surveyor: | <b>M. Pielacha</b> | PSR: | <b>P-905-025-026</b> |

| US MH: | <b>M-905-025</b> | DS MH: | <b>M-905-026</b> |

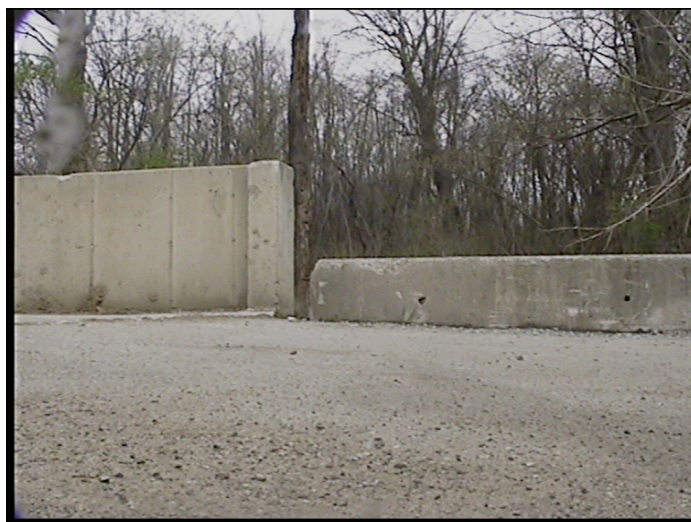
Code: **AMH**  
Description: **Manhole**

Distance (ft): **.0**  
Structural Grade: **0**  
O&M Grade: **0**  
Clock Start/From:  
Clock To:  
1st Value:  
2nd Value:  
Value Percent:  
Continuous Index:  
Within 8" of Joint: **NO**  
Remarks: **M-905-025**

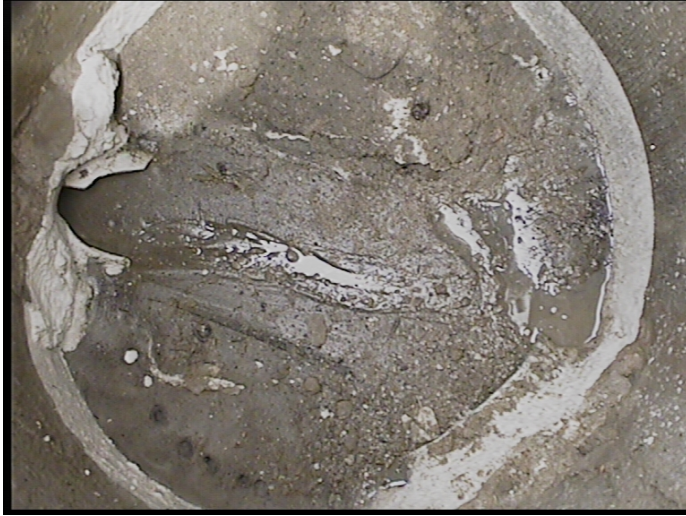
Code: **MWL**  
Description: **Water Level**

Distance (ft): **.0**  
Structural Grade: **0**  
O&M Grade: **0**  
Clock Start/From:  
Clock To:  
1st Value:  
2nd Value:  
Value Percent: **0.000**  
Continuous Index:  
Within 8" of Joint: **NO**  
Remarks:

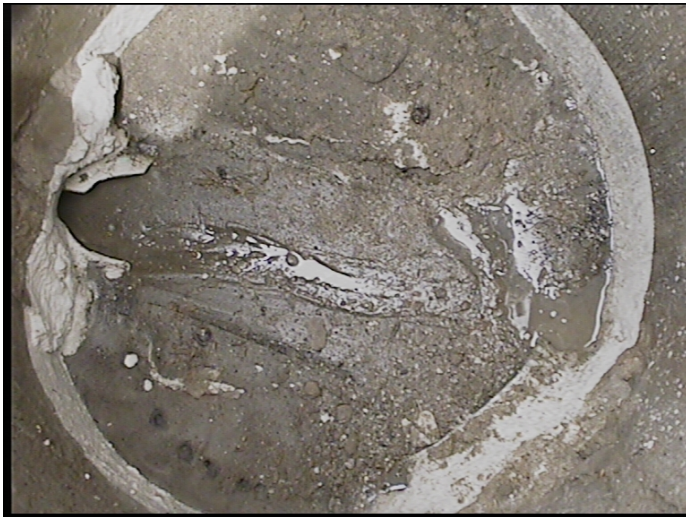
Code: **MSA**  
Description: **Abandoned Survey**

Distance (ft): **.0**  
Structural Grade: **0**  
O&M Grade: **0**  
Clock Start/From:  
Clock To:  
1st Value:  
2nd Value:  
Value Percent:  
Continuous Index:  
Within 8" of Joint: **NO**  
Remarks: **heavy sediment**
