## Profile/Photo Observation Report

| Customer: | <b>City of Hobart</b> | Clean Date: | | Shape: | <b>C</b> |

| Use: | <b>Sanitary</b> | Material: | <b>PVC</b> |
| US MH: | <b>M-905-028</b> | DS MH: | <b>M-905-029</b> |

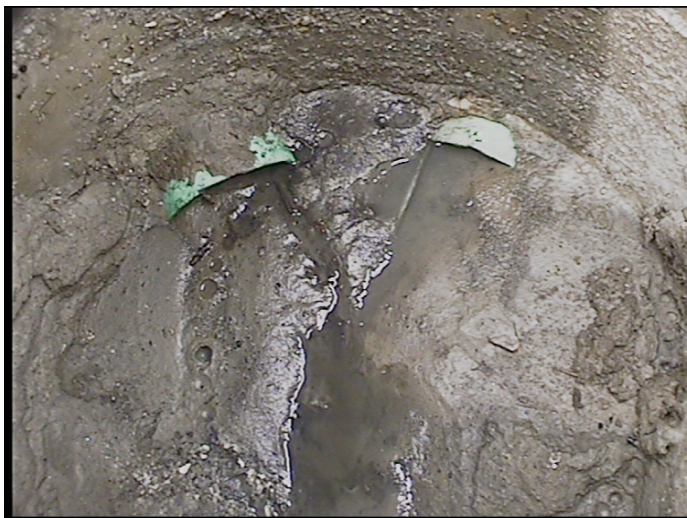
Code: **AMH**  
 Description: **Manhole**

Distance (ft): **.0**  
 Structural Grade: **0**  
 O&M Grade: **0**  
 Clock Start/From:  
 Clock To:  
 1st Value:  
 2nd Value:  
 Value Percent:  
 Continuous Index:  
 Within 8" of Joint: **NO**  
 Remarks: **M-905-029**

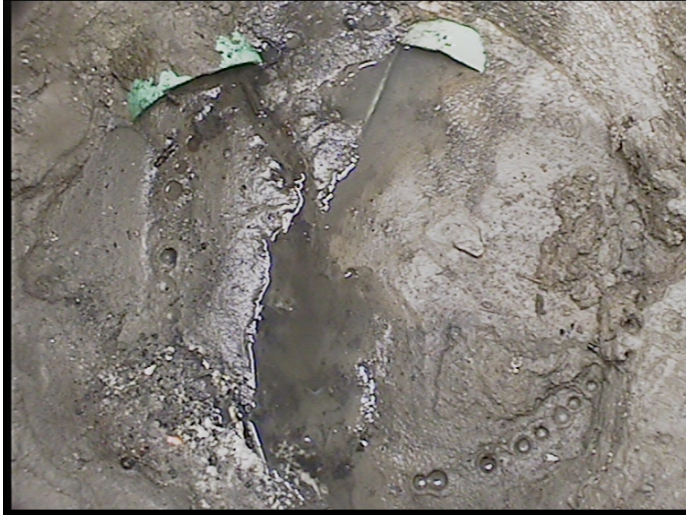
Code: **MWL**  
Description: **Water Level**

Distance (ft): **.0**  
Structural Grade: **0**  
O&M Grade: **0**  
Clock Start/From:  
Clock To:  
1st Value:  
2nd Value:  
Value Percent: **10.000**  
Continuous Index:  
Within 8" of Joint: **NO**  
Remarks:

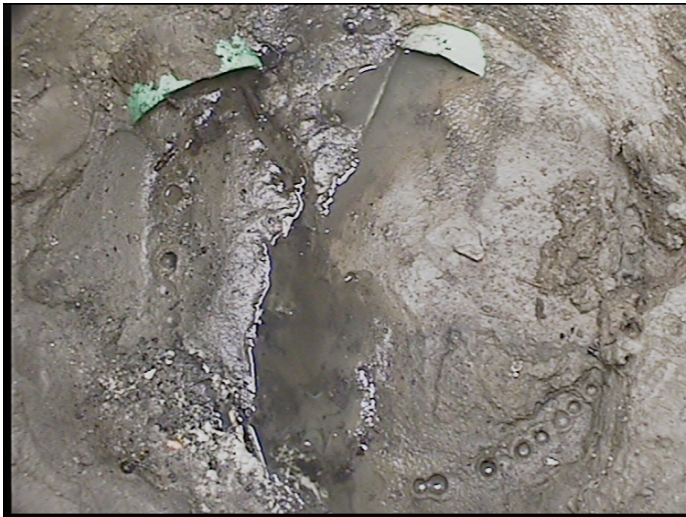
Code: **MSA**  
Description: **Abandoned Survey**

Distance (ft): **.0**  
Structural Grade: **0**  
O&M Grade: **0**  
Clock Start/From:  
Clock To:  
1st Value:  
2nd Value:  
Value Percent:  
Continuous Index:  
Within 8" of Joint: **NO**  
Remarks: **heavy sediment**
