## Profile/Photo Observation Report

Date:	<b>05/03/2018</b>	Weather:		Coding:	<b>PACP 6.0</b>
Pipe Length (ft):		Owner:	<b>City of Hobart</b>	Pre Clean:	<b>No Pre-Cleaning</b>
P.O.#:	<b>184</b>	Surveyor:	<b>M. Pielacha</b>	PSR:	<b>P-905-032-033</b>
Customer:	<b>City of Hobart</b>	Clean Date:		Shape:	<b>C</b>

Street:	<b>Shelby Street</b>	Flow Control:	<b>Not Controlled</b>
City:	<b>Hobart, IN</b>	Year Renewed:	
Location:	<b>Light Highway</b>	Tape/Media #:	<b>DEP 184</b>
Purpose:	<b>Routine Assessment</b>	Dia/Height:	<b>8"</b>
Use:	<b>Sanitary</b>	Material:	<b>VCP</b>
Drain Area:		Lining:	
Category:	<b>NA</b>		
Comment:	<b>5-21-2018</b>		
Location Details:		Direction of Survey:	<b>Upstream</b>
US MH:	<b>M-905-033</b>	DS MH:	<b>M-905-032</b>
		Total Length Surveyed (ft):	<b>24.5</b>

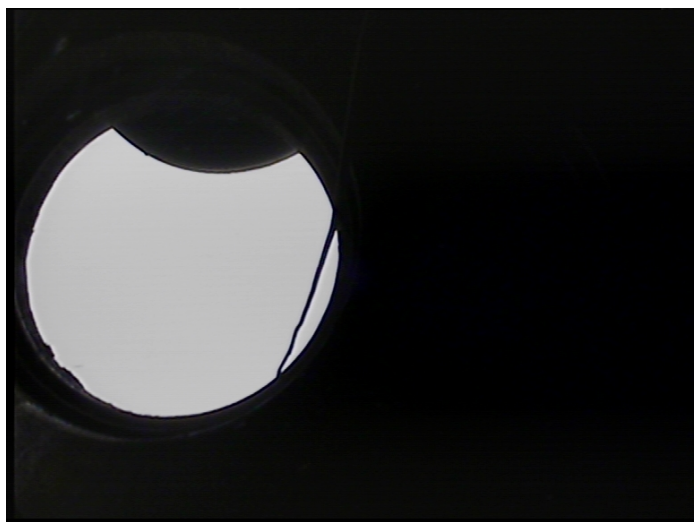
Code: **AMH**  
 Description: **Manhole**

Distance (ft): **.0**  
 Structural Grade: **0**  
 O&M Grade: **0**  
 Clock Start/From:  
 Clock To:  
 1st Value:  
 2nd Value:  
 Value Percent:  
 Continuous Index:  
 Within 8" of Joint: **NO**  
 Remarks: **M-905-033**

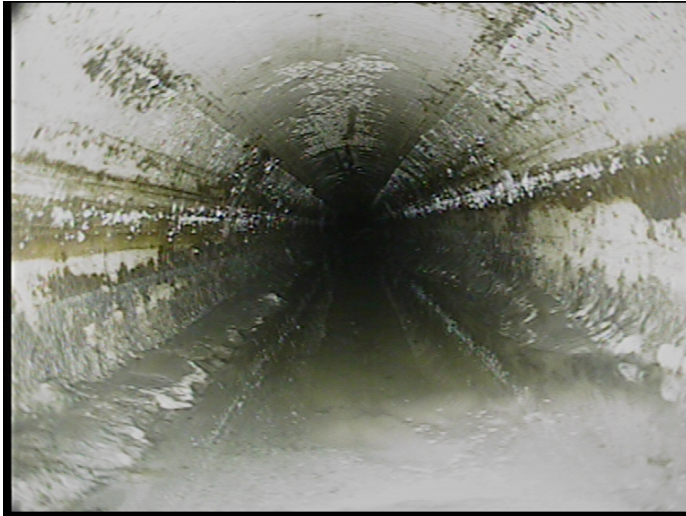
Code: **MWL**  
Description: **Water Level**

Distance (ft): **.0**  
Structural Grade: **0**  
O&M Grade: **0**  
Clock Start/From:  
Clock To:  
1st Value:  
2nd Value:  
Value Percent: **10.000**  
Continuous Index:  
Within 8" of Joint: **NO**  
Remarks:

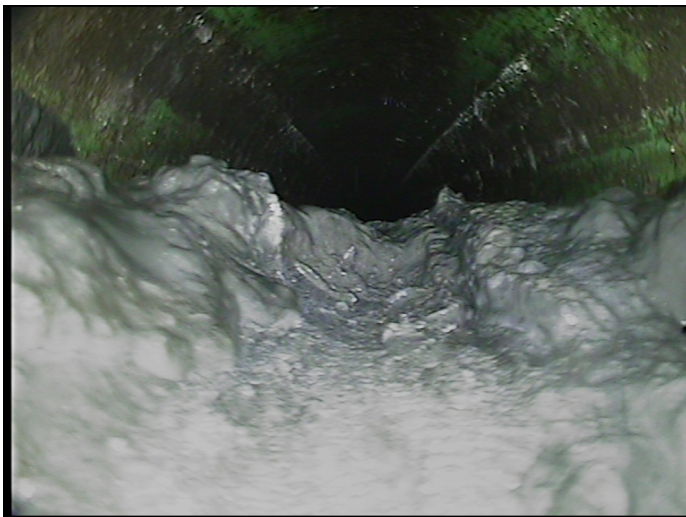
Code: **DSF**  
Description: **Deposits Settled Fine**

Distance (ft): **22.8**  
Structural Grade: **0**  
O&M Grade: **4**  
Clock Start/From: **4**  
Clock To: **8**  
1st Value:  
2nd Value:  
Value Percent: **25.000**  
Continuous Index:  
Within 8" of Joint: **NO**  
Remarks:
