## Profile/Photo Observation Report

Date:	<b>09/10/2022</b>	Weather:		Coding:	<b>PACP 7.0</b>
Pipe Length (ft):	<b>263.0</b>	Owner:	<b>City of Hobart</b>	Pre Clean:	<b>Heavy Cleaning</b>
P.O.#:	<b>YES502259</b>	Surveyor:	<b>S. Bucklin</b>	PSR:	<b>P-905-034-035</b>
Customer:	<b>City of Hobart</b>	Clean Date:	<b>08/23/2022</b>	Shape:	<b>C</b>

Street:	<b>East 5th Street</b>	Flow Control:	<b>Not Controlled</b>
City:	<b>Hobart, IN</b>	Year Renewed:	
Location:	<b>Easement/Right of Way</b>	Tape/Media #:	
Purpose:	<b>Routine Assessment</b>	Dia/Height:	<b>8"</b>
Use:	<b>Sanitary Sewage Pipe</b>	Material:	<b>PVC</b>
Drain Area:		Lining:	<b>None</b>
Category:	<b>NA</b>		
Comment:			
Location Details:	<b>JUST NORTH OF THE DRIVEWAY TO</b>	Direction of Survey:	<b>Upstream</b>
US MH:	<b>M-905-035</b>	DS MH:	<b>M-905-034</b>
		Total Length Surveyed (ft):	<b>260.7</b>

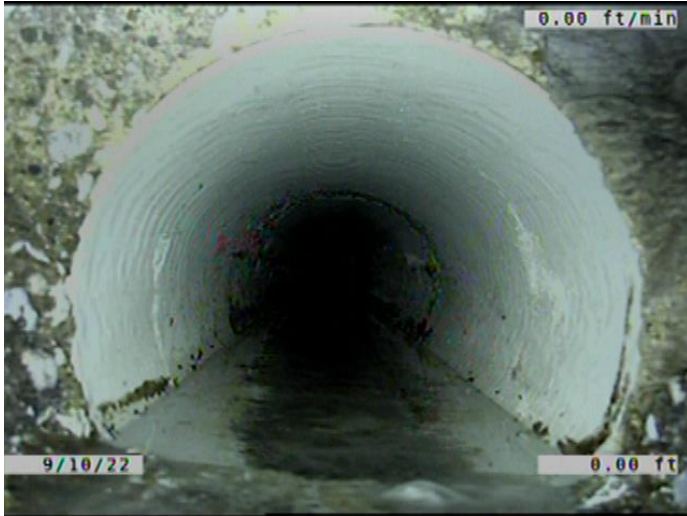
Code:	<b>MWL</b>
Description:	<b>Miscellaneous Water Level</b>
Distance (ft):	<b>.0</b>
Structural Grade:	<b>0</b>
O&M Grade:	<b>0</b>
Clock Start/From:	
Clock To:	
1st Value:	
2nd Value:	
Value Percent:	<b>10.000</b>
Continuous Index:	
Within 8" of Joint:	<b>NO</b>
Remarks:

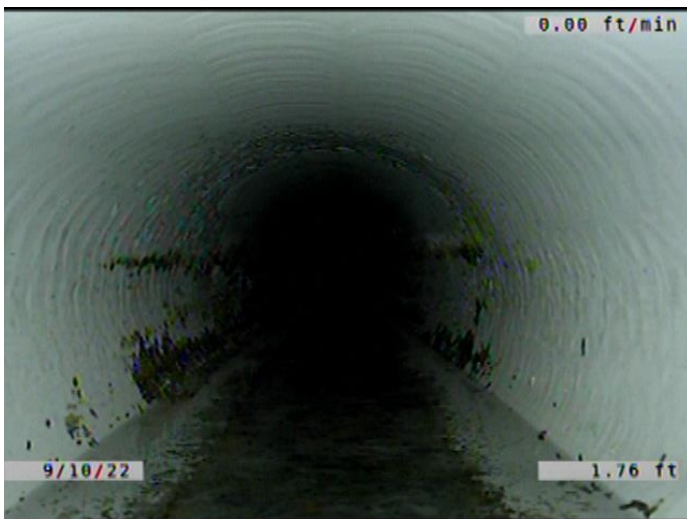
Code:	<b>DSF</b>
Description:	<b>Deposits Settled Fine</b>
Distance (ft):	<b>1.8</b>
Structural Grade:	<b>0</b>
O&M Grade:	<b>2</b>
Clock Start/From:	<b>5</b>
Clock To:	<b>7</b>
1st Value:	
2nd Value:	
Value Percent:	<b>5.000</b>
Continuous Index:	<b>S01</b>
Within 8" of Joint:	<b>YES</b>
Remarks:

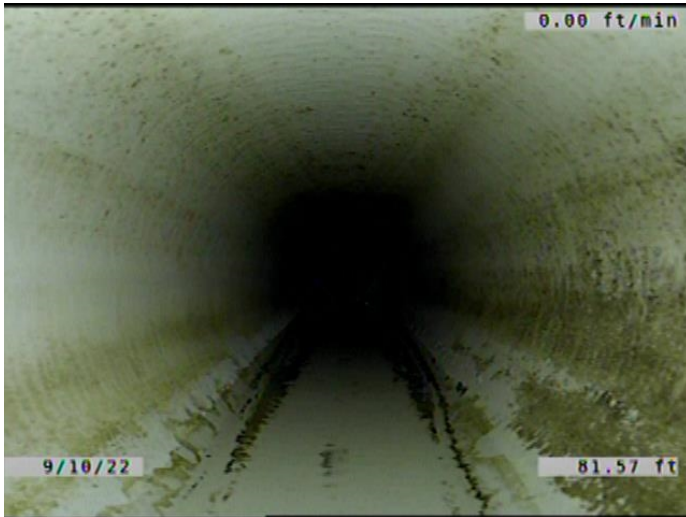
Code: **MWLS**  
Description: **Miscellaneous Water Level Sag**

Distance (ft): **81.6**  
Structural Grade: **2**  
O&M Grade: **0**  
Clock Start/From:  
Clock To:  
1st Value:  
2nd Value:  
Value Percent: **10.000**  
Continuous Index: **S02**  
Within 8" of Joint: **NO**  
Remarks:

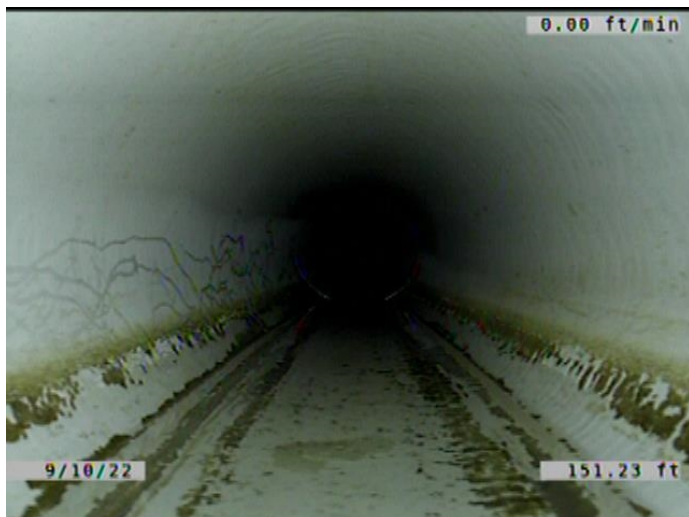
Code: **MWLS**  
Description: **Miscellaneous Water Level Sag**

Distance (ft): **151.2**  
Structural Grade: **2**  
O&M Grade: **0**  
Clock Start/From:  
Clock To:  
1st Value:  
2nd Value:  
Value Percent: **15.000**  
Continuous Index:  
Within 8" of Joint: **NO**  
Remarks:

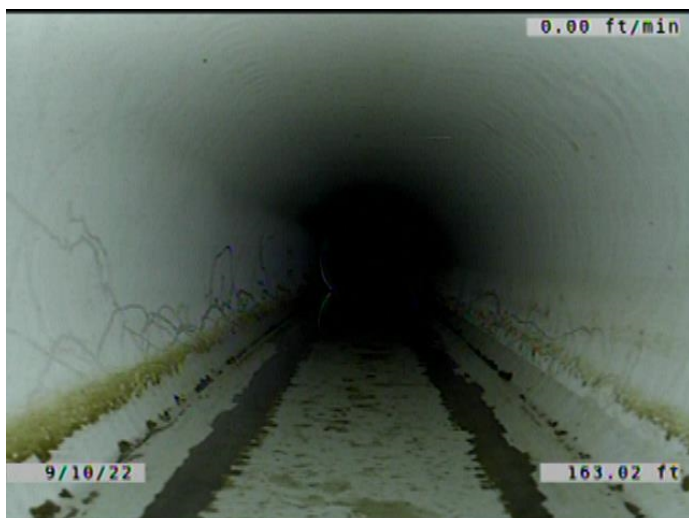
Code: **MWLS**  
Description: **Miscellaneous Water Level Sag**

Distance (ft): **163.0**  
Structural Grade: **2**  
O&M Grade: **0**  
Clock Start/From:  
Clock To:  
1st Value:  
2nd Value:  
Value Percent: **15.000**  
Continuous Index: **S03**  
Within 8" of Joint: **NO**  
Remarks:

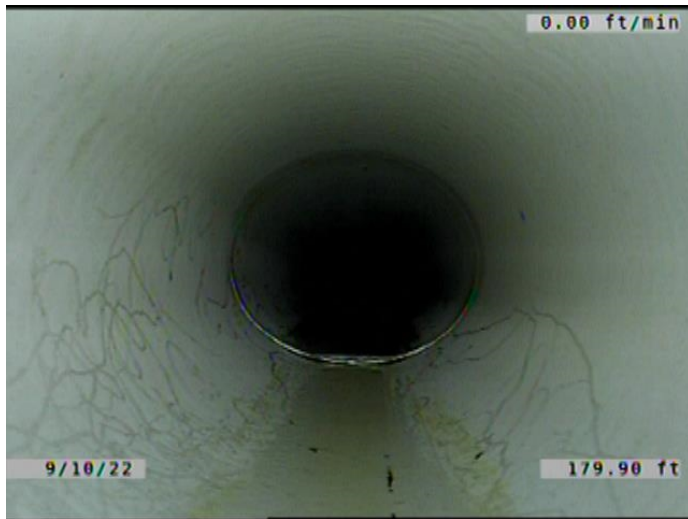
Code: **MWLS**  
Description: **Miscellaneous Water Level Sag**

Distance (ft): **179.9**  
Structural Grade: **2**  
O&M Grade: **0**  
Clock Start/From:  
Clock To:  
1st Value:  
2nd Value:  
Value Percent: **15.000**  
Continuous Index: **F03**  
Within 8" of Joint: **NO**  
Remarks:

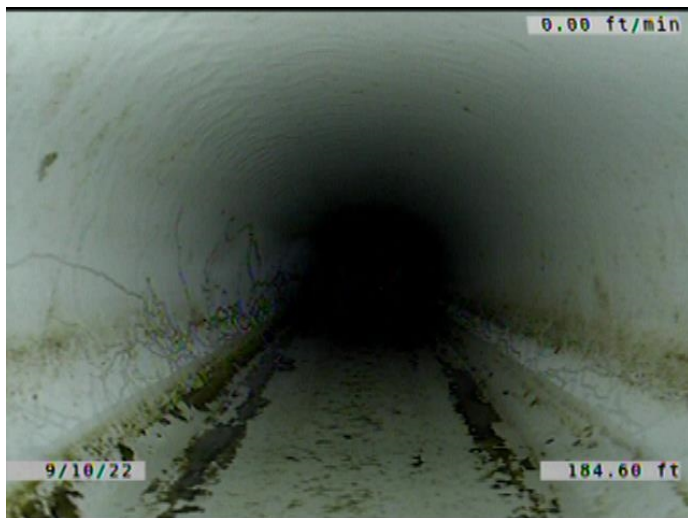
Code: **MWLS**  
Description: **Miscellaneous Water Level Sag**

Distance (ft): **184.6**  
Structural Grade: **2**  
O&M Grade: **0**  
Clock Start/From:  
Clock To:  
1st Value:  
2nd Value:  
Value Percent: **15.000**  
Continuous Index: **S04**  
Within 8" of Joint: **NO**  
Remarks:

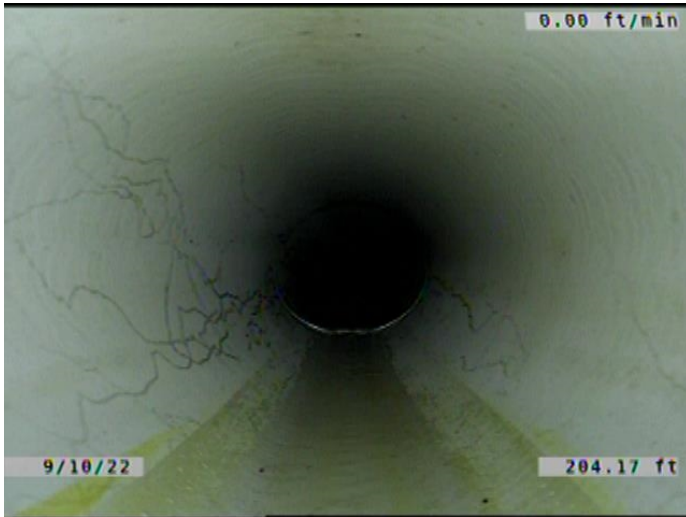
Code: **MWLS**  
Description: **Miscellaneous Water Level Sag**

Distance (ft): **204.2**  
Structural Grade: **2**  
O&M Grade: **0**  
Clock Start/From:  
Clock To:  
1st Value:  
2nd Value:  
Value Percent: **15.000**  
Continuous Index: **F04**  
Within 8" of Joint: **NO**  
Remarks:

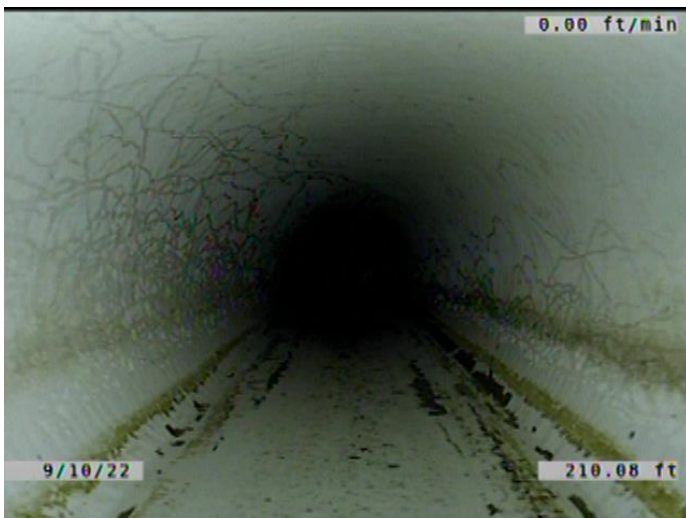
Code: **MWLS**  
Description: **Miscellaneous Water Level Sag**

Distance (ft): **210.1**  
Structural Grade: **2**  
O&M Grade: **0**  
Clock Start/From:  
Clock To:  
1st Value:  
2nd Value:  
Value Percent: **15.000**  
Continuous Index: **S05**  
Within 8" of Joint: **NO**  
Remarks:

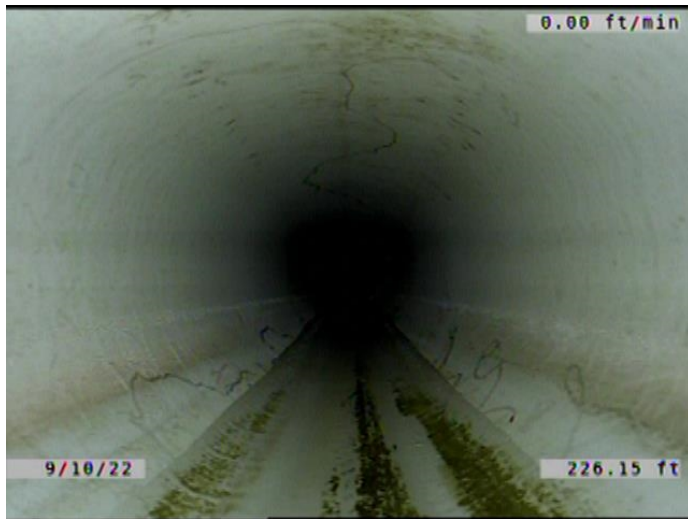
Code: **MWLS**  
Description: **Miscellaneous Water Level Sag**

Distance (ft): **226.2**  
Structural Grade: **2**  
O&M Grade: **0**  
Clock Start/From:  
Clock To:  
1st Value:  
2nd Value:  
Value Percent: **15.000**  
Continuous Index: **F05**  
Within 8" of Joint: **NO**  
Remarks:

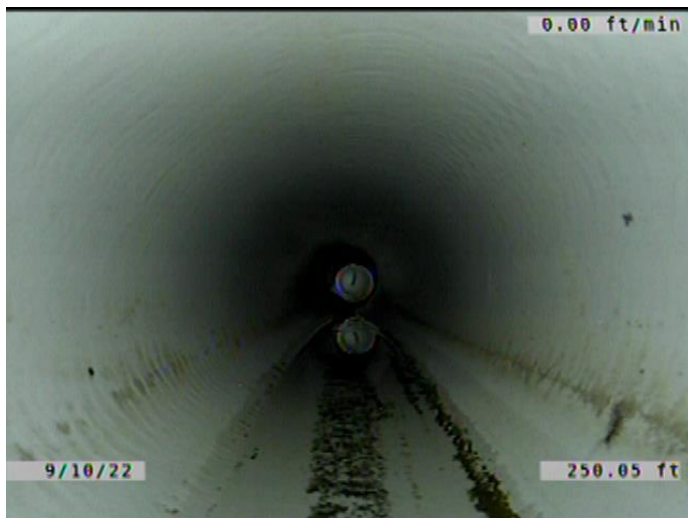
Code: **MWLS**  
Description: **Miscellaneous Water Level Sag**

Distance (ft): **250.0**  
Structural Grade: **2**  
O&M Grade: **0**  
Clock Start/From:  
Clock To:  
1st Value:  
2nd Value:  
Value Percent: **5.000**  
Continuous Index:  
Within 8" of Joint: **NO**  
Remarks:
