## Profile/Photo Observation Report

Street:	<b>E 9TH PL</b>	Flow Control:	<b>Not Controlled</b>
City:	<b>Hobart, IN</b>	Year Renewed:	
Location:	<b>Yard</b>	Tape/Media #:	
Purpose:	<b>Maintenance Related</b>	Dia/Height:	<b>8"</b>
Use:	<b>Sanitary</b>	Material:	<b>PVC</b>
Drain Area:	<b>NA</b>	Lining:	<b>Cured in Place</b>
Category:	<b>NA</b>		
Comment:	<b>flow incorrect.</b>

Location Details:		Direction of Survey:	<b>Downstream</b>
US MH:	<b>M-906-004</b>	DS MH:	<b>M-906-009</b>
		Total Length Surveyed (ft):	<b>237.3</b>

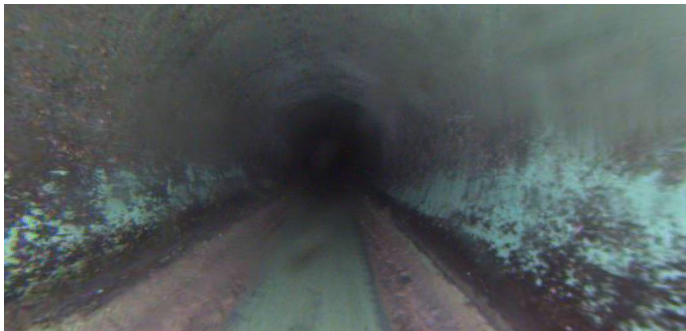
Code: **AMH**  
Description: **Manhole**

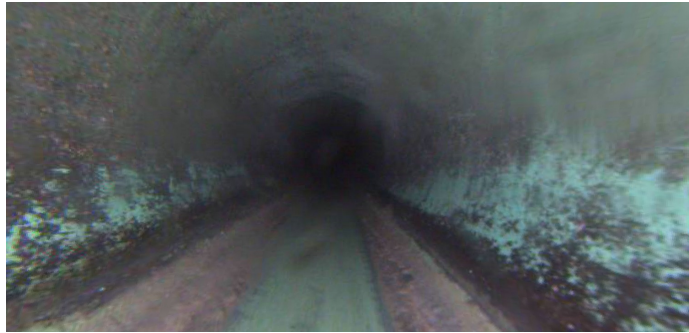
Code: **MWL**  
Description: **Water Level**

Distance (ft): **.0**  
Structural Grade: **0**  
O&M Grade: **0**  
Clock Start/From:  
Clock To:  
1st Value:  
2nd Value:  
Value Percent: **5.000**  
Continuous Index:  
Within 8" of Joint: **NO**  
Remarks:

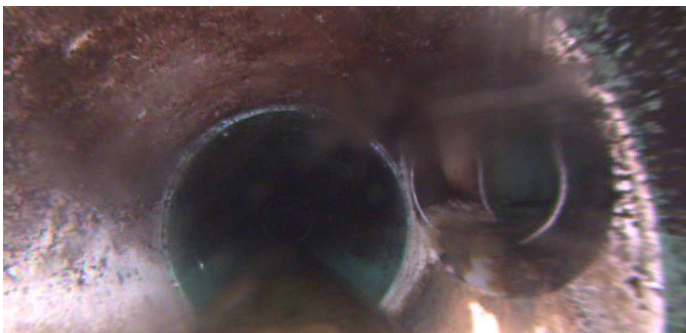
Code: **TF**  
Description: **Tap Factory**

Distance (ft): **173.8**  
Structural Grade: **0**  
O&M Grade: **0**  
Clock Start/From: **3**  
Clock To:  
1st Value: **4.000**  
2nd Value:  
Value Percent:  
Continuous Index:  
Within 8" of Joint:  
Remarks:

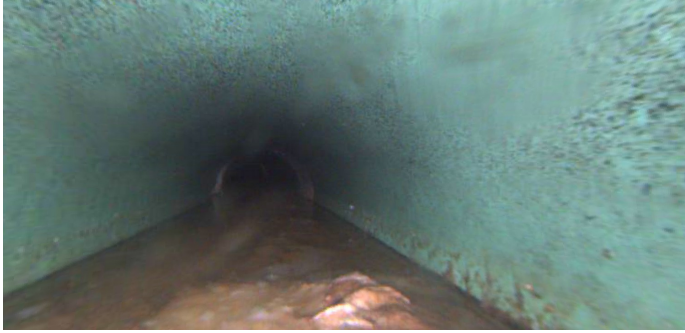
Code: **MWL**  
Description: **Water Level**

Distance (ft): **213.9**  
Structural Grade: **0**  
O&M Grade: **0**  
Clock Start/From:  
Clock To:  
1st Value:  
2nd Value:  
Value Percent: **30.000**  
Continuous Index:  
Within 8" of Joint: **NO**  
Remarks:

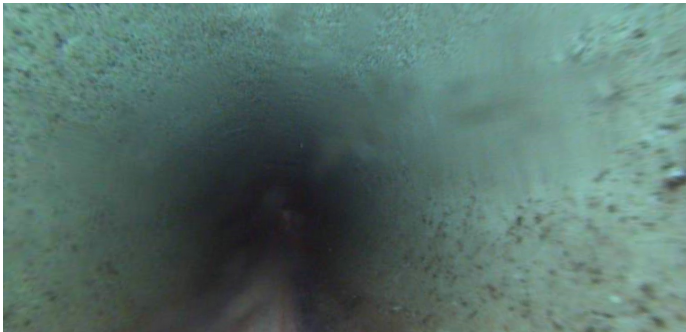
Code: **MWL**  
Description: **Water Level**

Distance (ft): **230.9**  
Structural Grade: **0**  
O&M Grade: **0**  
Clock Start/From:  
Clock To:  
1st Value:  
2nd Value:  
Value Percent: **5.000**  
Continuous Index:  
Within 8" of Joint: **NO**  
Remarks:
